**PHASE I ENVIRONMENTAL SITE ASSESSMENT
U.S. GEOLOGICAL SURVEY CAMPUS
345 MIDDLEFIELD ROAD
MENLO PARK, CALIFORNIA**

12 SEPTEMBER 2019

U.S. General Services Administration
50 United Nations Plaza
San Francisco, CA 94102-3434

Adanta, Inc.
1801 Oak Street
Napa, CA 94559

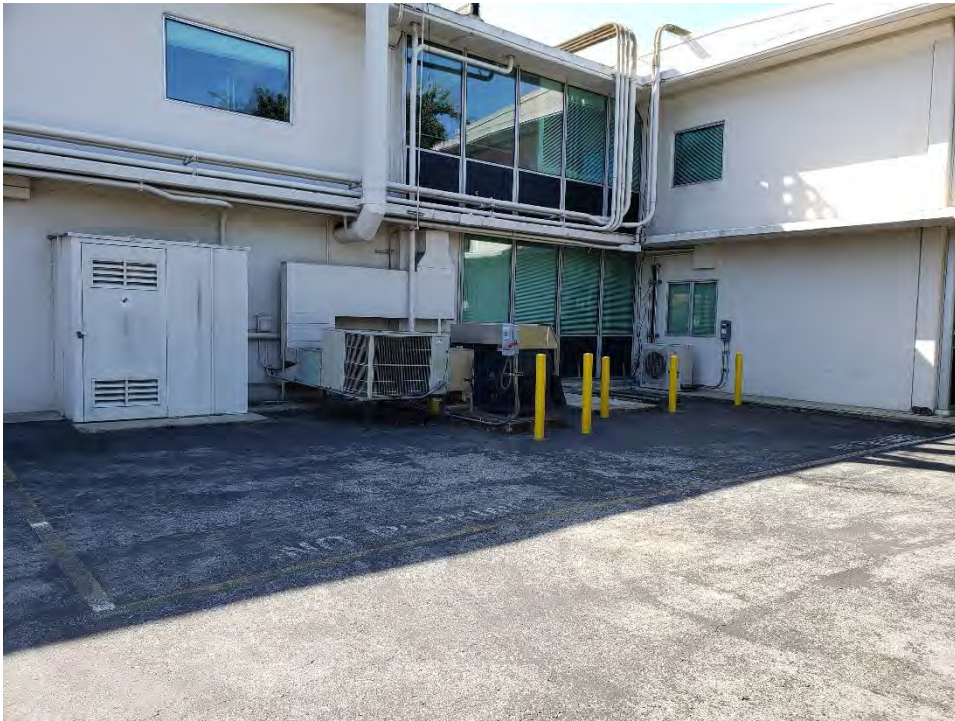
Photograph 2 - View of electrical transformers and air conditioning units adjacent to Building 2. Note cleanliness of area and placement of protective bollards.

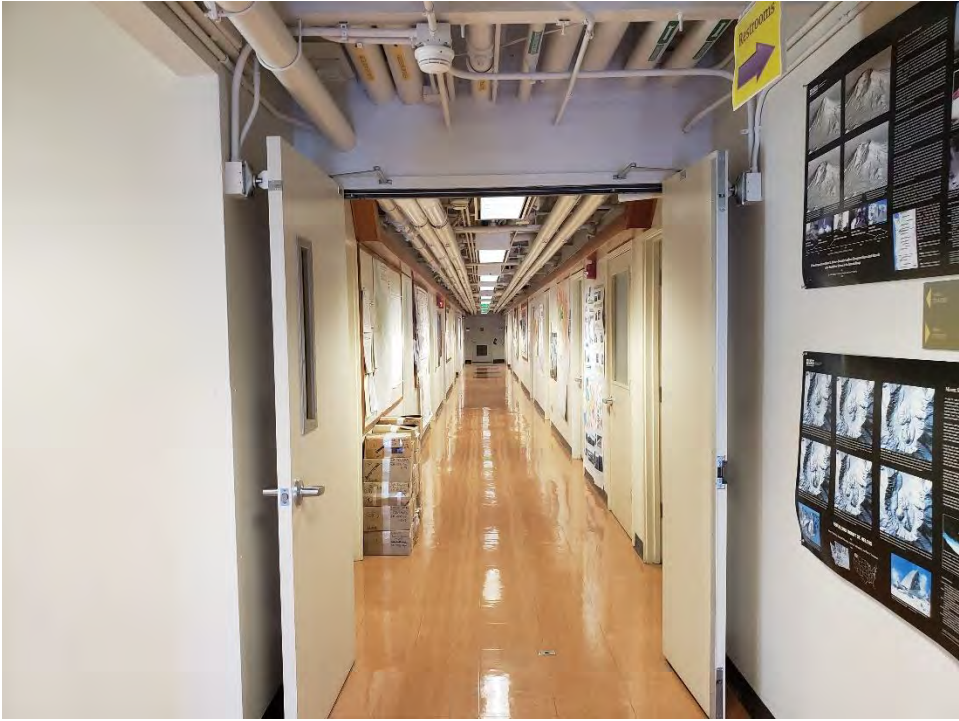
Photograph 3 - View of interior hallway of Building 2. Note exposed but well-maintained ceiling piping.

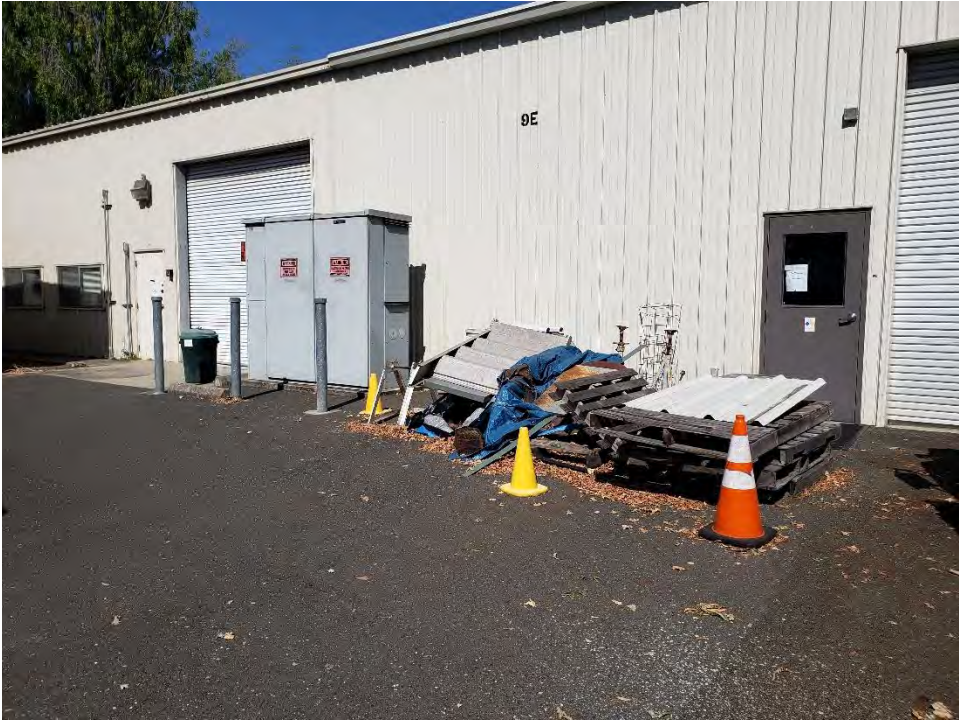
During the Property survey, several debris piles were observed adjacent to buildings rented out to commercial tenants along the southern boundary. One of these debris piles contained a partially empty propane container. Additionally, a yellow flammable materials storage cabinet was observed outdoors. The cabinet was locked and inaccessible; however, the site escort stated it was most likely empty as it was tenant owned and were vacating the premises. Laboratories were observed on the second floor of Building 15 and no concerns were identified regarding hazardous material storage and/or management.

Photograph 4 - View of debris pile adjacent to transformer on east side of Building 9E.

- Properly dispose of the solid waste identified adjacent to Building 9E (see Appendix A, photographs 4 and 5).
- Ensure proper cleanup and disposal of used absorbent (see Appendix A, photograph 7).
- Further research the status of the three groundwater monitoring wells identified on the property (see Section 5.2).
- Determine ownership/responsibility for the identified hazardous materials storage locker and determine contents. Properly dispose of any excess materials and/or hazardous waste.
- As noted in Section 1.1, the SPCC Plan identifies five ASTs and one UST located on the subject property. The plan states that three ASTs (Tanks 3, 3a, and 11) and the UST are operated by the USGS and two ASTs (Tanks 1c, 1-2) are operated by GSA. Clarify ownership/operation of all storage tanks to ensure regulatory requirements are not overlooked.

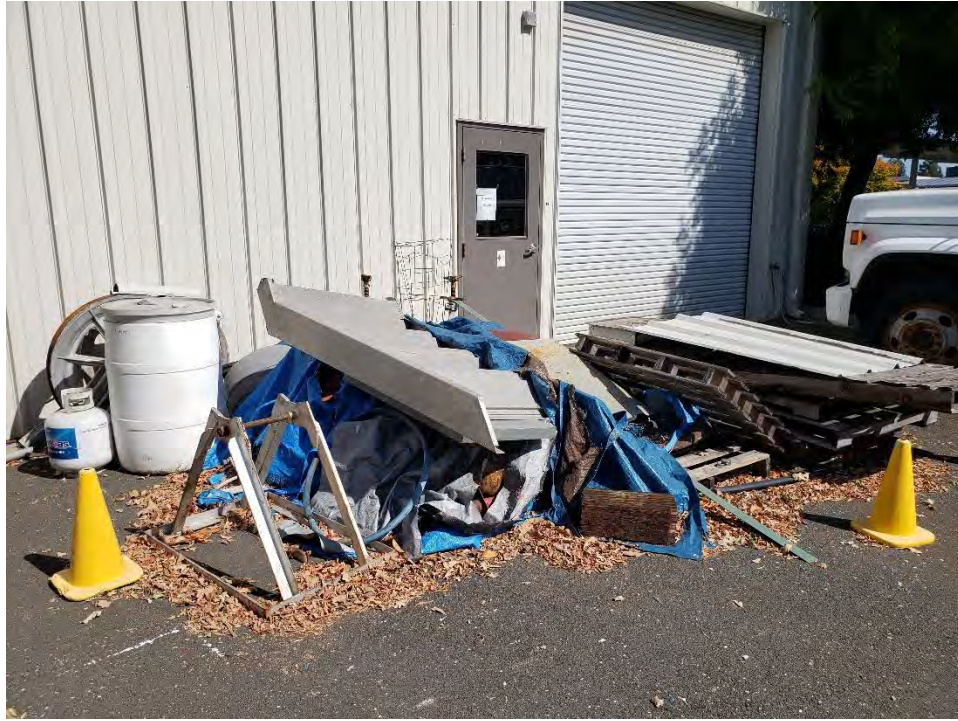
Photograph 5 - View of partially empty propane container within Building 9E debris pile.

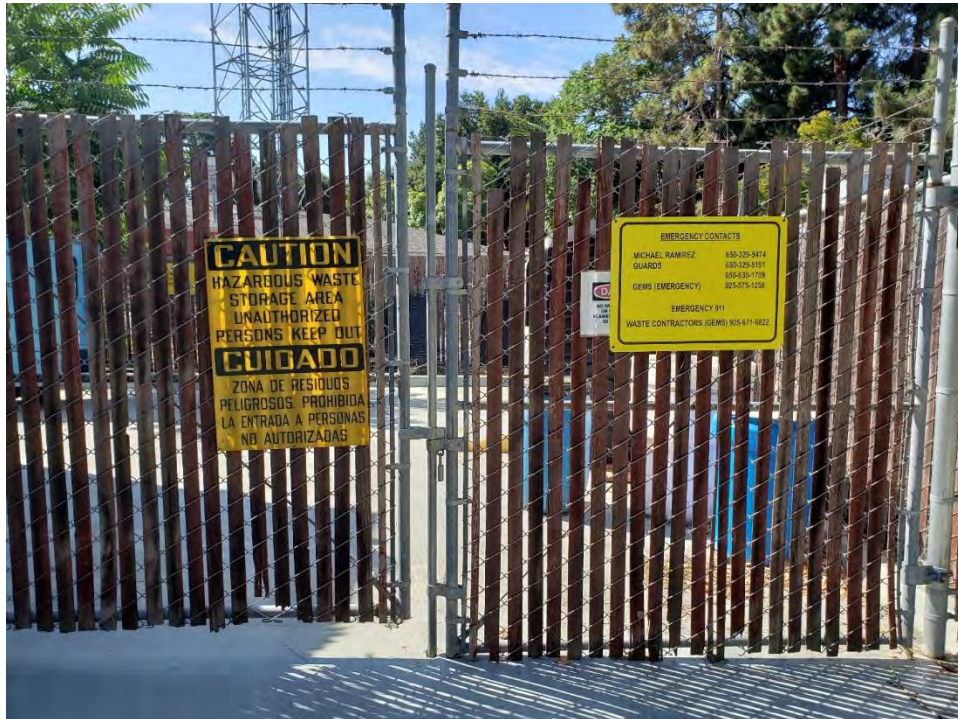
storage shed was present in the southwestern portion of the Property. This area was highly secured, well maintained and no issues were observed.

Photograph 6 - View of secured and well-kept hazardous materials storage area (Building 12).

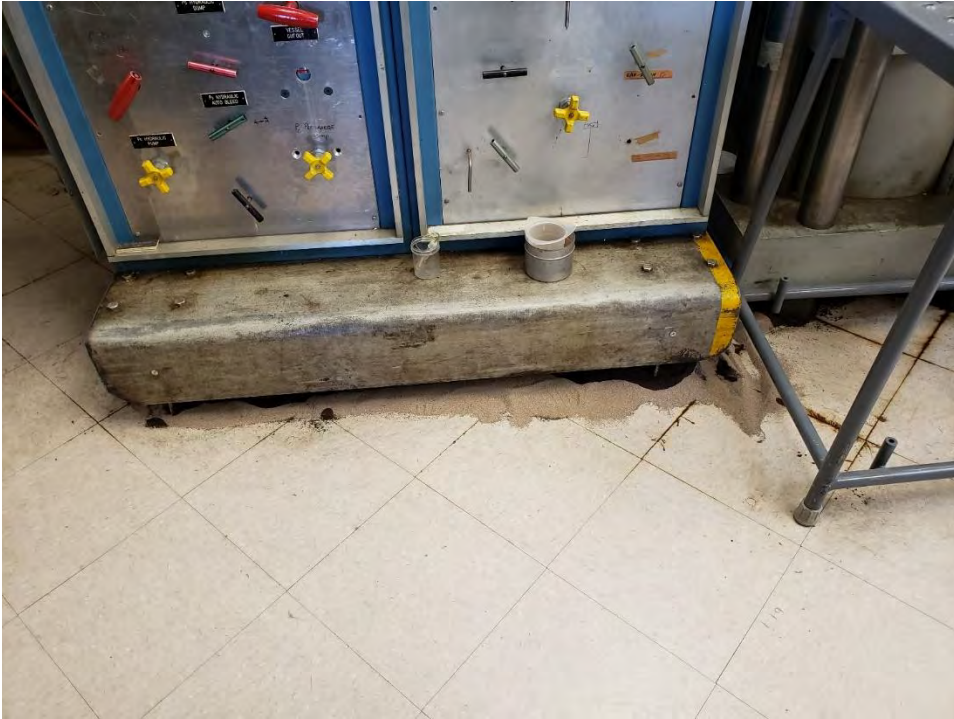
During the survey of the interior of the buildings, common cleaning and maintenance chemicals were observed in storage areas. Fluid leaks were apparent from industrial machinery within one of the rented buildings and addressed through the application of absorbent material. These leaks posed no environmental threat.

Photograph 7 - View of contained fluid leak beneath industrial machinery within Building 10. Note absorbent material used to keep leak within machine footprint.

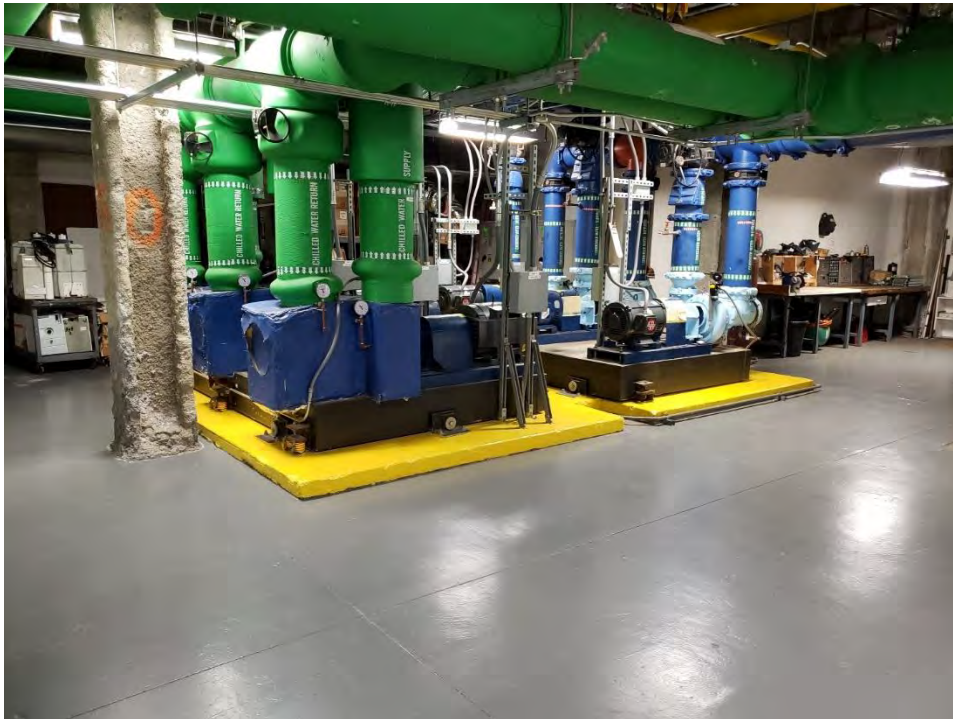
Photograph 10 - View of machine/maintenance area within basement area of Building 15. Note well-maintained equipment and cleanliness of surrounding areas.
