# Integrated Daylighting Systems

Alastair Robinson, Claudine Custodio and Stephen Selkowitz  
Lawrence Berkeley National Laboratory

The Green Proving Ground program leverages GSA's real estate portfolio to evaluate innovative sustainable building technologies and practices. Findings are used to support the development of GSA performance specifications and inform decision-making within GSA, other federal agencies, and the real estate industry. The program aims to drive innovation in environmental performance in federal buildings and help lead market transformation through deployment of new technologies.

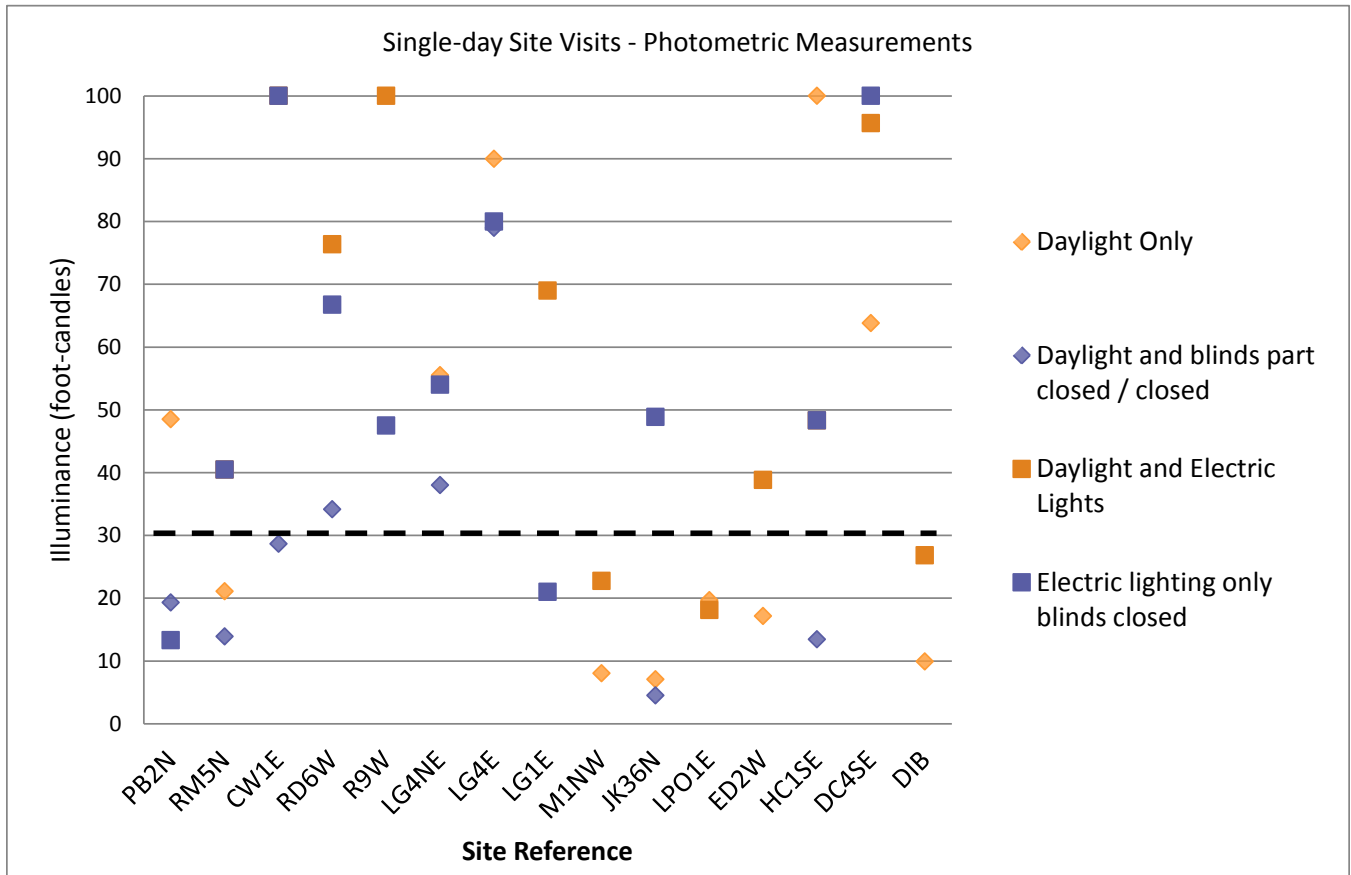
Figure 1: Photometric snapshot results for assessed GSA sites

Of the 13 sites visited for single-day site assessments, eight sites (offices) were capable of meeting necessary light levels with natural light alone during bright conditions. Of these eight sites, six were observed to support light levels at work locations above the recommended P100 lighting levels with daylight alone, although switching lights off required manual operation of wall switches at all but one site; lights were typically programmed to dim to a minimum light/power output but not switch off. Two of the eight sites were observed to be capable of utilizing natural light sufficiently to not require electric lighting during bright conditions. Lighting control systems at these two sites were not programmed to enable lights to switch off automatically, and had no operable switches to manually switch lights off. An assessment of electric lighting

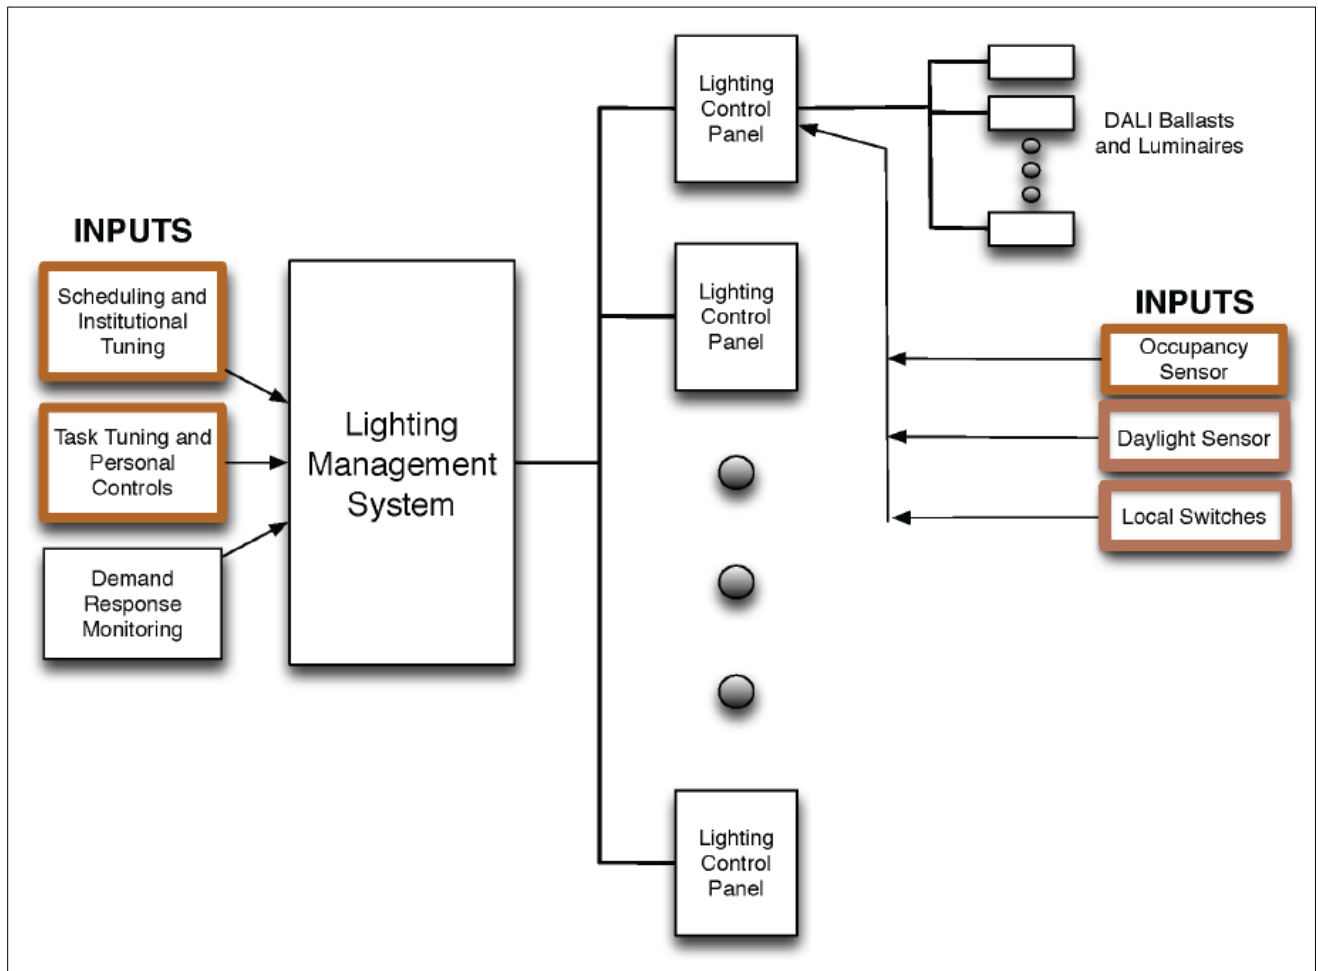
A basic schematic of IDS and lighting control system is shown in Figure 3 below. It illustrates the nature of the system in which there are inputs from a centralized lighting control system, which establishes the overall conditions under which each of the control strategies function, and from remote sensors and switches, which operate local lighting according to the appropriate control conditions. With regards to IDS, this translates into programming maximum lighting power input to meet preset light levels, and calibrating local photosensors to adjust lighting power according to available natural light.

**Figure 3: Schematic design of one example of an IDS lighting management system. This study examines the effects of the highlighted control elements: scheduling and institutional tuning, task tuning and personal controls, occupancy sensors, local switches and daylight dimming**

Two different approaches to dimming control are utilized in the IDS included in this study. At the 3 California sites, a Digital Addressable Lighting Interface (DALI) based control system was implemented. DALI is not only dimming control, rather it is a lighting control protocol, controlled and operated via digital signals from the controls system to the control modules (ballasts in this case) over low voltage communication wires. The ballast also communicates with the control system, supporting status reporting and monitoring. At the Chicago and Hammond sites, ‘DALI-like’ systems were installed, where almost identical functionality can be programmed, but it is the manufacturer’s proprietary system rather than an industry standard.

The alternative is use of a 0-10V signal to control light output. 0-10V dimming systems are controlled and operated via analogue signals sent to the ballast. These signals set the operating conditions for the ballasts and can be controlled at the zone level – all of the lighting connected to a single circuit will dim to the same level, although they may be controlled by different sensors and therefore act independently.

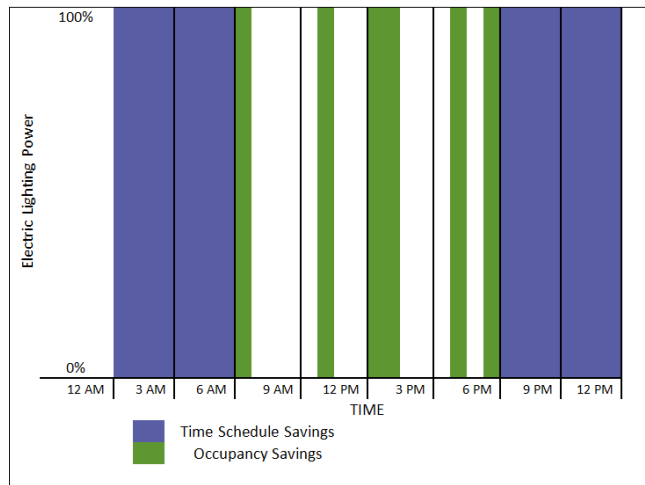
Occupancy sensors-based energy savings arise from vacancy periods in work spaces during office hours, either at the zone or individual office / cubicle level, depending on the approach to installation adopted within each building or zone.

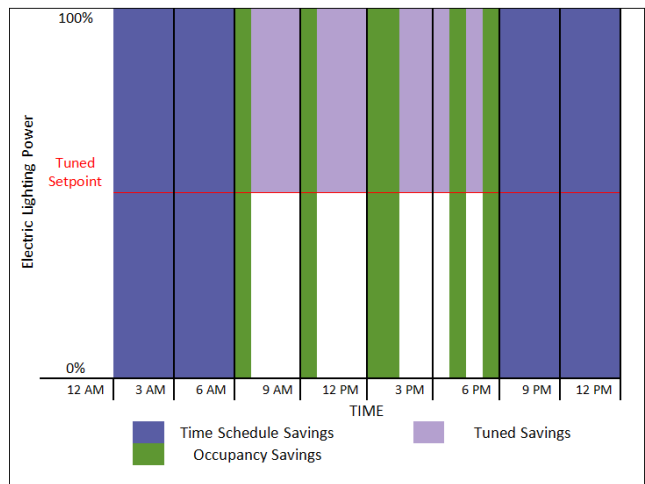
Energy savings from tuning / dimming of light levels to design illuminance requirements reflect the difference between the power used at 100% lighting output and that used at the tuned lighting levels. The tuned lighting output level is set at the individual site and in the first instance; the target is to meet the IESNA minimum light level requirements. Individual occupant preferences may cause this to vary within a single site.

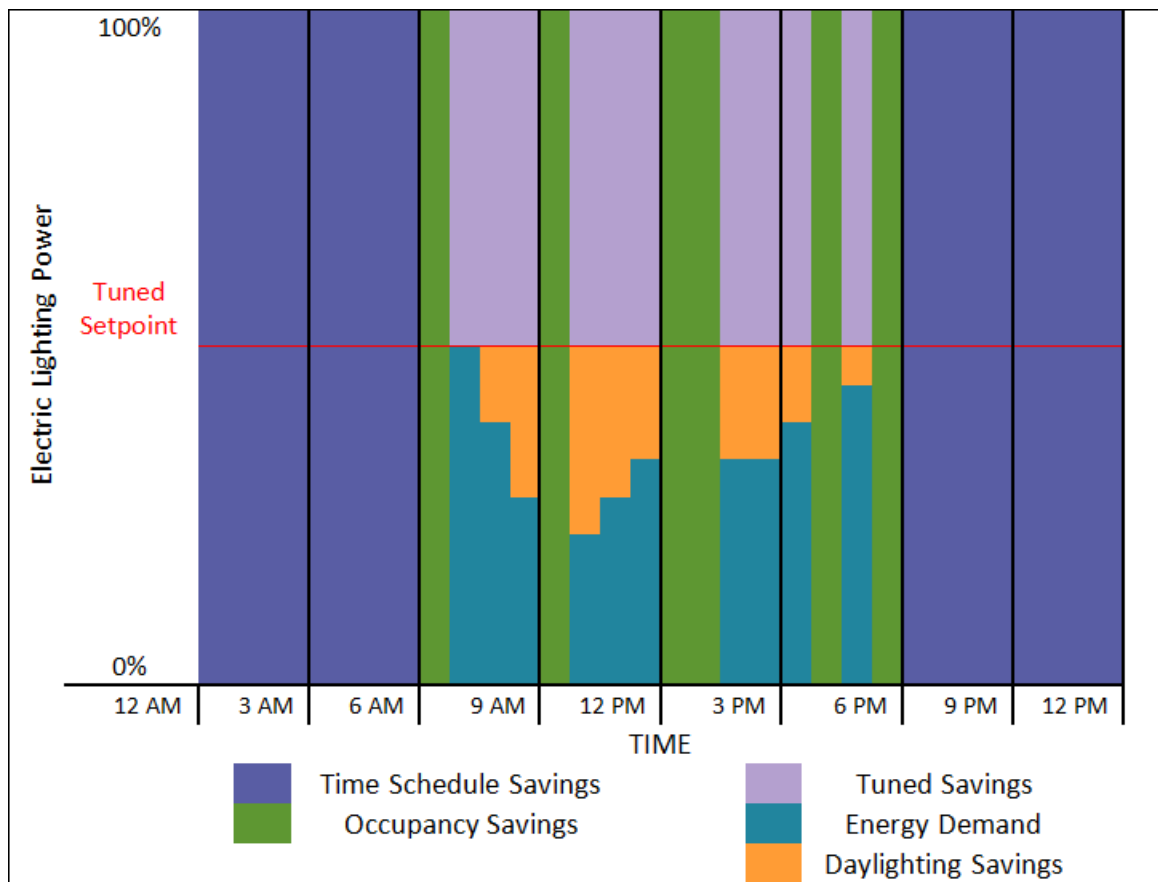
Energy savings from daylight dimming occurs during periods when power consumption falls below that of the tuned lighting output. This is a response to available natural light which is sufficient to reduce the necessary output of electric lighting.

**Figure 5: Definition and separation of lighting energy savings by control strategy**

In this study, two energy savings calculations are completed for each site. The first assumes that energy savings from IDS come from daylight dimming alone. The second is calculated on the basis that both daylight dimming and high-end tuning require the same electronic dimming ballast hardware and therefore that both control strategies would be implemented together.

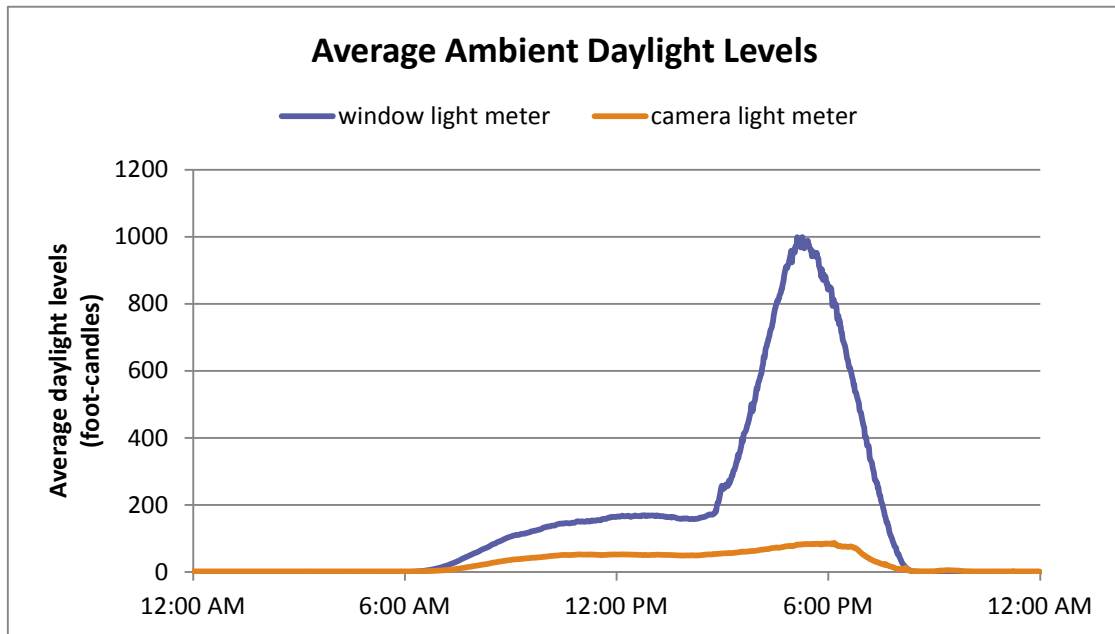
**Figure 10: Ronald Dellums Federal Building, 6<sup>th</sup> Floor measured average ambient daylight levels (vertical illuminance) recorded at window-mounted light meter and a camera tripod-mounted light meter positioned approximately 10 feet from the window. The data comprises light levels measured for weekdays over a period of approximately four months.**

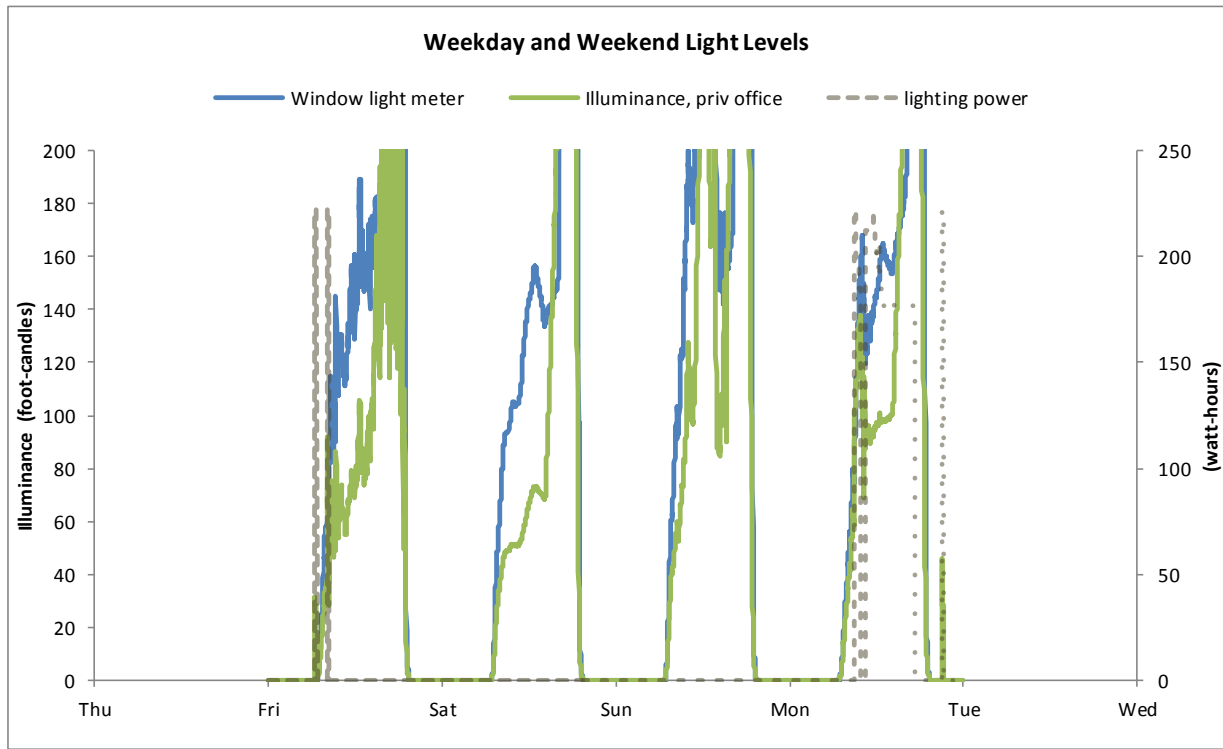
**Figure 12: Ronald Dellums Federal Building, 6<sup>th</sup> Floor, private office, example measured ambient light levels for weekdays and weekends, indicating dependence of lighting levels on operation of electric lighting – the monitored period is Friday 21 September to Monday 25 September.**

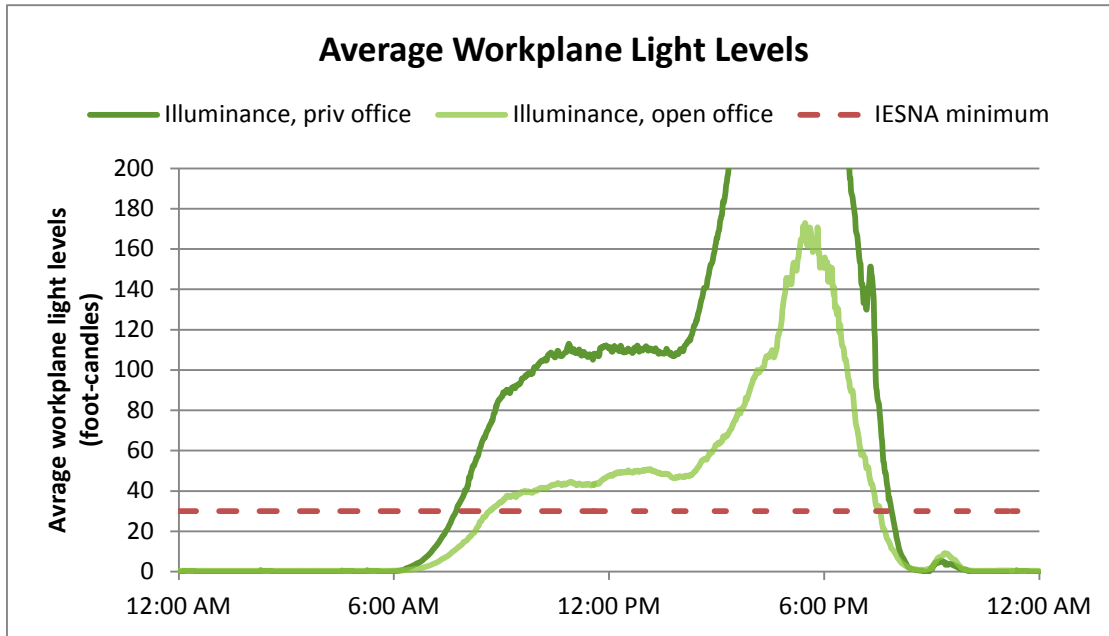
Figure 13 highlights average light levels adjacent to the workplane. The data suggests that the IDS system generally provided higher light levels than recommended by the IESNA. During the monitoring period, average light levels in the private office exceeded the minimum recommendations from approximately 7:30AM until approximately 6:00PM, far exceeding them with values greater than 100 footcandles) between 11:00AM and 6:00PM. For the open office cubicles, light levels exceeded 30 footcandles from approximately 8:30AM until 8:00PM, and far exceeded them between approximately 4:30PM and 6:30PM. The average vertical illuminance data recorded during the monitoring period (not plotted on axes) suggests that disability glare is not an issue at any of the monitored work spaces.

**Figure 13: Ronald Dellums Federal Building, 6<sup>th</sup> Floor, measured average horizontal light levels (illuminance) recorded in the private office and open office cubicles throughout the monitoring period. The data comprises light levels measured for weekdays over a period of approximately four months.**

Maximum lamp output was tuned to 46% of rated power output in the private office and 56% of rated power input in the open office space, and would operate as soon as the office or cubicles were occupied. Due to the prevailing bright, clear weather conditions during the monitoring period, the data shows that light levels are relatively independent of the operation of electric lights. The data also shows that the lights operated somewhat independently of daylight conditions. The results indicate that light levels required to complete work tasks are normally achieved or exceeded (for the most part, quite significantly).

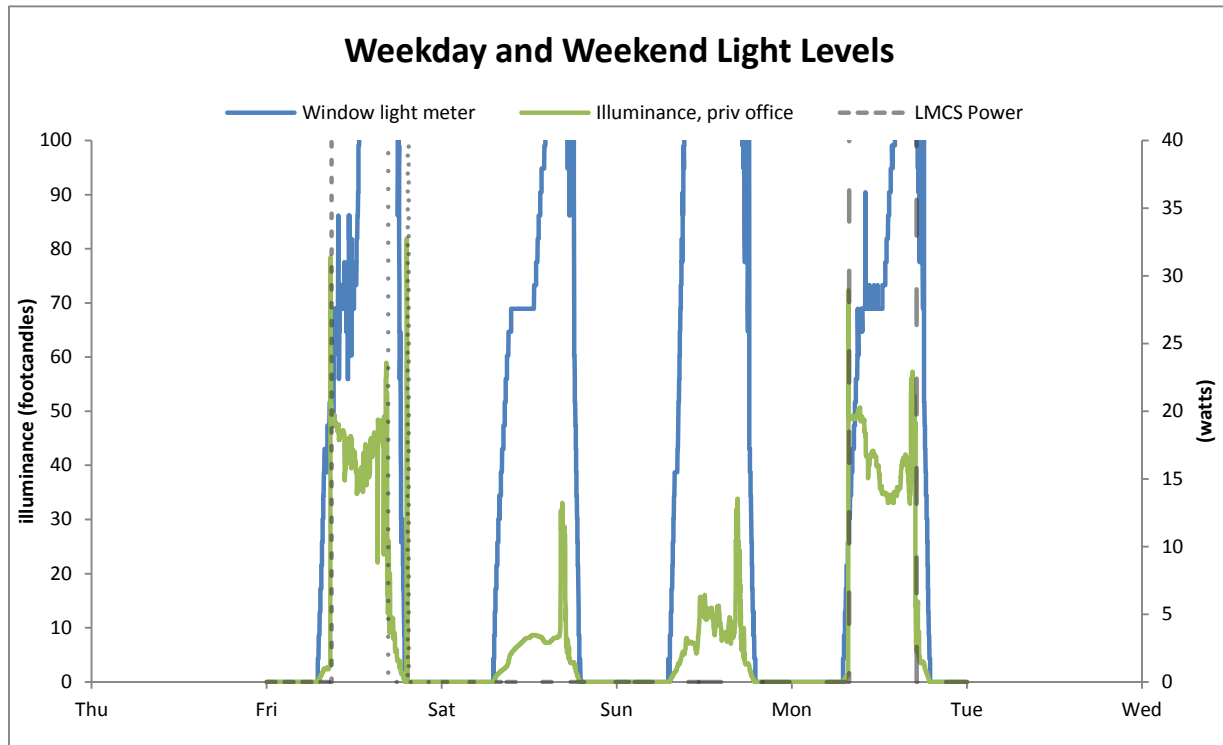
Figure 18 highlights light levels and lighting power use in the measured area for a period including week days and weekend days. The data indicates shows that weekend light levels, when electric lighting is not operational, are significantly lower than those on weekdays. The conclusion is that despite prevailing bright conditions, light levels on the space are dependent on electric lighting to meet recommended minimum light levels. A review of the photographic images taken during the monitoring period indicate the primary cause of this - the majority of blinds remained drawn and partly closed regardless of the time of day.

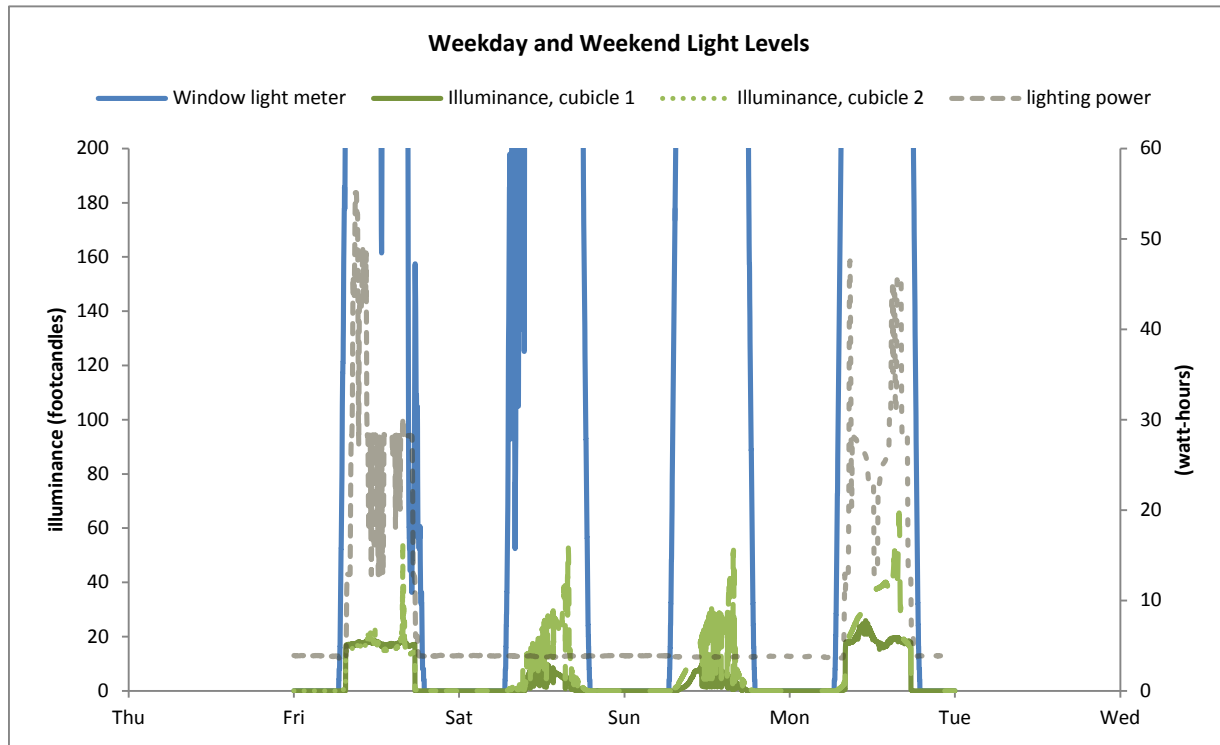
Figure 21 highlights light levels and lighting power use in the measured area for a period including week days and weekend days. The data indicates that weekend light levels, when electric lights are not operating, are lower than those on weekdays. The conclusion is that despite prevailing bright conditions, light levels on the space are dependent to a degree on electric lighting to meet recommended minimum light levels. This is particularly true of the cubicle 1 space.

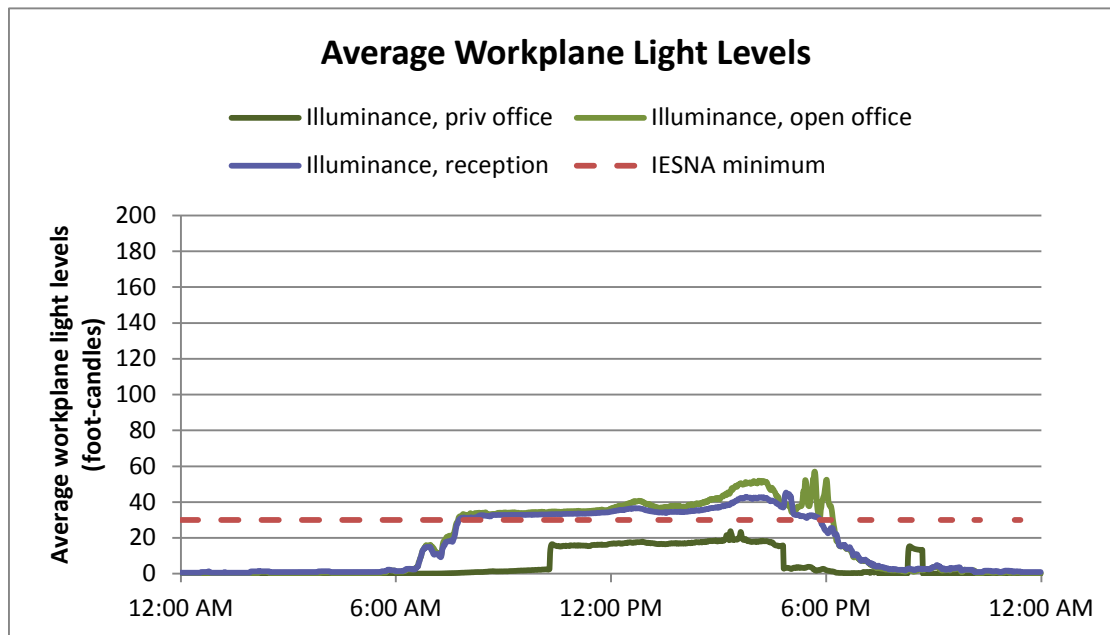
Figure 25 shows that the IDS system generally provides light to two of the permanent work locations (the reception and open office area) at the target levels recommended by the IESNA or marginally higher. Light levels in the private office are typically lower at between 15-20 footcandles. Note that lamp output was not tuned at this location – lighting would operate at 100% of rated power input when not dimming to daylight. Lights would operate as soon as the first person entered the office. The average vertical illuminance data recorded during the monitoring period (not plotted on axes) suggests that disability glare is not an issue.
