**DRAFT
ENVIRONMENTAL
ASSESSMENT**

Rouses Point
Land Port of Entry

Rouses Point,
New York

May 2024

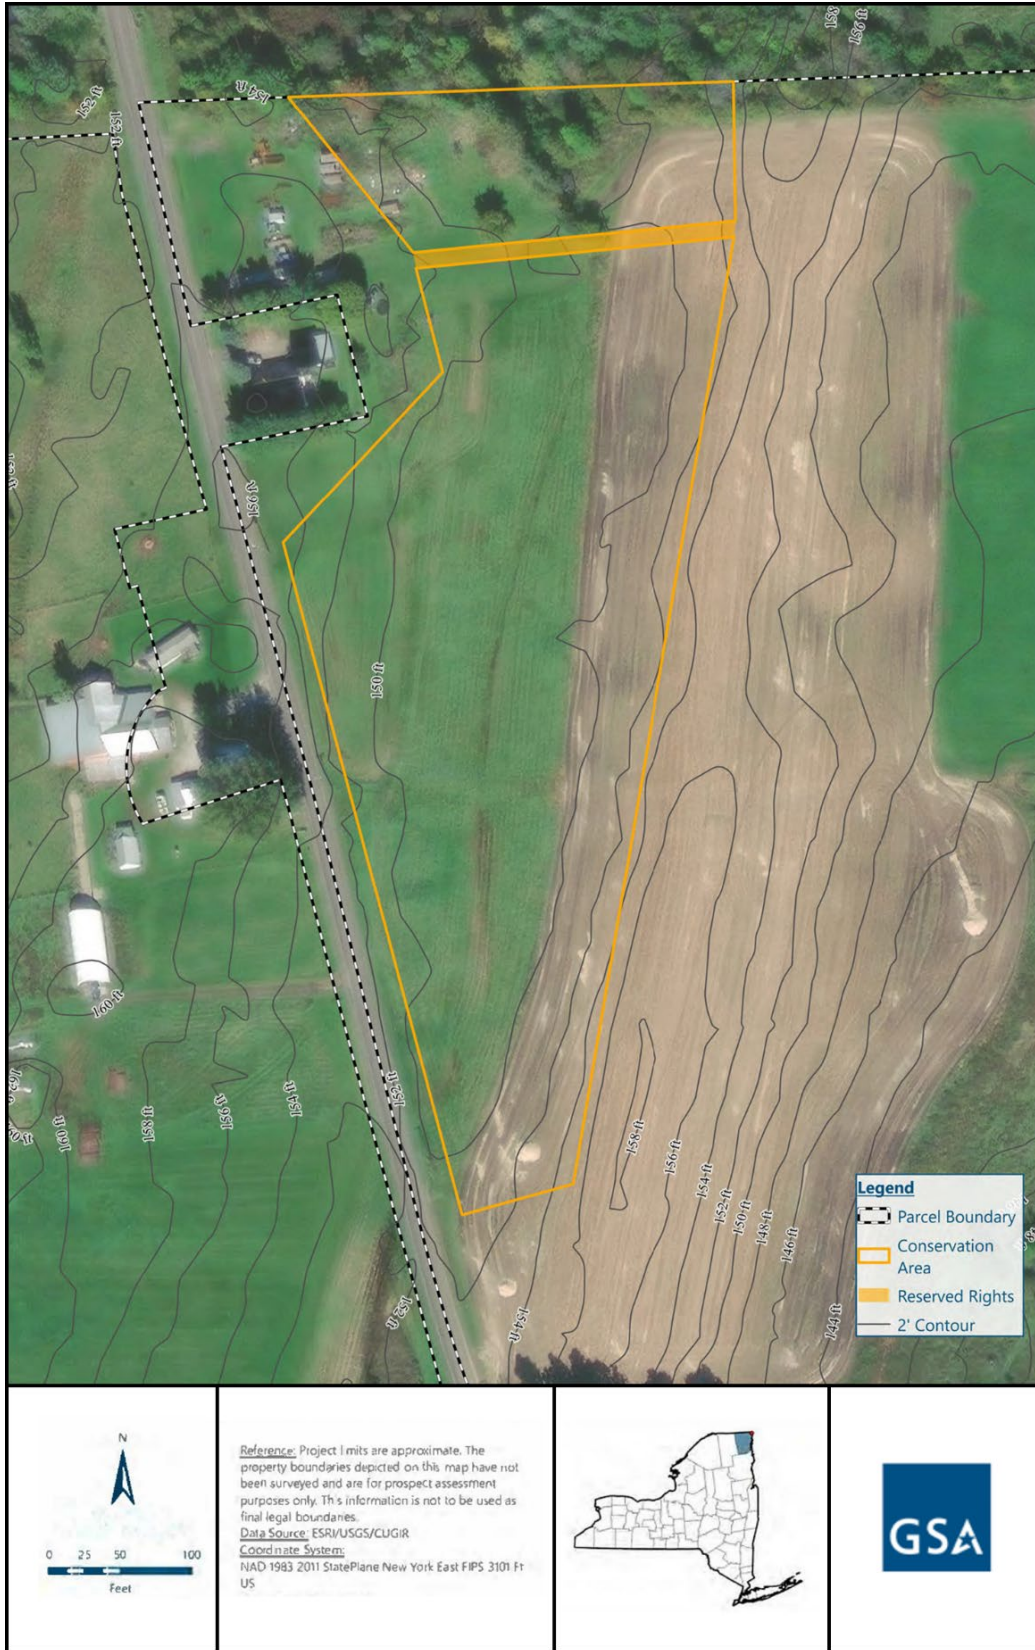
Figure 3. Potential Off-site Mitigation Area

As a result of the above search and evaluation, GSA has selected a potential site for off-site wetlands creation to mitigate impacts from disturbance of the wetlands at the project. The potential off-site mitigation site would be used for approximately 6 acres of wetlands creation and is located approximately 2 miles south of the project site within the Town of Champlain adjacent to Hayford Road and south of US Route 11. It resides in the St. Lawrence Valley physiographic province, which exhibits a mix of land uses from forestry to agriculture (Figure 3).

The off-site mitigation location has been reviewed for potential impacts to existing threatened and endangered species by consultation with the U. S. Fish and Wildlife Service (USFWS) via their Information for Planning and Consultation (IPaC) system. The IPaC system species determination review is done in accordance with the Endangered Species Act of 1973 (ESA; 87 Stat. 884, as amended; 16 U.S.C. 1531 et seq.). Information obtained from the USFWS IPaC system indicated that the only ESA-listed or candidate species potentially occurring in the project area is the monarch butterfly (*Danaus plexippus*), which was confirmed in the official species list. The monarch butterfly is a candidate for listing under the ESA but is not currently a listed species.

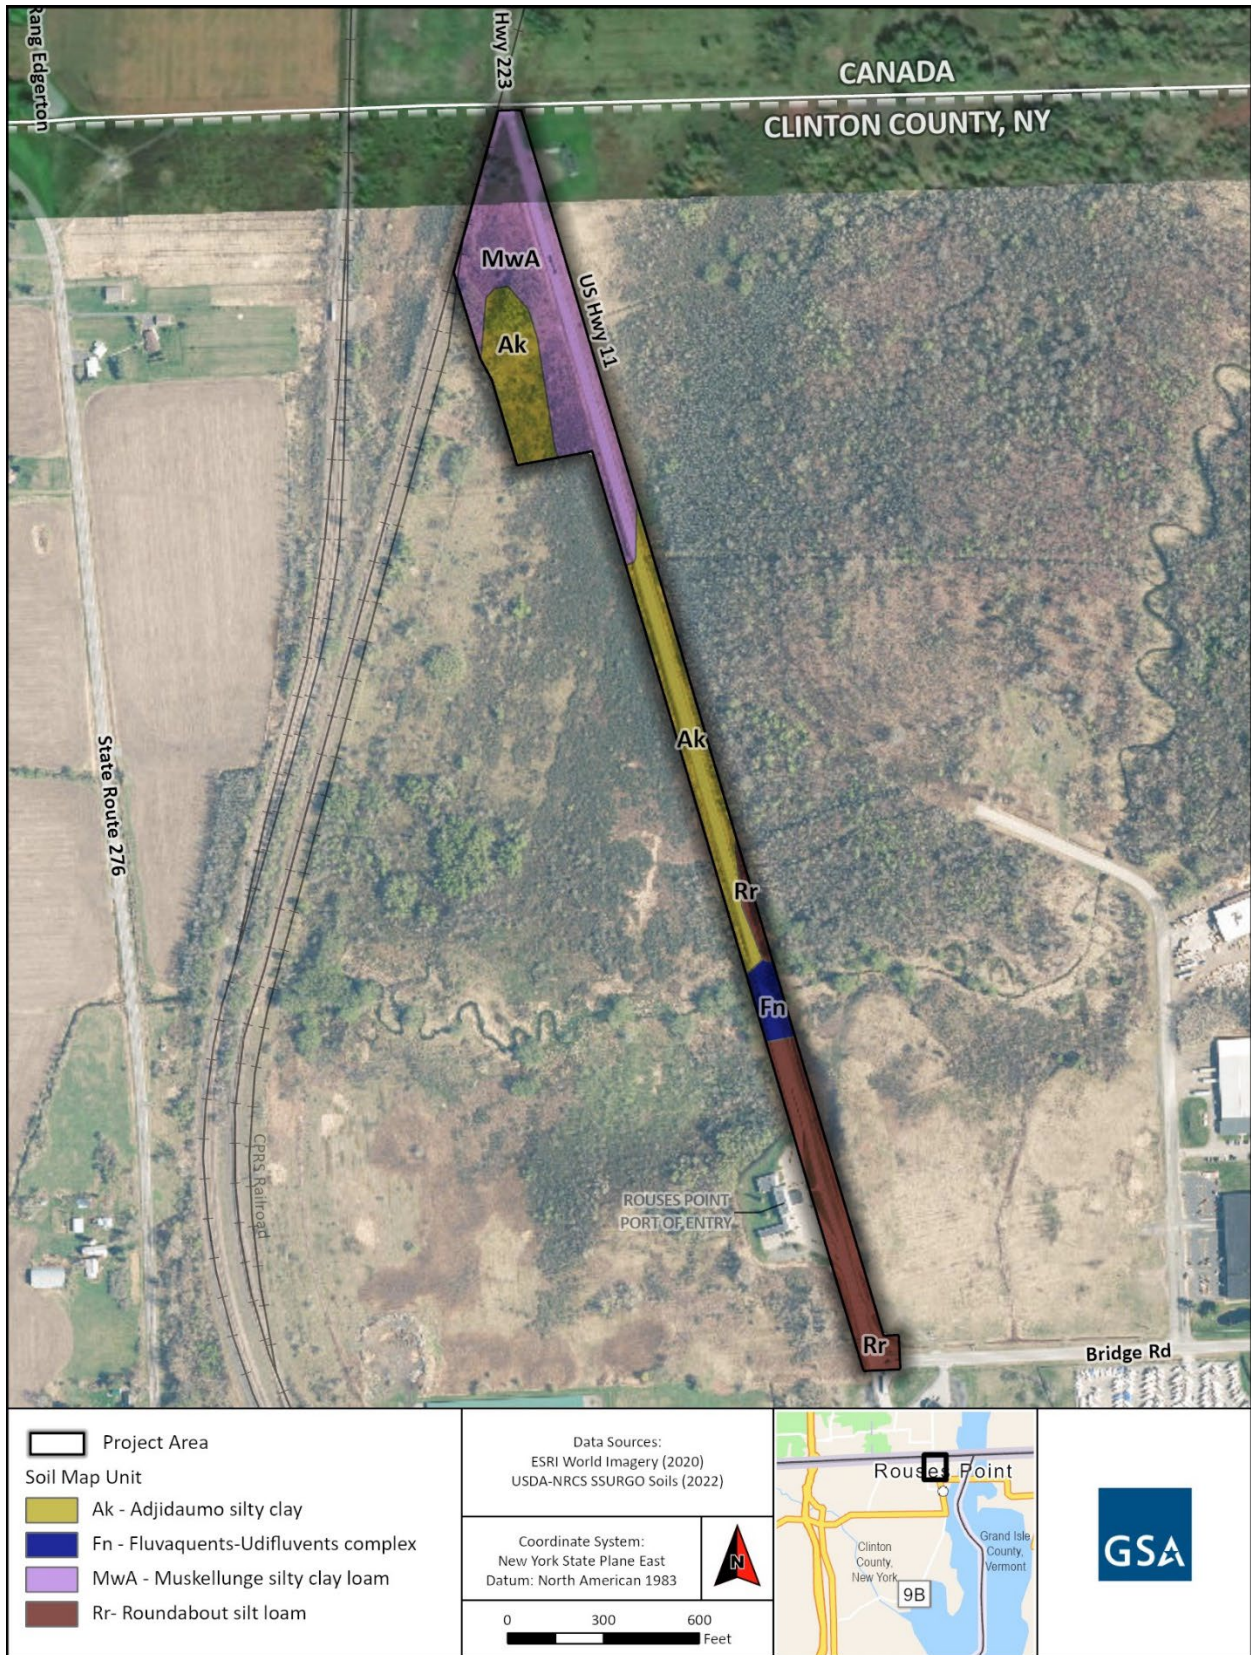
Figure 6. Soils

The proposed project area is located in the St. Lawrence Valley Physiographic Province. The area is relatively flat with elevations ranging from approximately 107 to 117 feet above mean sea level. Soils in the proposed project area are mostly classified as Muskellunge silty clay loam, 0 to 3 percent slopes (53 percent) and Adjidaumo silty clay, 0 to 3 percent slopes (32 percent). The remainder of the proposed project area is composed of Roundabout silt loam (12 percent) and Fluvaquents-Udifluvents complex, frequently flooded (2 percent) soils (Figure 6). Soils in the proposed project area are poorly or somewhat poorly drained, except for the Fluvaquents-Udifluvents complex soils. Adjidaumo silty clay soils are considered farmland of statewide importance. Muskellunge silty clay loam and Roundabout silt loam soils are considered prime farmland. All soils in the proposed project area are classified as hydric.

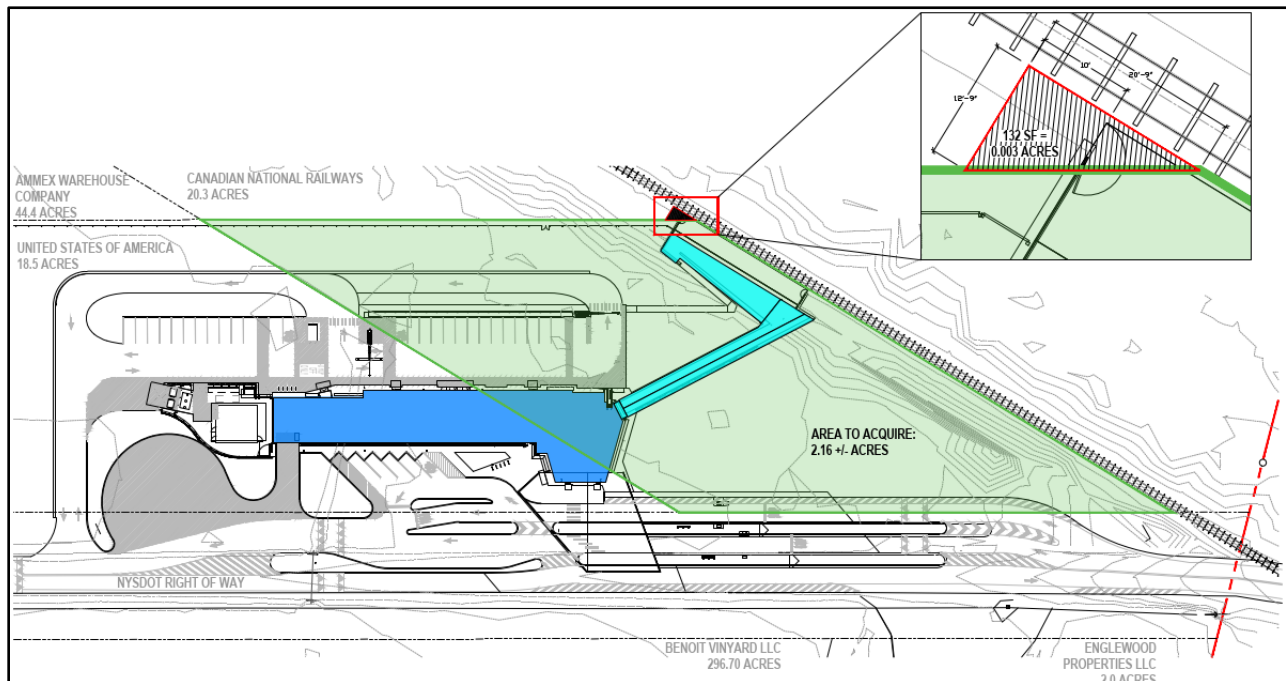
Figure 8. Land Use and Acquisition of Canadian National Railroad Property

For construction of the new LPOE, 2.16 acres of property owned by CN would be required. The acreage would be purchased from CN and owned by the U.S. Government (Figure 8).

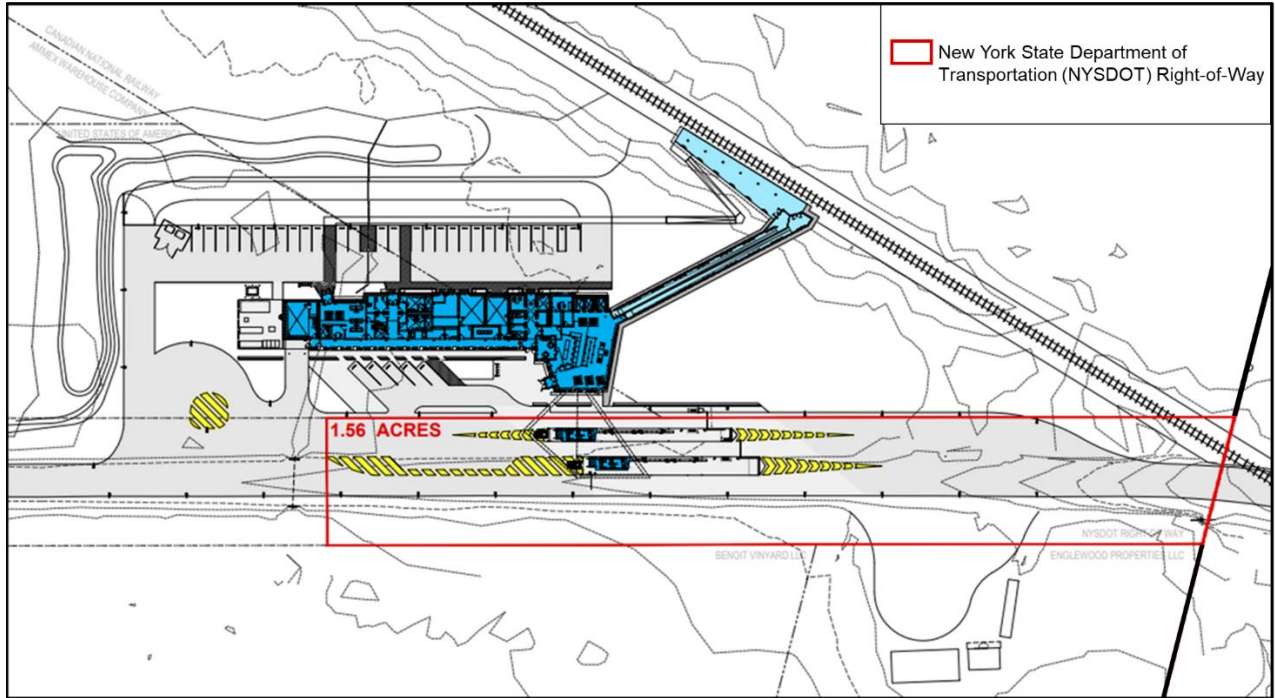
Figure 9. New York State Department of Transportation (NYSDOT) Right-of-Way

Use of 1.56 acres of the NYSDOT US Route 11 ROW is required for construction of new LPOE vehicle inspection lanes and infrastructure. In addition, the NYSDOT ROW will be used for utility extensions to the new LPOE. Electrical and sewer service will be installed on the west side of NYSDOT US Route 11 and the potable water service will be installed along the east side of NYSDOT US Route 11.

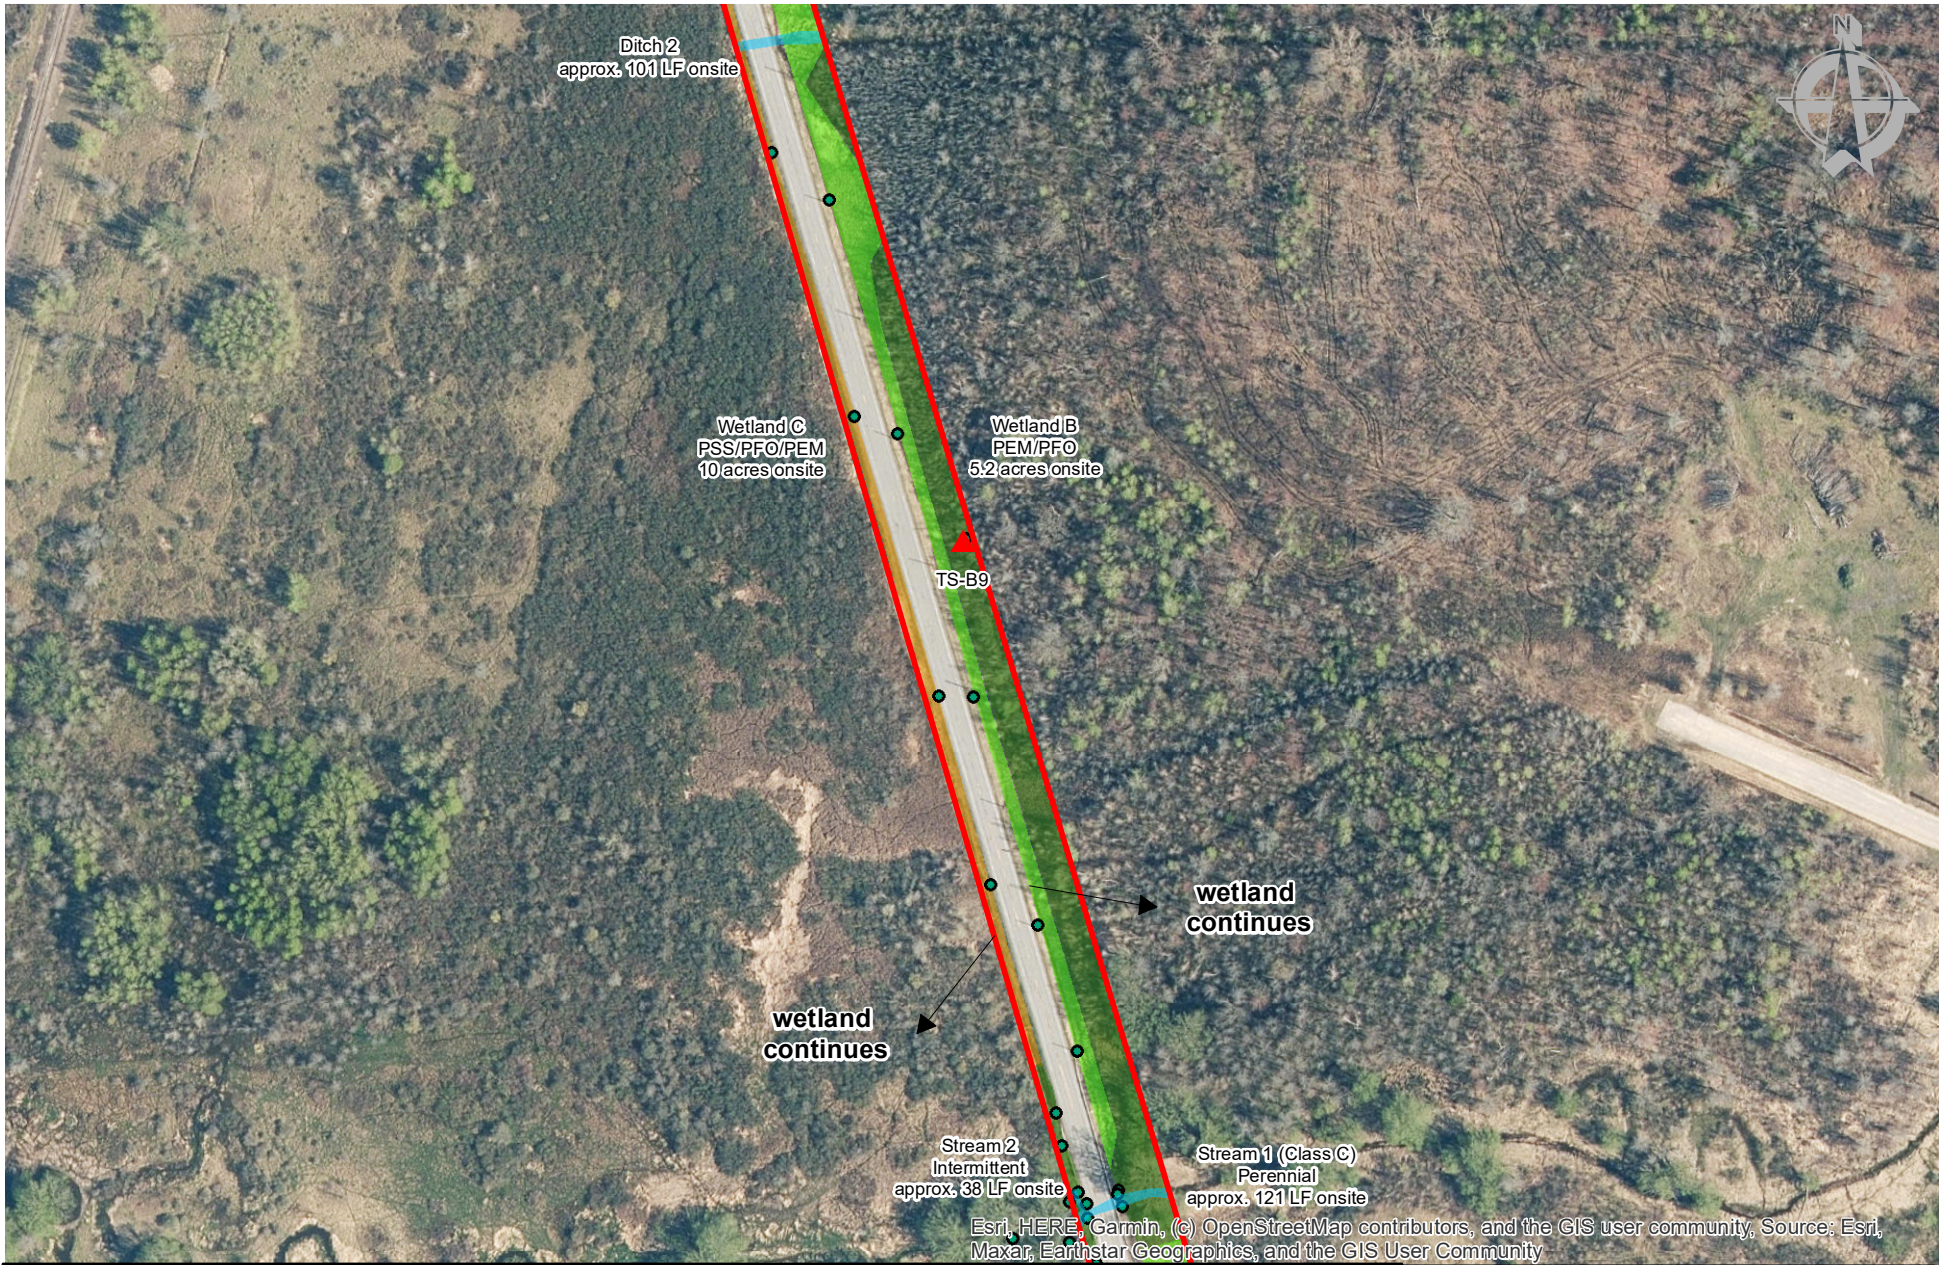
FIGURE 5
Area 2 - Wetland Delineation Map

Legend	
	Project Boundary
	Emergent Wetland
	Test Site
	Forested Wetland
	Streams
	Scrub Shrub Wetland
	Resource Flags

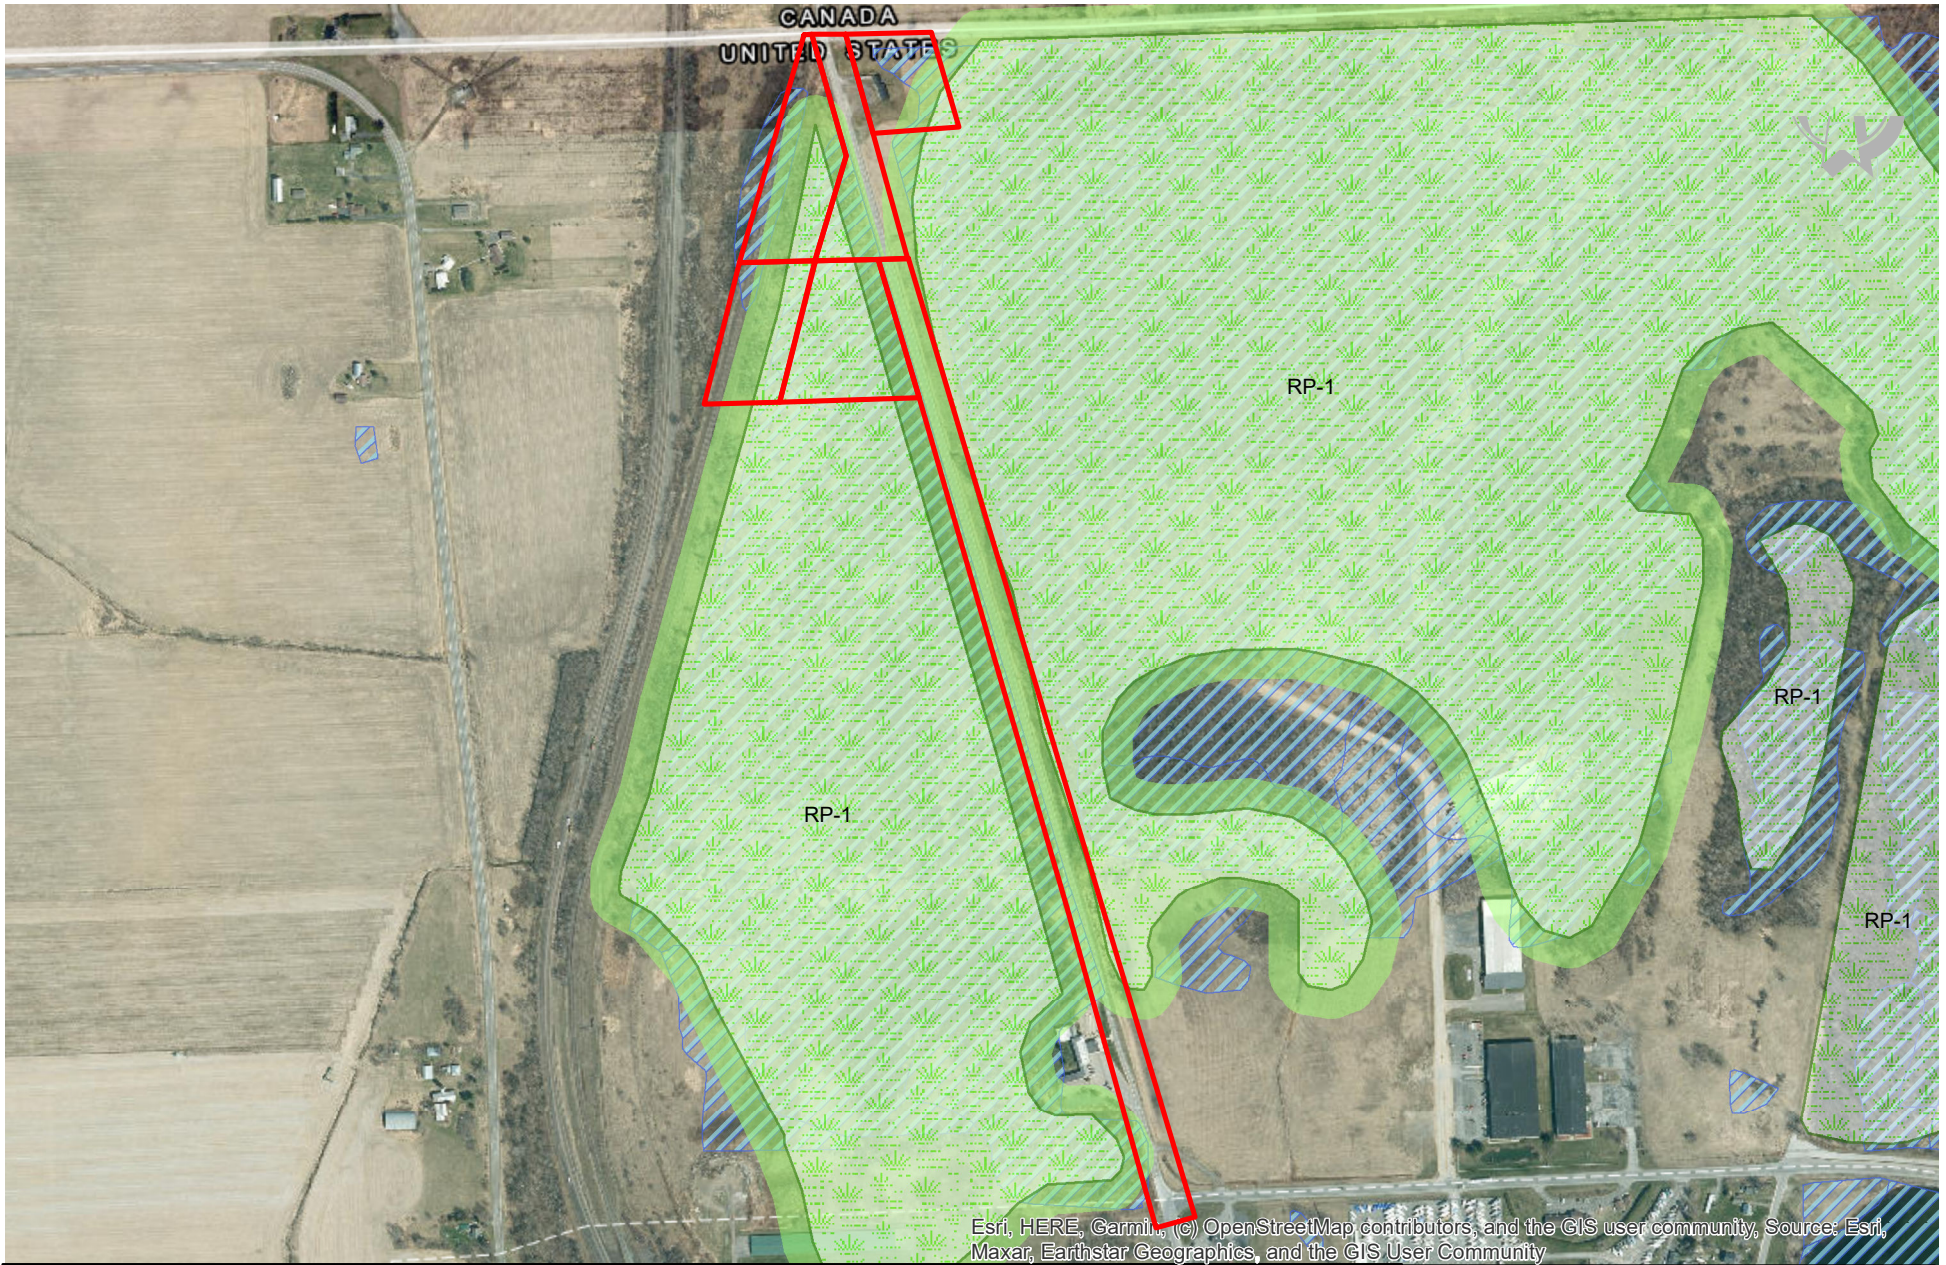
<p>Legend</p> <ul style="list-style-type: none"> Project Boundary NYSDEC Wetlands NYSDEC 100' Buffer NWI Wetlands 	<p>FIGURE 7 NYSDEC/NWI Wetlands Map</p> <p>Rouses Point Port of Entry - Route 11 Town of Champlain Clinton County, NY</p>

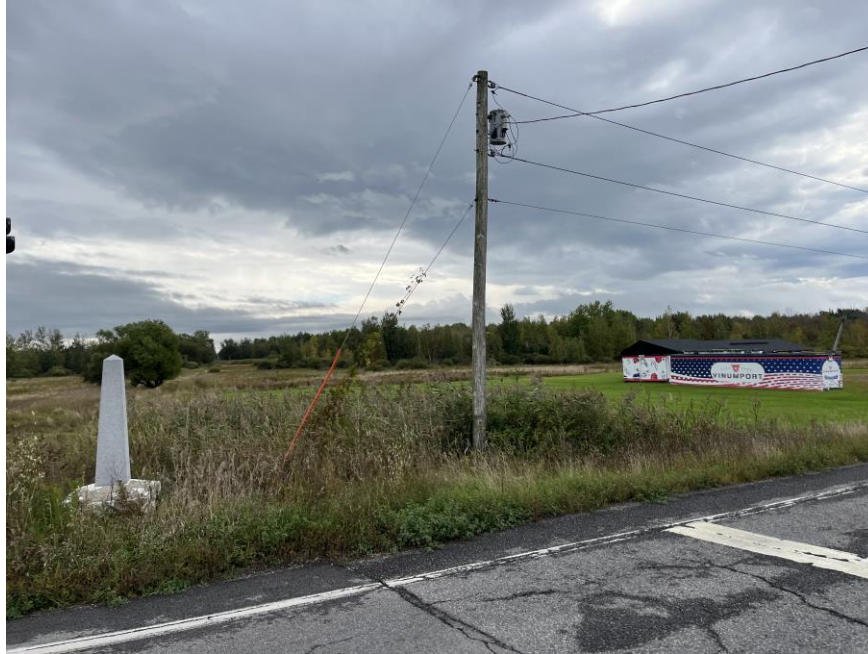
Photo Description: Wetland A

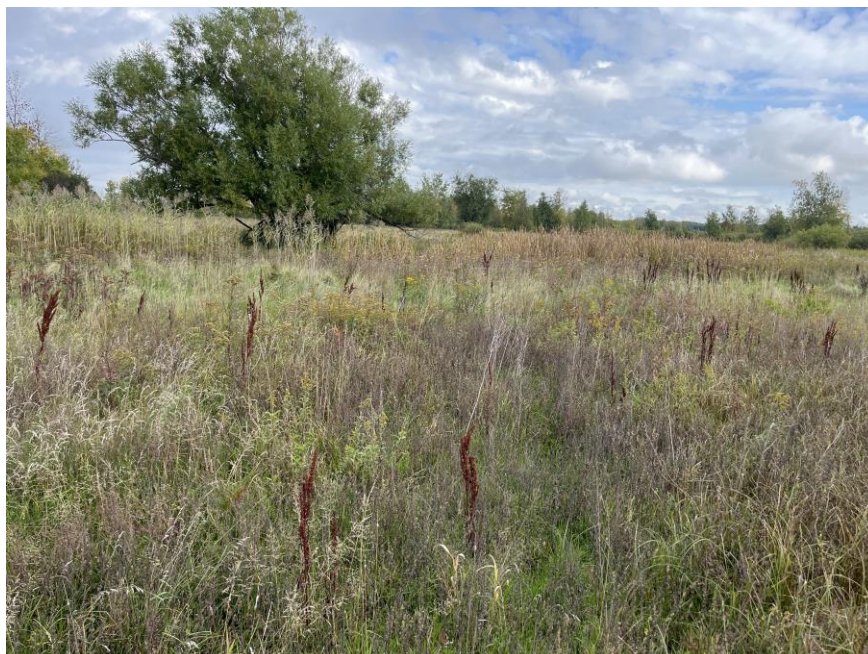
Photo Description: Wetland B (Emergent community)

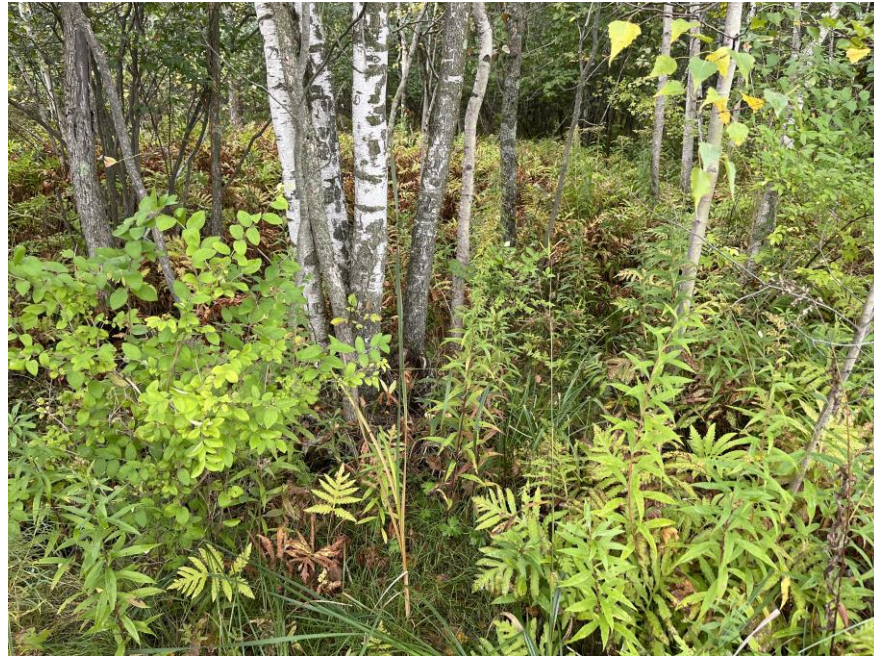
Photo Description: Wetland B (Forested community)

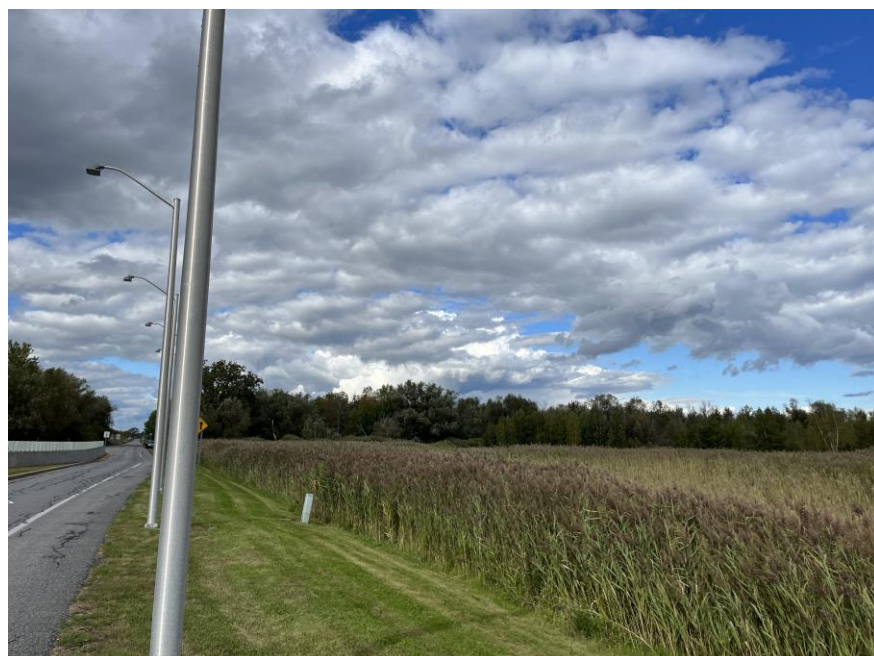
Photo Description: Wetland B (Emergent community)

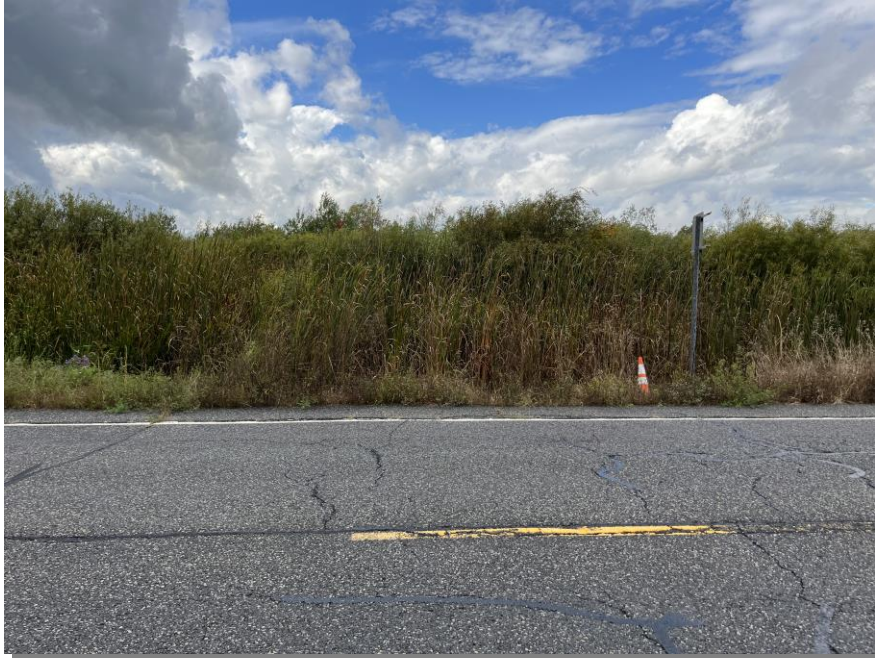
Photo Description: Wetland C (Scrub shrub community)

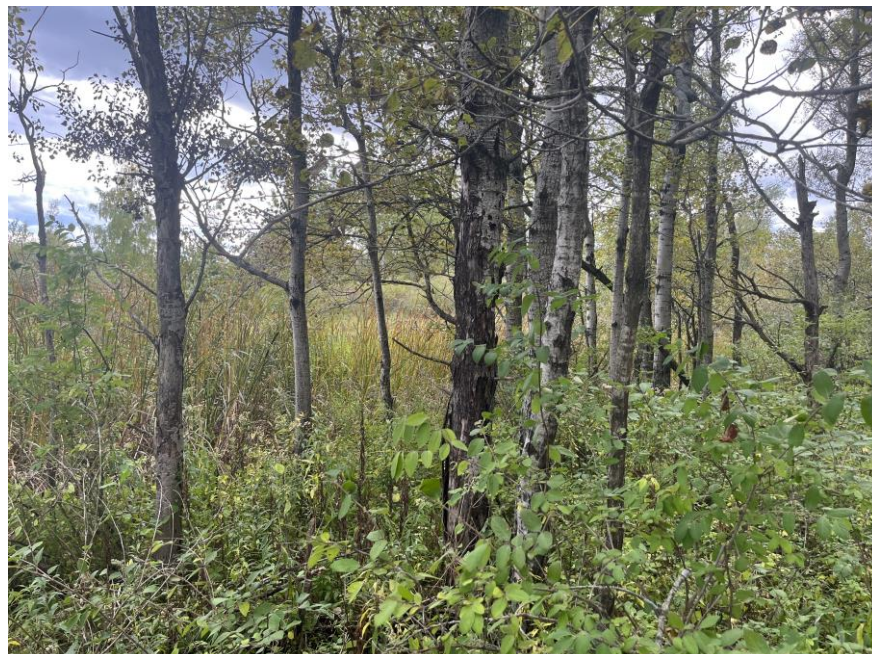
Photo Description: Wetland C (Forested community)

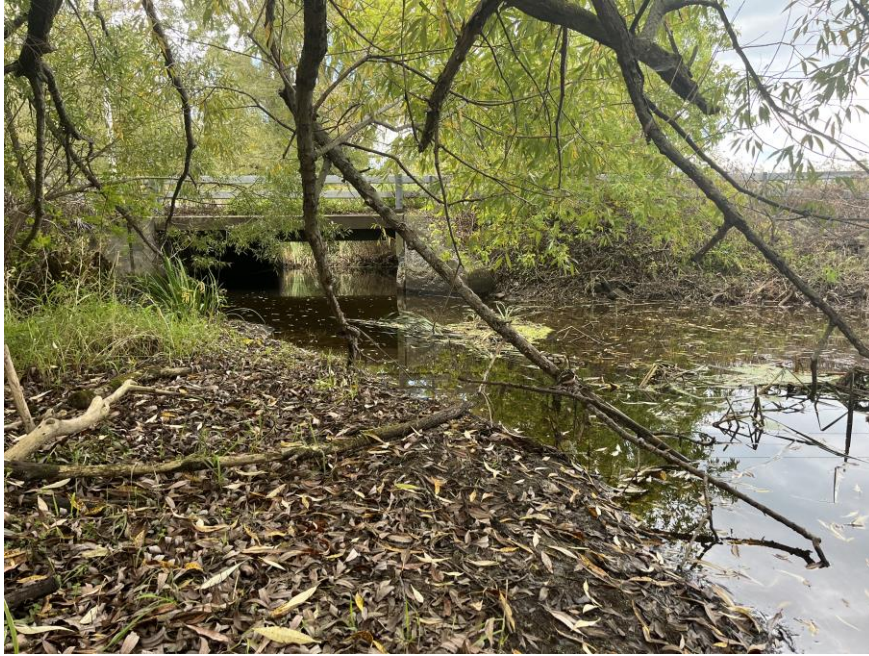
Photo Description: Stream 1 (Flows east)

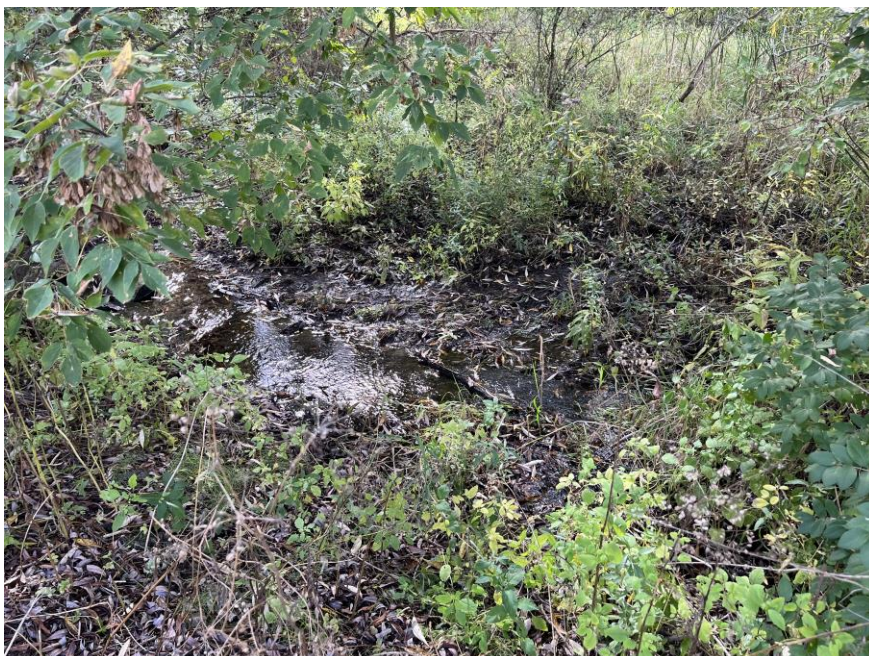
Photo Description: Stream 2

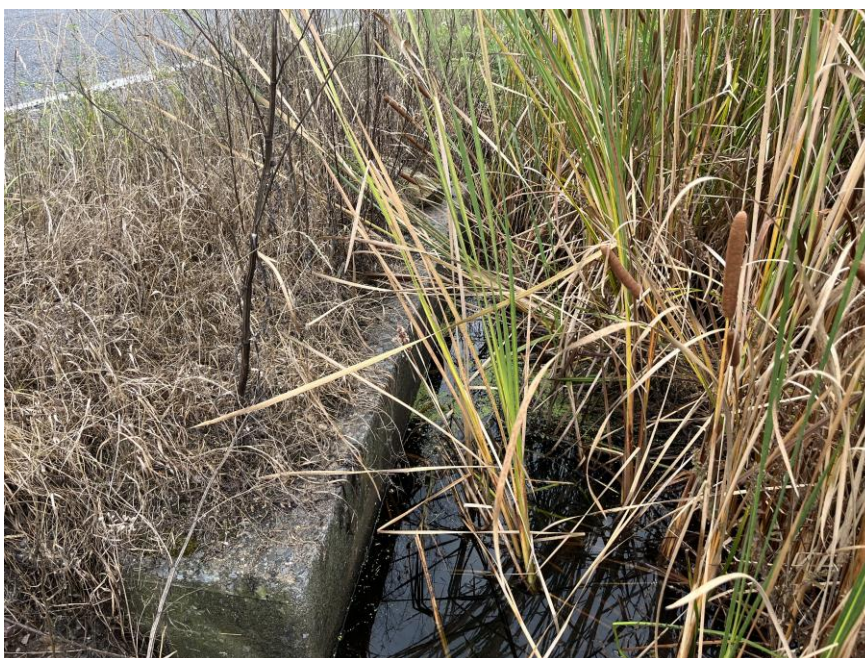
Photo Description: Culvert for wetland ditch/drainage
