# U.S. Department of Homeland Security Nebraska Avenue Complex Master Plan DRAFT ENVIRONMENTAL IMPACT STATEMENT

# Cultural Landscape Report

# NEBRASKA AVENUE COMPLEX Cultural Landscape Report

Washington, D.C.

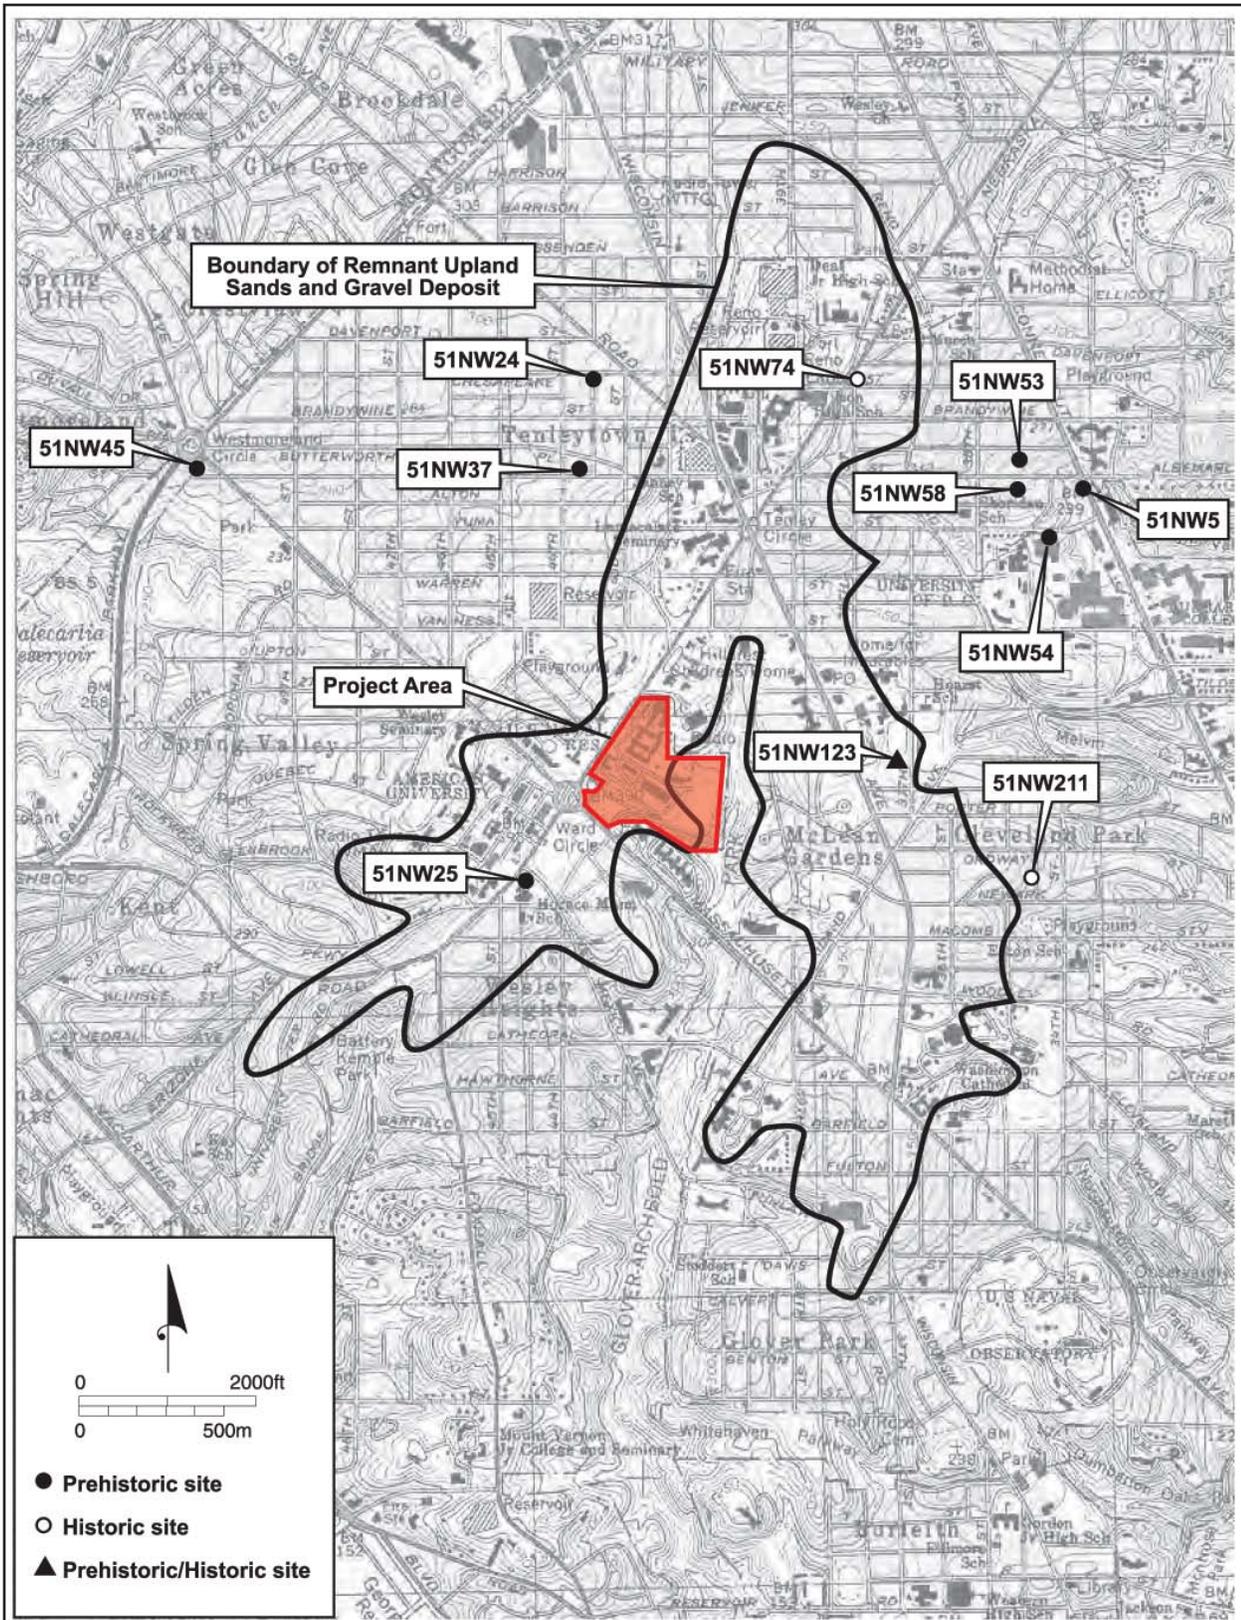
Figure 2-1. Location of the project area within the boundary of remnant upland sands and gravel deposits that made the site attractive to prehistoric peoples. Source: Goode and Seibert, 2009; modified by JMA 2010.

The NAC is located in a portion of the Fall Zone is characterized by upland coarse sands and gravels deposited during the Miocene or Pliocene Periods. This deposit is an erosional remnant that caps hills in a small zone between Rock Creek and the Little Falls Branch that includes the project area (Figure 2-1). These remnant deposits provided prehistoric groups with inexhaustible supplies of quartz and quartzite, with occasional pebbles of chert, jasper, chalcedony and other rocks. It is likely that the prehistoric site identified within the project area may be related to quarry/lithic procurement and workshop activities where cobbles were collected and reduced.

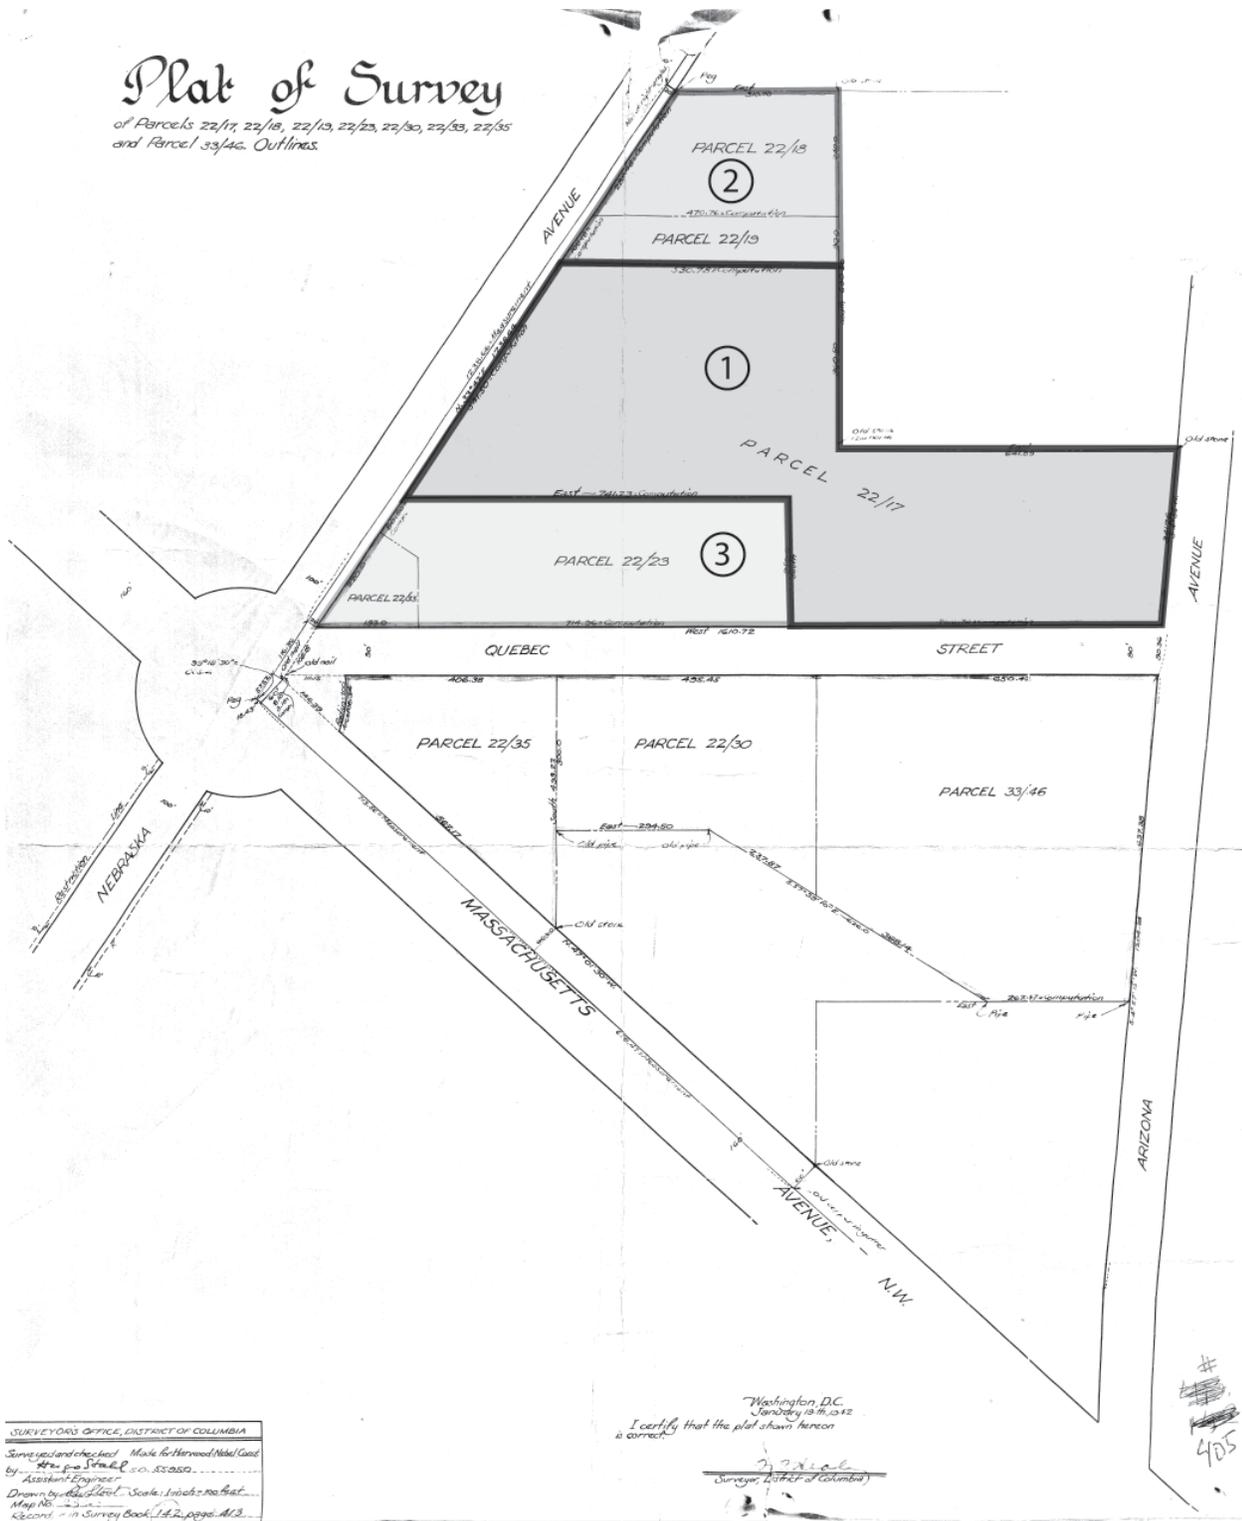
**Figure 2-6.** Survey of Mount Vernon Seminary property taken in 1942 for U.S. Navy acquisition, annotated to show sequence of property acquisition by Mount Vernon Seminary. Tract 1 is the original parcel purchased by Somers in 1913. She acquired Tract 2 just before she sold her holdings to Mount Vernon Seminary, Inc. The corporation either purchased or received in donation Tract 3 from Adelia Gates Hensley in the 1920s. Source: Nebraska Avenue Complex Public Works Archives.

In 1913 Somers purchased 12.46 acres of the historic Grasslands estate on the east side of Loughboro Road (present Nebraska Avenue) (Figure 2-6). Suburban Washington, D.C. of the early twentieth century, with its rolling farmland and thick woodlots, was the ideal setting for the new campus of the Mount Vernon Seminary for Girls. Located at the end of the Massachusetts Avenue trolley line in 1914, the property was described by a neighbor who exclaimed that

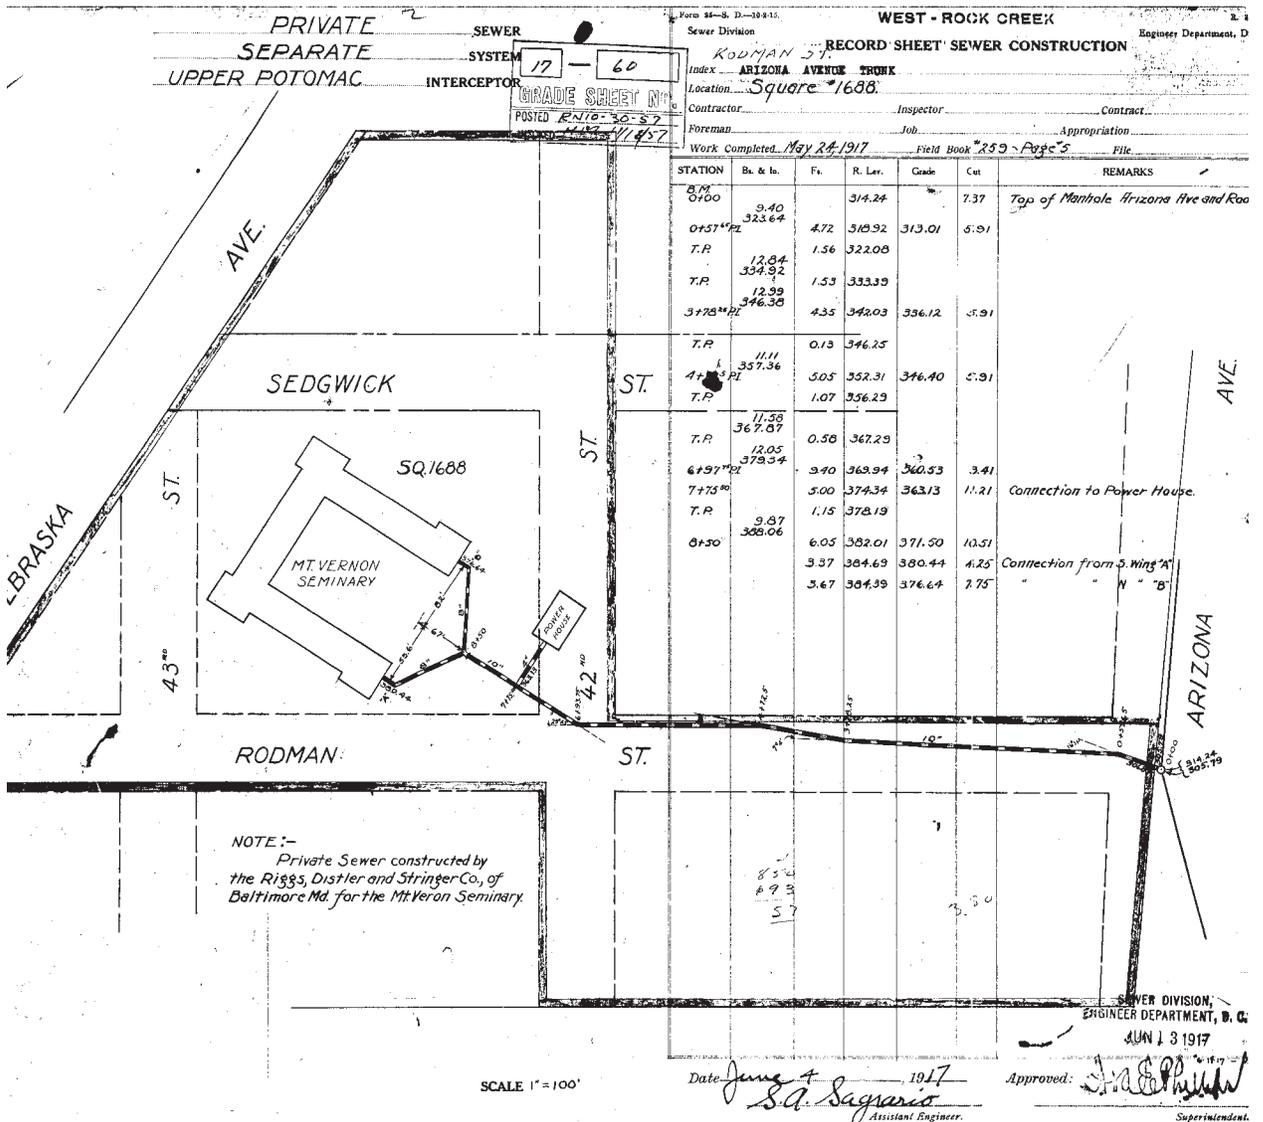
Figure 2-10. Construction permit document for installation of a sewer line to serve the Main School Building of Mount Vernon Seminary. Note that road plats for a subdivision planned in this location are visible, illustrating how the earlier subdivision affected the configuration of the property. The additional 2.15-acre property purchased from Adelia Hensley may be the platted rectangle on the plan containing the notes. It also appears that what was platted as Rodman Street became Quebec Street at some later date. Source: Nebraska Avenue Complex Public Works Archives.

acres to the property on its north end, incorporating what had been a right-of-way for a planned street called Sedgwick Street and an additional 2.18 acres to the north (Figure 2-10). Around the same time, the seminary acquired an adjoining 2.15 acre parcel from Adelia Hensley on which the school planned to eventually build a house for its headmistress.<sup>10</sup> In 1916, Somers incorporated the school and by June, had sold the original parcel and the additional tracts to the Mount Vernon Seminary, Inc., for \$72,000. Somers hired an architect and a few months later, construction on the new school began.

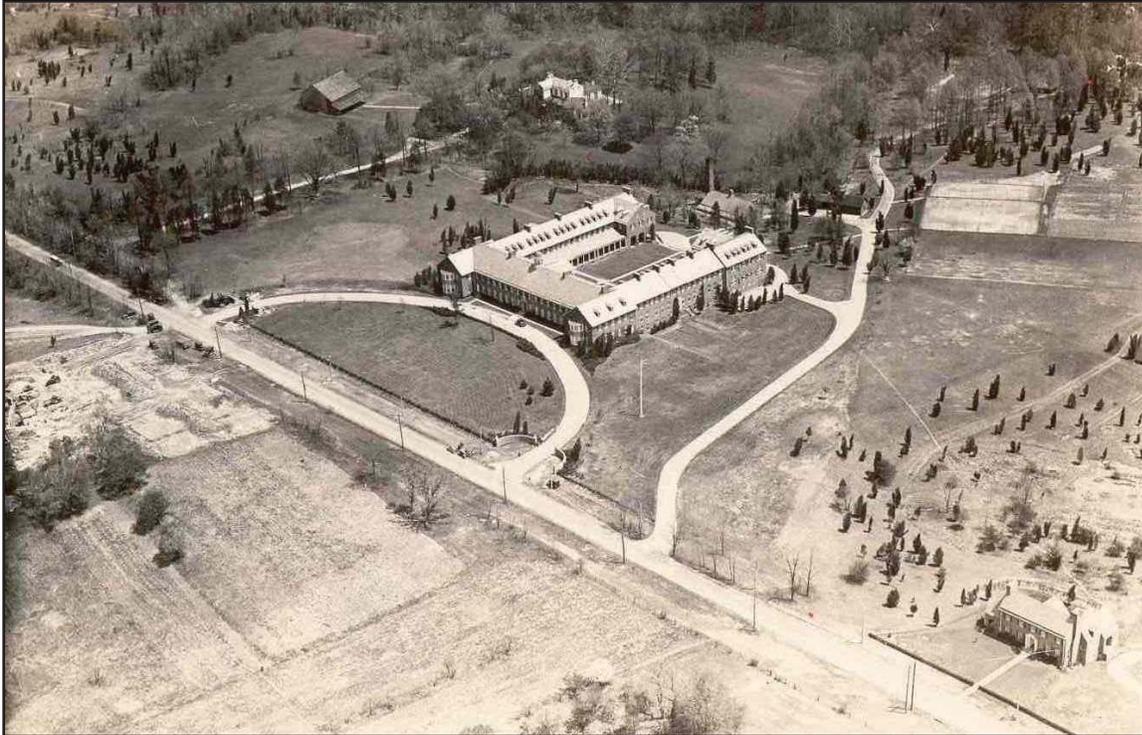
**Figure 2-11.** Aerial photograph of the Mount Vernon Seminary taken in 1924, but prior to the construction of the chapel. Note the location of the entrance allée to Grassland (left) and the house and barn beyond, as well as the symmetrical layout of the main school building and the semi-circular drive. *Source: Mount Vernon Seminary and College Archives, The Gelman Library at Mount Vernon Campus.*

The campus opened on October 3, 1917, with 100 students. The first building was a large Georgian Revival structure containing enough classrooms and dormitory rooms for 130 resident students (Building 1, Main School Building) (Figures 2-11 and 2-12). It was designed by New York architect Wesley Sherwood Bessell.

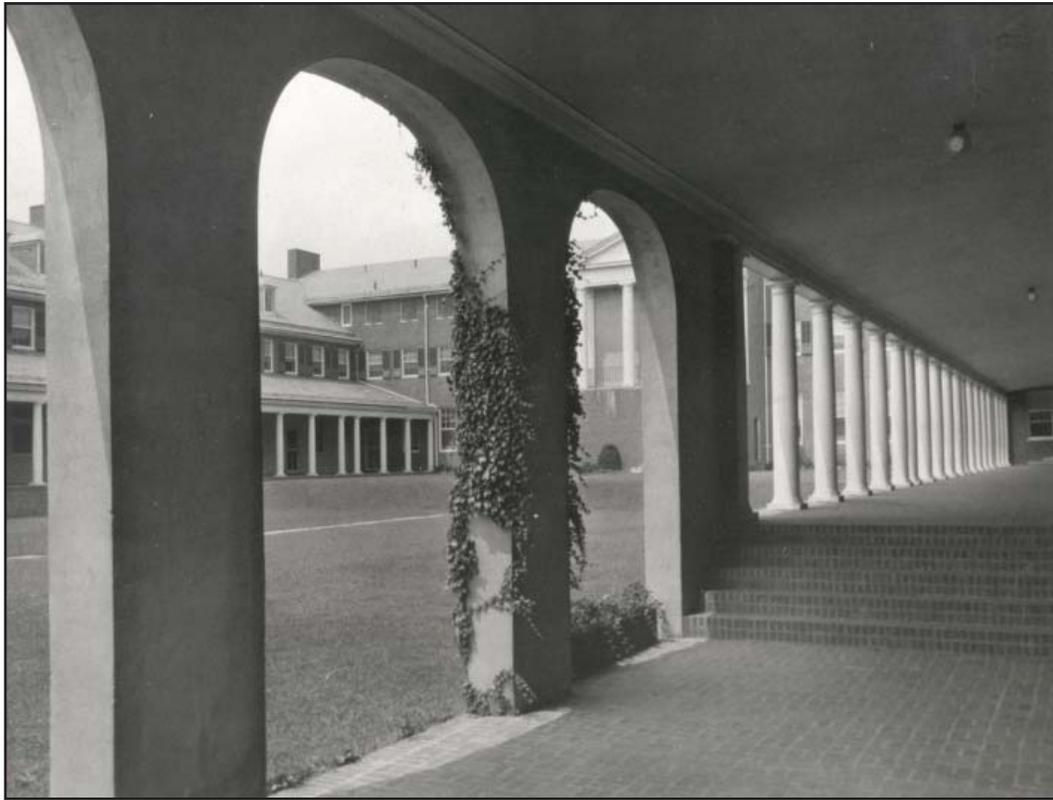
**Figure 2-14.** Main School Building (Building 1) cloister and colonnades. *Source: Mount Vernon Seminary and College Archives, The Gelman Library at Mount Vernon Campus.*

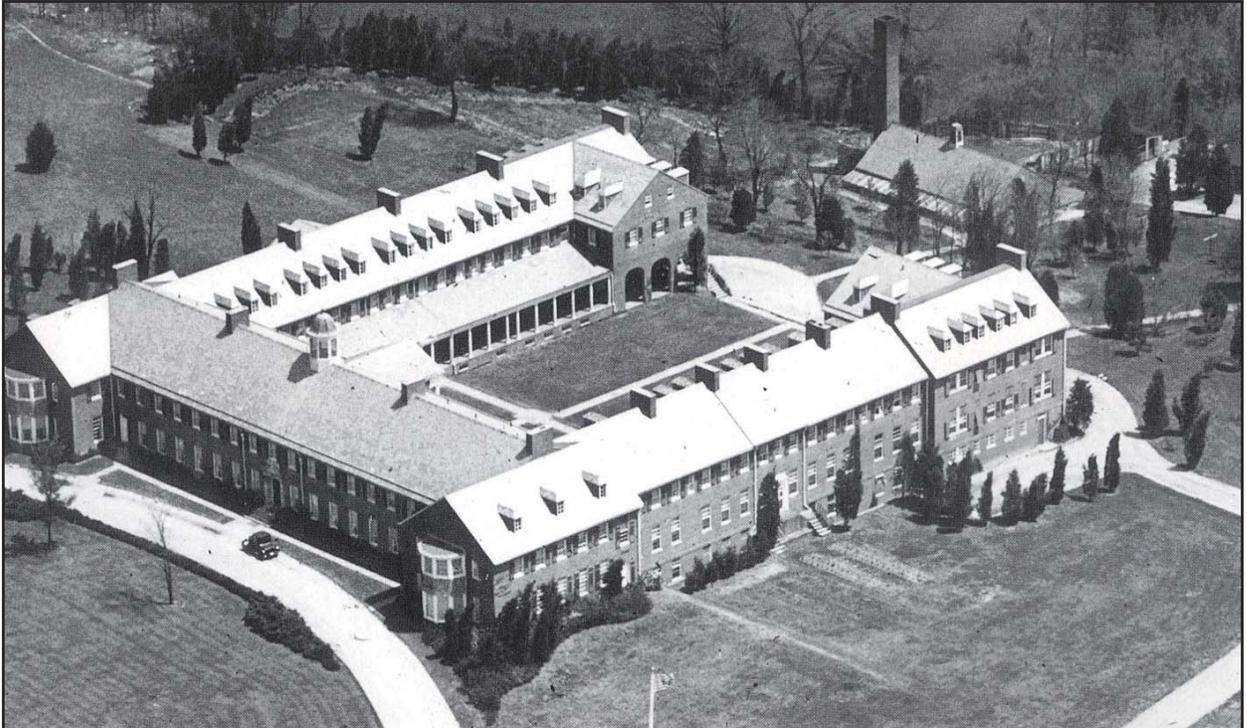
**Figure 2-17.** Aerial photograph showing locations of earthen terraces (lighter grey bands). Source: *Dear Daughters*, 64.

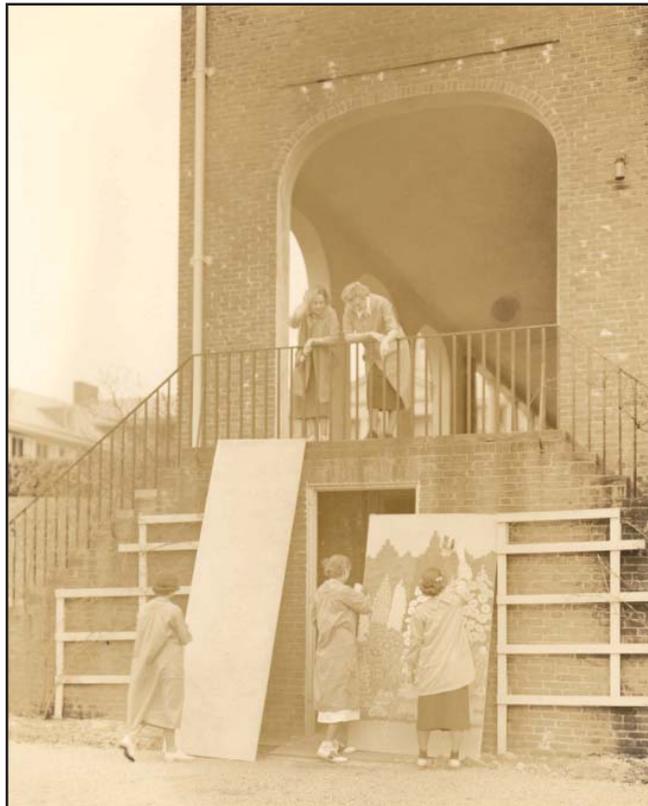
**Figure 2-20.** White-painted wooden trellis at the east end of the north arm of the Main School Building. *Source: Mount Vernon Seminary and College Archives, The Gelman Library at Mount Vernon Campus.*

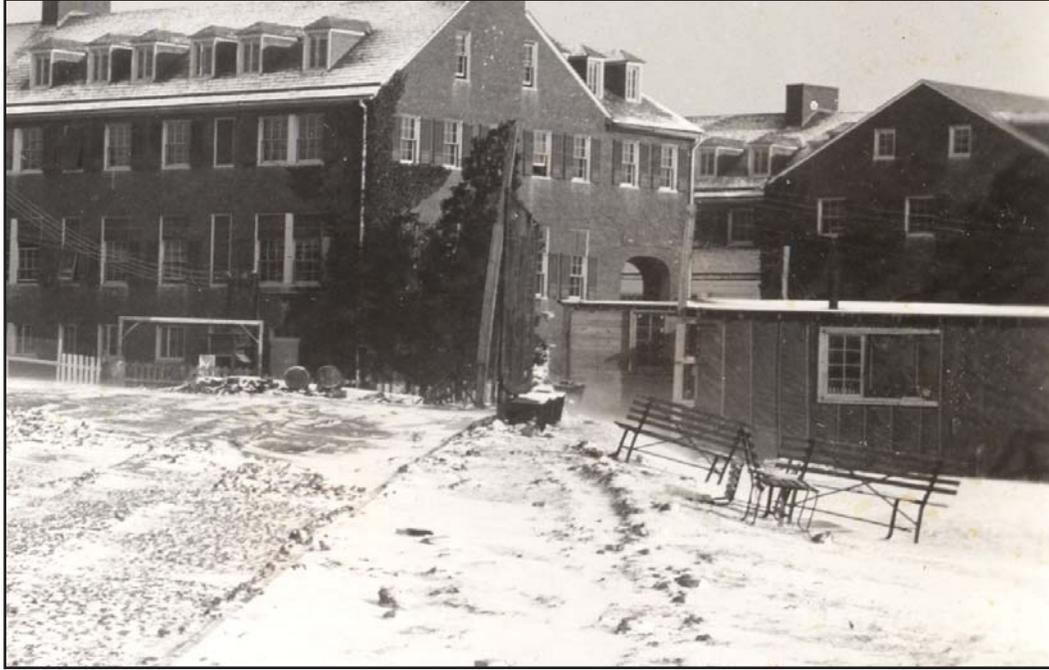
**Figure 2-21.** Delicate cast iron and wood benches from the Mount Vernon Seminary, photographed during construction on the campus in the 1940s. *Source: Nebraska Avenue Complex Public Works Archives.*

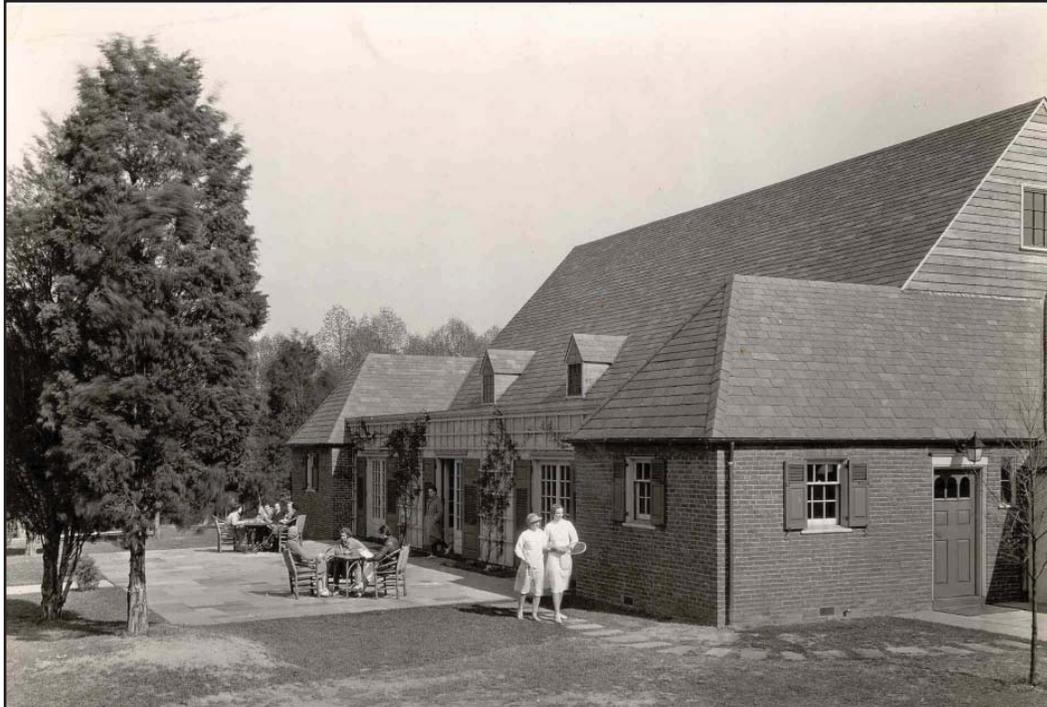
**Figure 2-32.** Rectangular flagstone terrace that was located to the north of the Field House during the period of significance. Note also the wooden trellises that support vines above the doorways. Also note the flagstone path leading to the side door of the building. *Source: Mount Vernon Seminary and College Archives, The Gelman Library at Mount Vernon Campus.*

and kept in wildflowers with trees, primarily Eastern red cedar, dotted throughout (Figures 2-32 through 2-34).

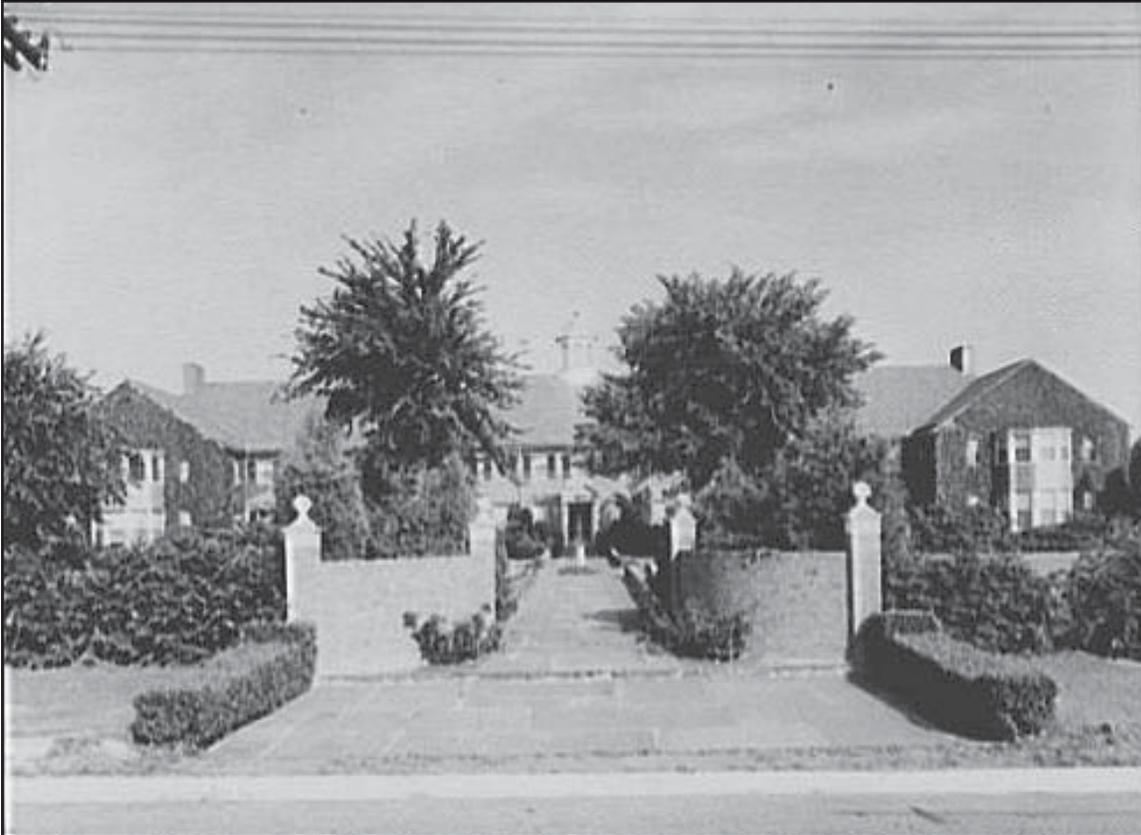
**Figure 2-35.** Central pedestrian gateway and flagstone terrace leading to the main door of the school building (no longer extant). The gateway was constructed of the same materials and in the Colonial Revival style used for the Adelia Hensley Memorial Gate and the north gate. *Source: Library of Congress.*

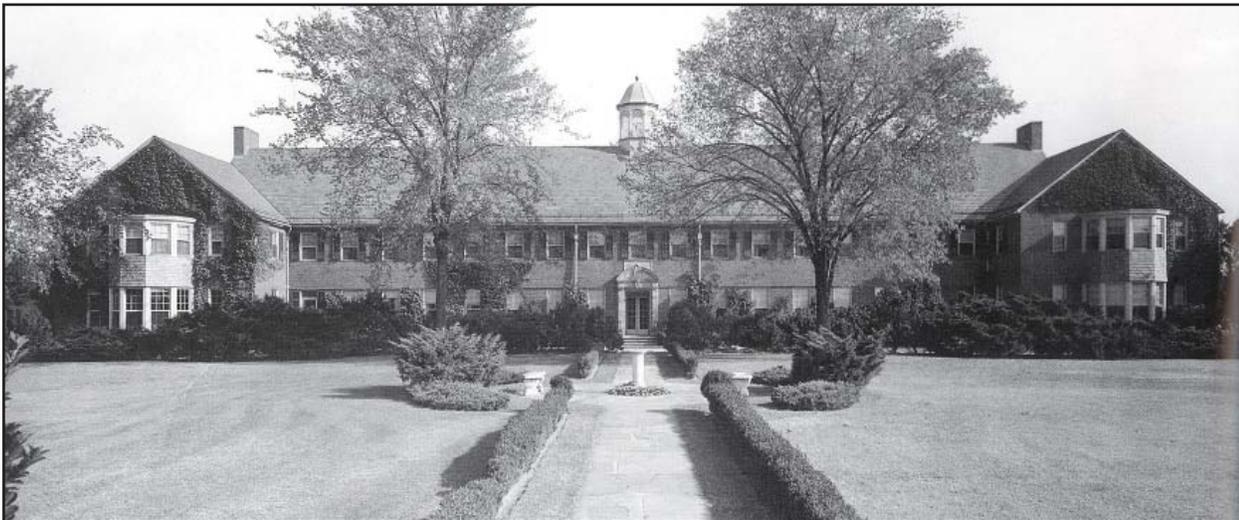
**Figure 2-36.** Photograph of the Main School Building prior to 1942 shows a bluestone flagstone walkway to the main door of the school building. Note the sundial at the center (from rose garden?) and flanking concrete benches, as well as the symmetrical evergreen planting. *Source: Dear Daughters, 66.*

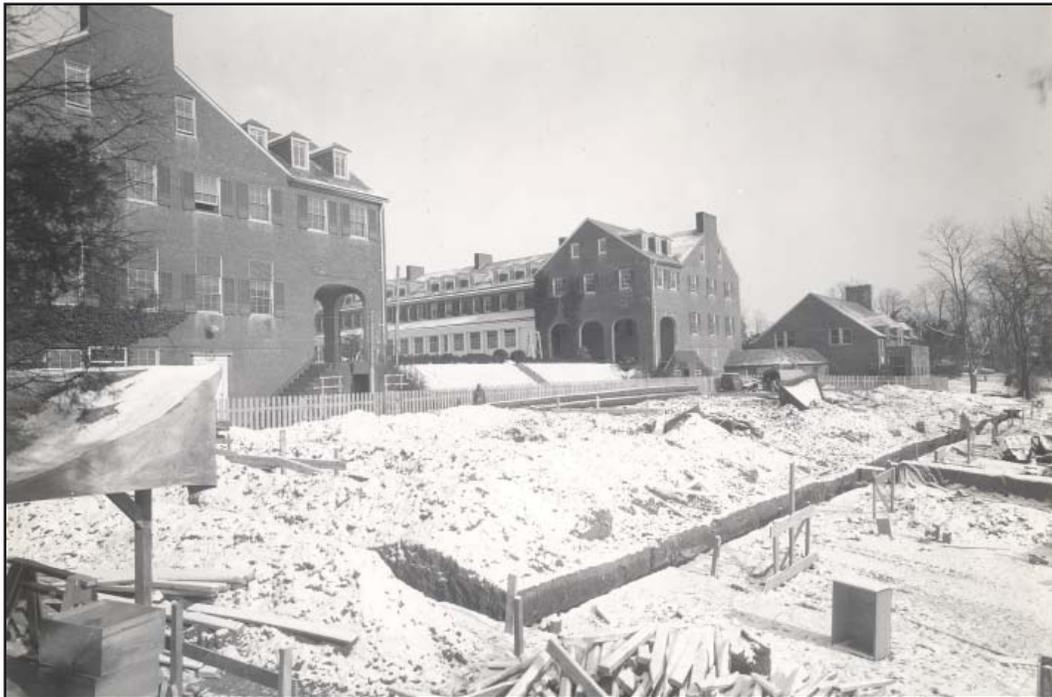
**Figure 2-38.** 1943 photograph of the construction of Building 3 behind Building 1. Note the wood trellises are still extant at the ends of Building 1. *Source:* *Nebraska Avenue Complex Public Works Archives.*

- Figure 2-38. 1943 photograph of the construction of Building 3 behind Building 1. Note the wood trellises are still extant at the ends of Building 1. 31

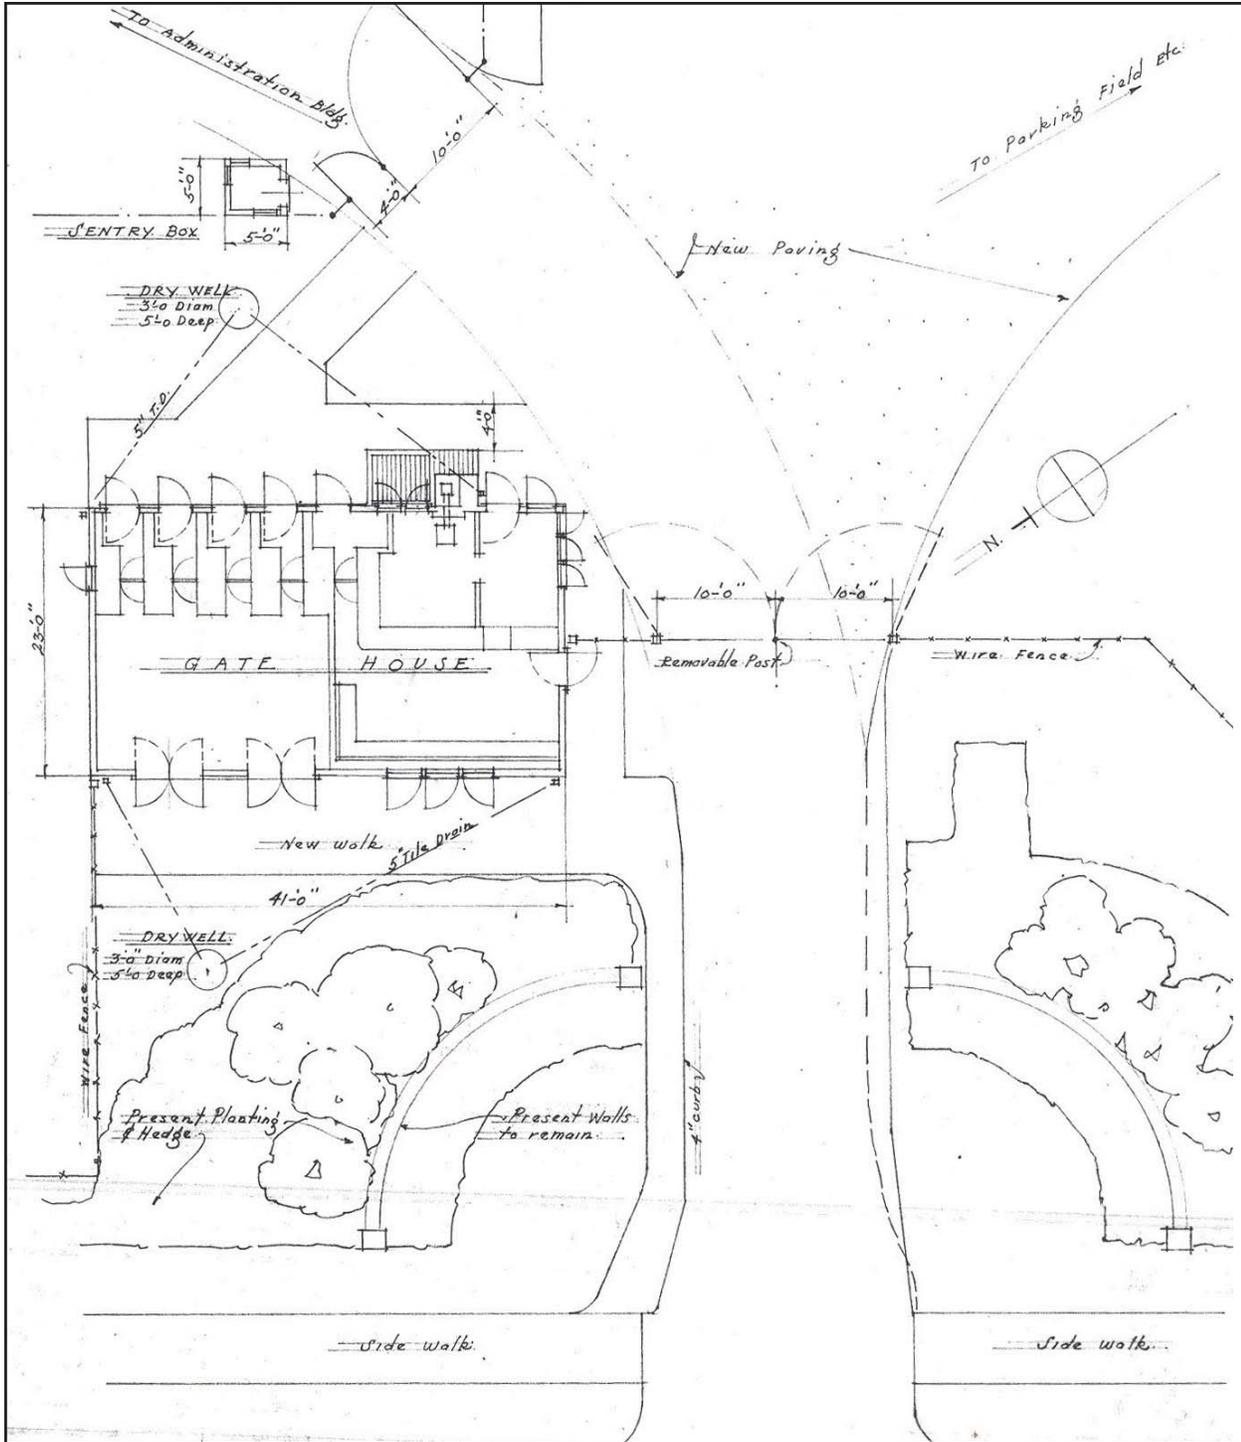
**Figure 2-39.** This plan for the Gate House indicated the retention of existing plantings, installation of drainage lines, installation of fencing and gates and new paving. Note that in this plan, the south side of the Hensley Gate is still extant but would at some point be moved to allow for a wider entrance. Source: Nebraska Avenue Complex Public Works Archives.

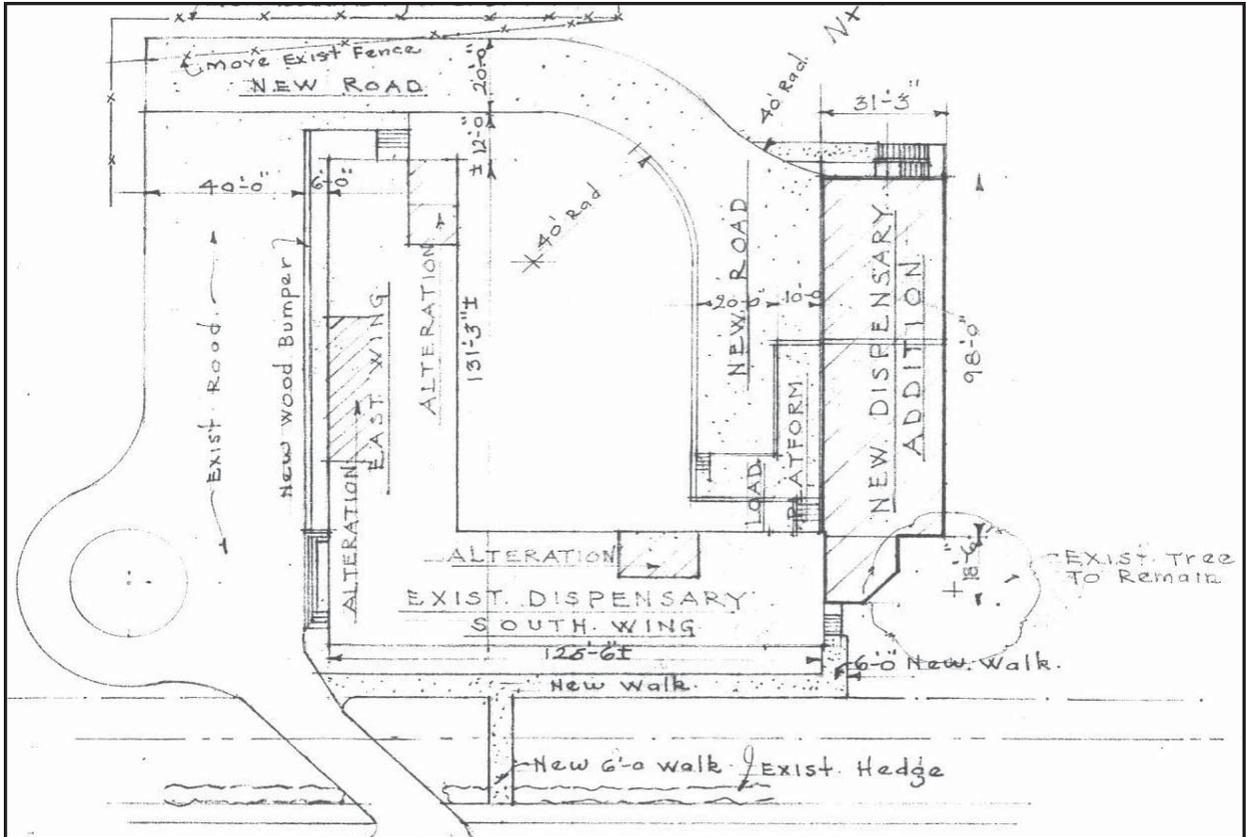
**Figure 2-40.** Plans for Building 7 from 1943 show existing plants and the retention of the original service drive entrance of Mount Vernon Seminary (diagonal entrance). Note that a remnant of this entrance still exists in the form of two parking spaces set at that angle in front of the building. *Source: Nebraska Avenue Complex Public Works Archives.*

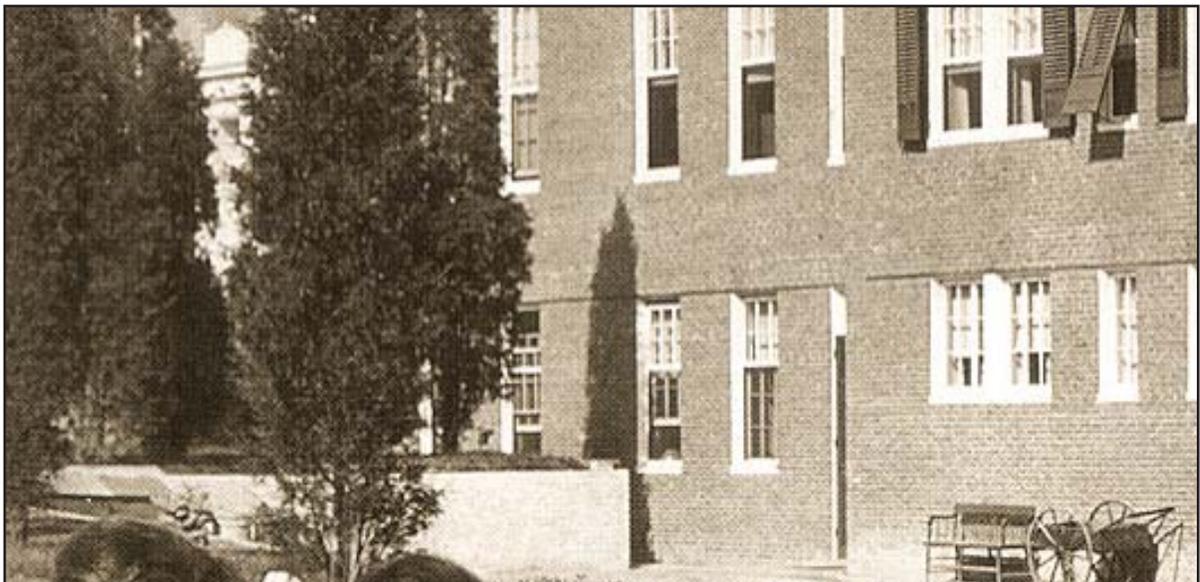
**Figure 2-41.** Detail from a photograph from the 1920s shows the brick retaining wall south of Building 1 that is still existing in the landscape between Building 1 and Building 17. *Source: Mount Vernon Seminary and College Archives, The Gelman Library at Mount Vernon Campus.*

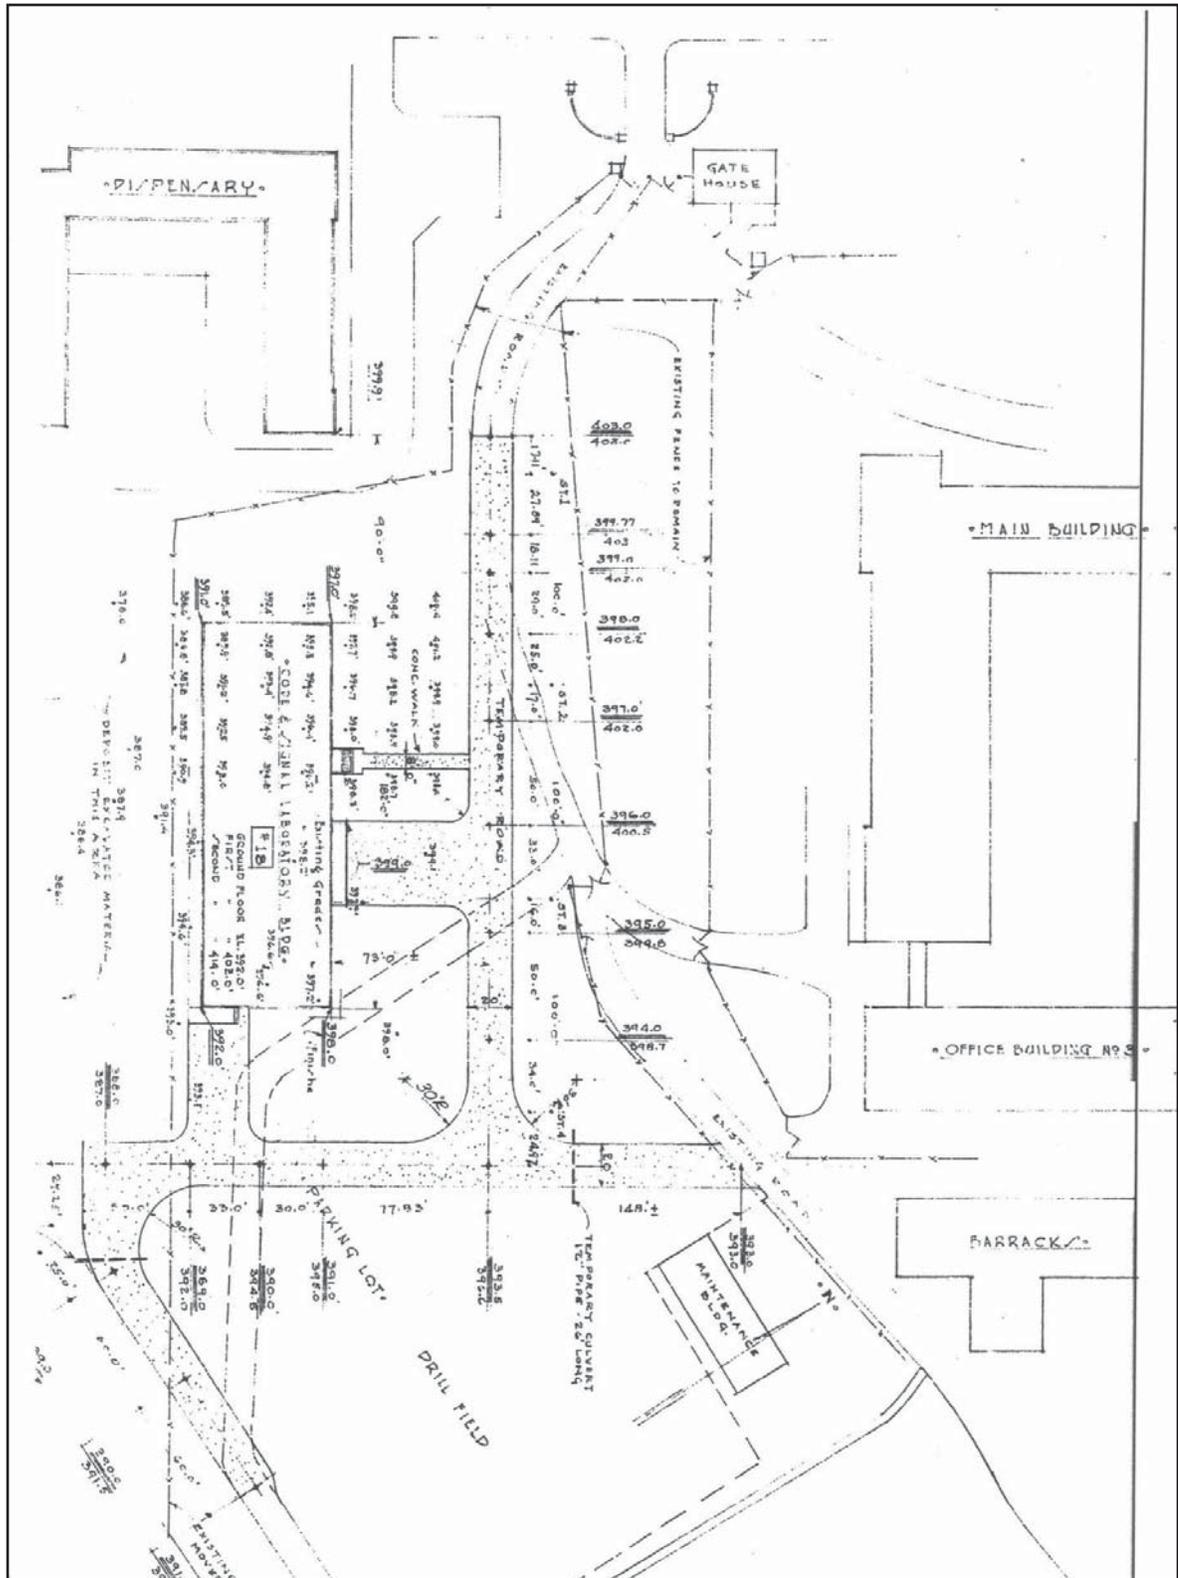
**Figure 2-42.** This plan from 1944 shows the circulation plan for Building 18 from that period. Note that this establishes the alignment for Mount Vernon Drive. Also note the building on the right indicated as Barracks; this building is no longer extant. The plan also indicated that the area now used as a group picnic area was once a parking lot and drill field. Source: Nebraska Avenue Complex Public Works Archives.

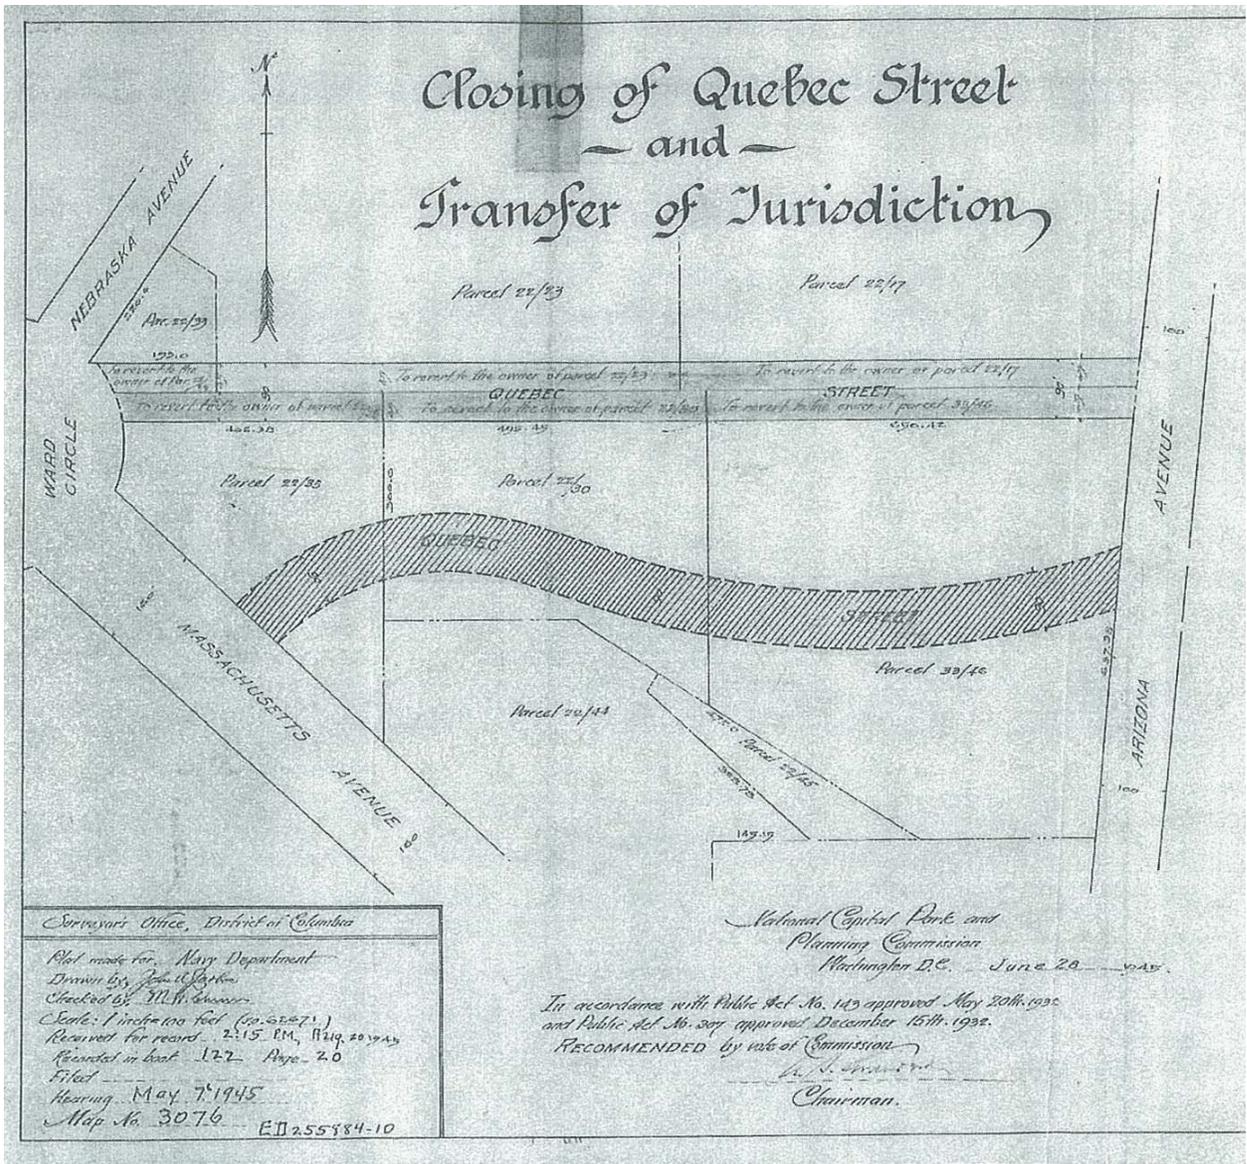
**Figure 2-43.** Detail taken from document detailing the relocation and reconfiguration of the Quebec Street right-of-way and the transfer of jurisdiction to the District of Columbia. Source: Nebraska Avenue Complex Public Works Archives.

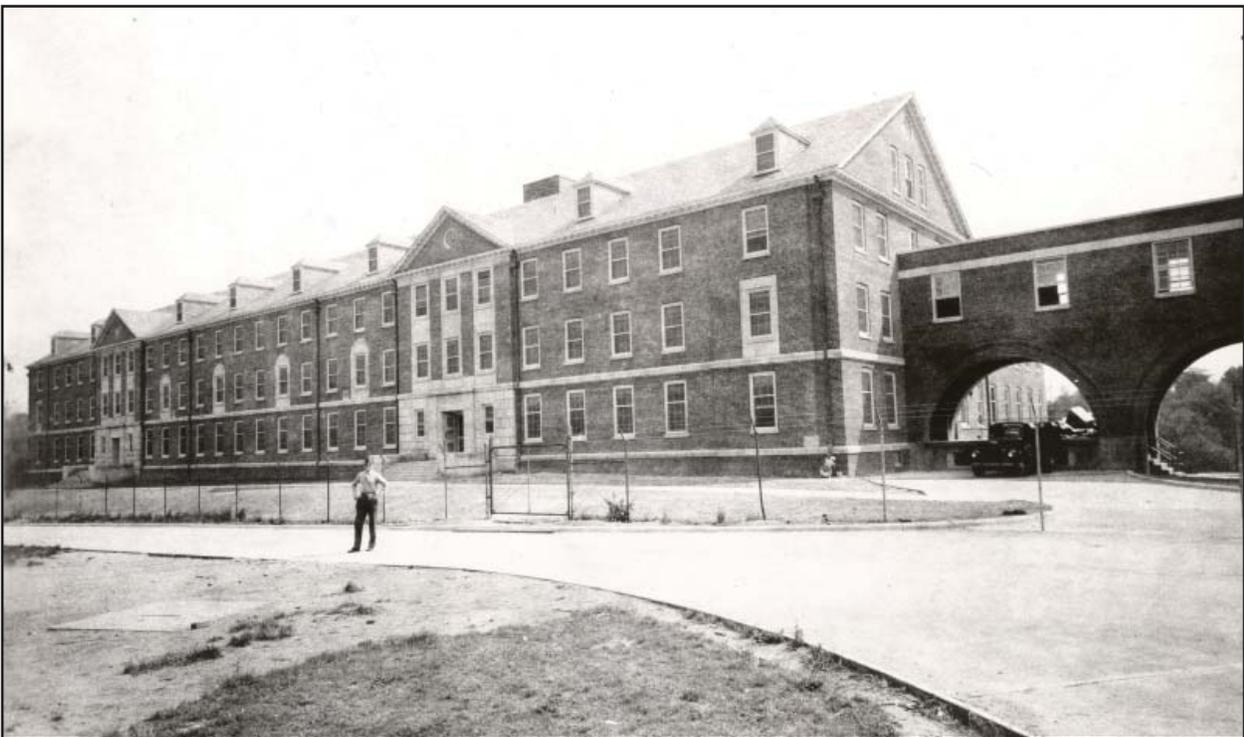
**Figure 2-45.** Photograph showing the connector between Buildings 18 and 19. *Source: Nebraska Avenue Complex Public Works Archives.*
