# U.S. Department of Homeland Security Nebraska Avenue Complex Master Plan DRAFT ENVIRONMENTAL IMPACT STATEMENT

# Cultural Landscape Report

# NEBRASKA AVENUE COMPLEX Cultural Landscape Report

Washington, D.C.

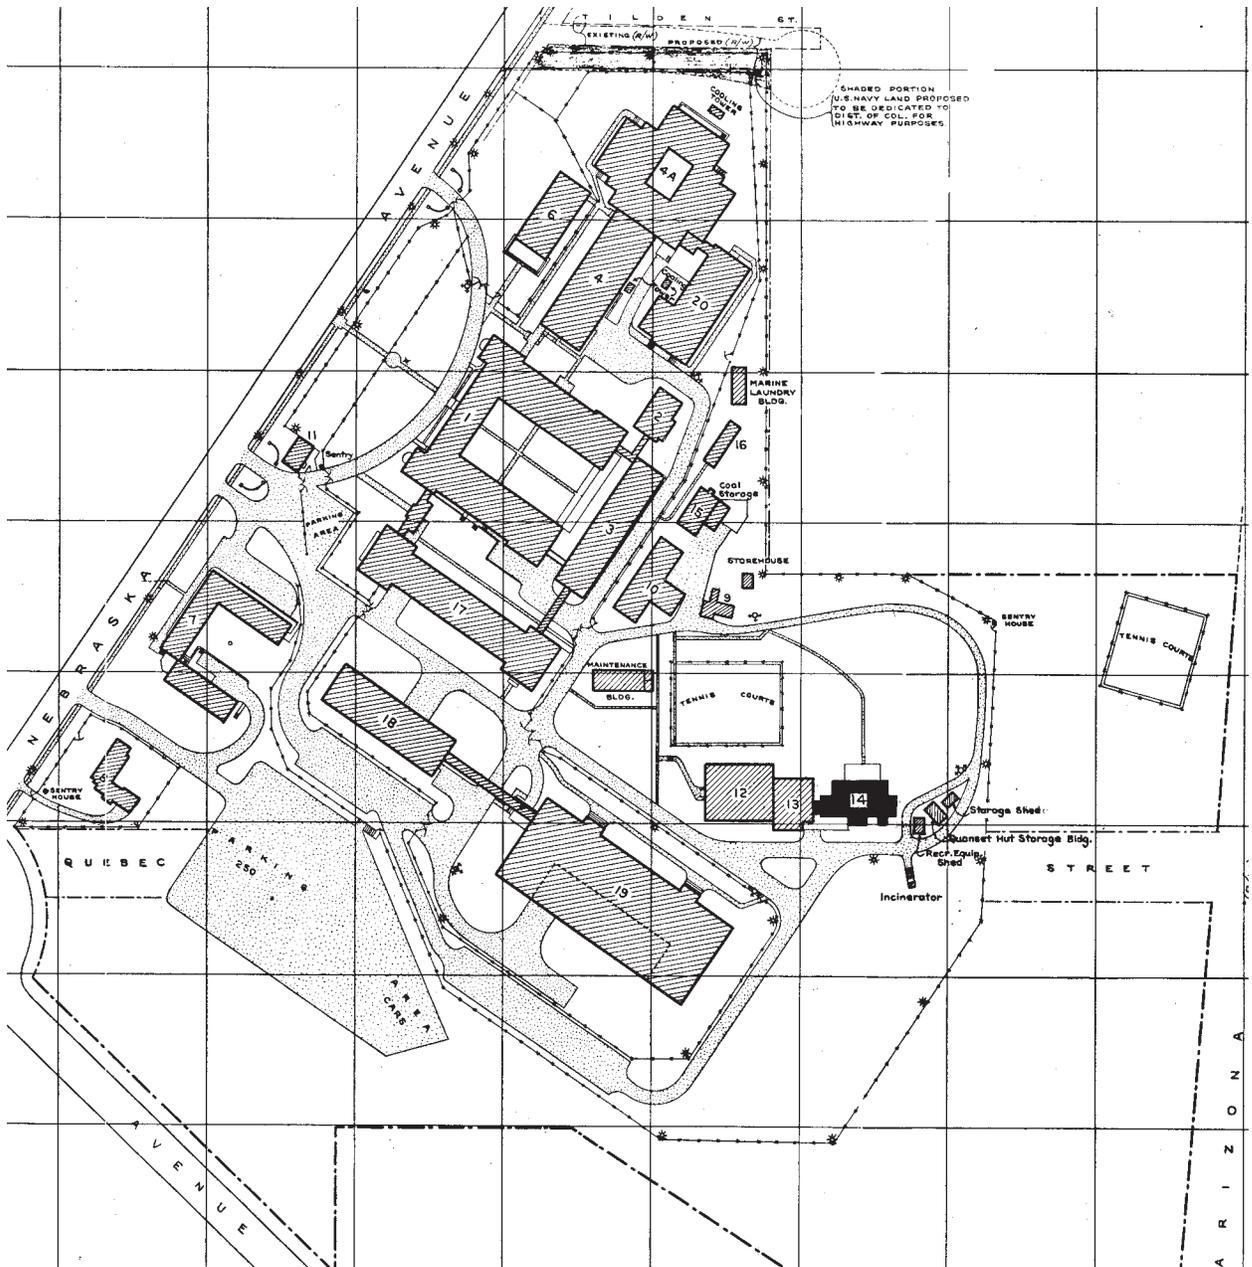
**Figure 2-46.** Detail from construction plans developed in 1948 for alterations to Building 14, the “Mess Hall.” Note the double entrance to the site on Nebraska Avenue has been constructed, but the south side of the Hensley Gate is still in its original location. In addition, the tennis courts built by Elizabeth Somers are still shown in the eastern portion of the property and the diagonal path, still extant, is shown leading to the Building 14 terrace. *Source: Nebraska Avenue Complex Public Works Archives.*

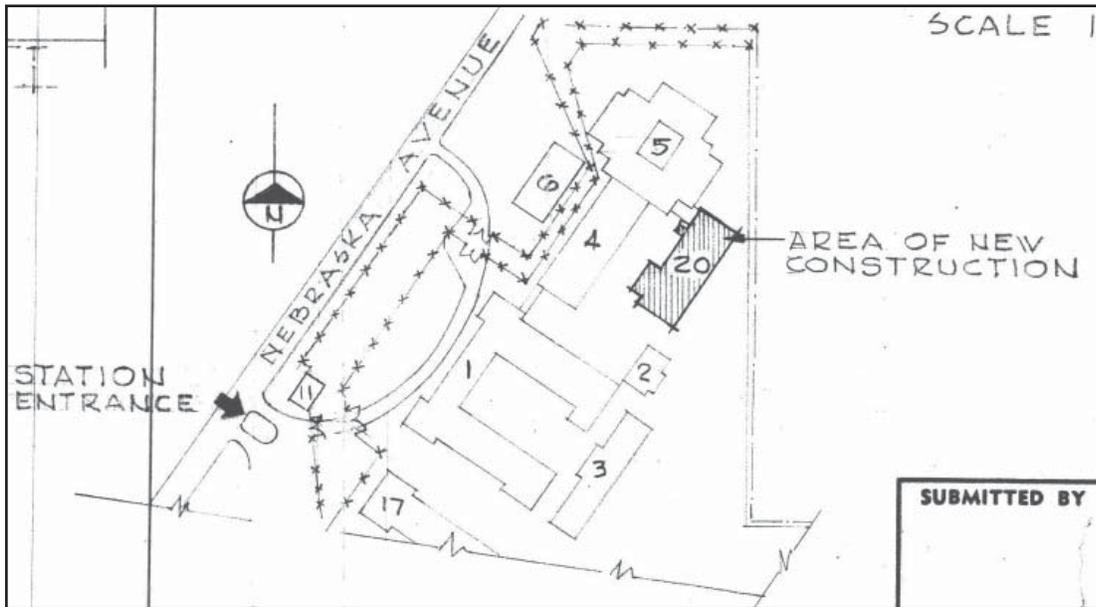
**Figure 2-48.** This location plan from 1959 shows the layout at the time of the double security fencing. Note that it also shows the main entrance in its current configuration with two lanes and an island, indicating that it dates to sometime between 1952 and 1959. *Source: Nebraska Avenue Complex Public Works Archives.*

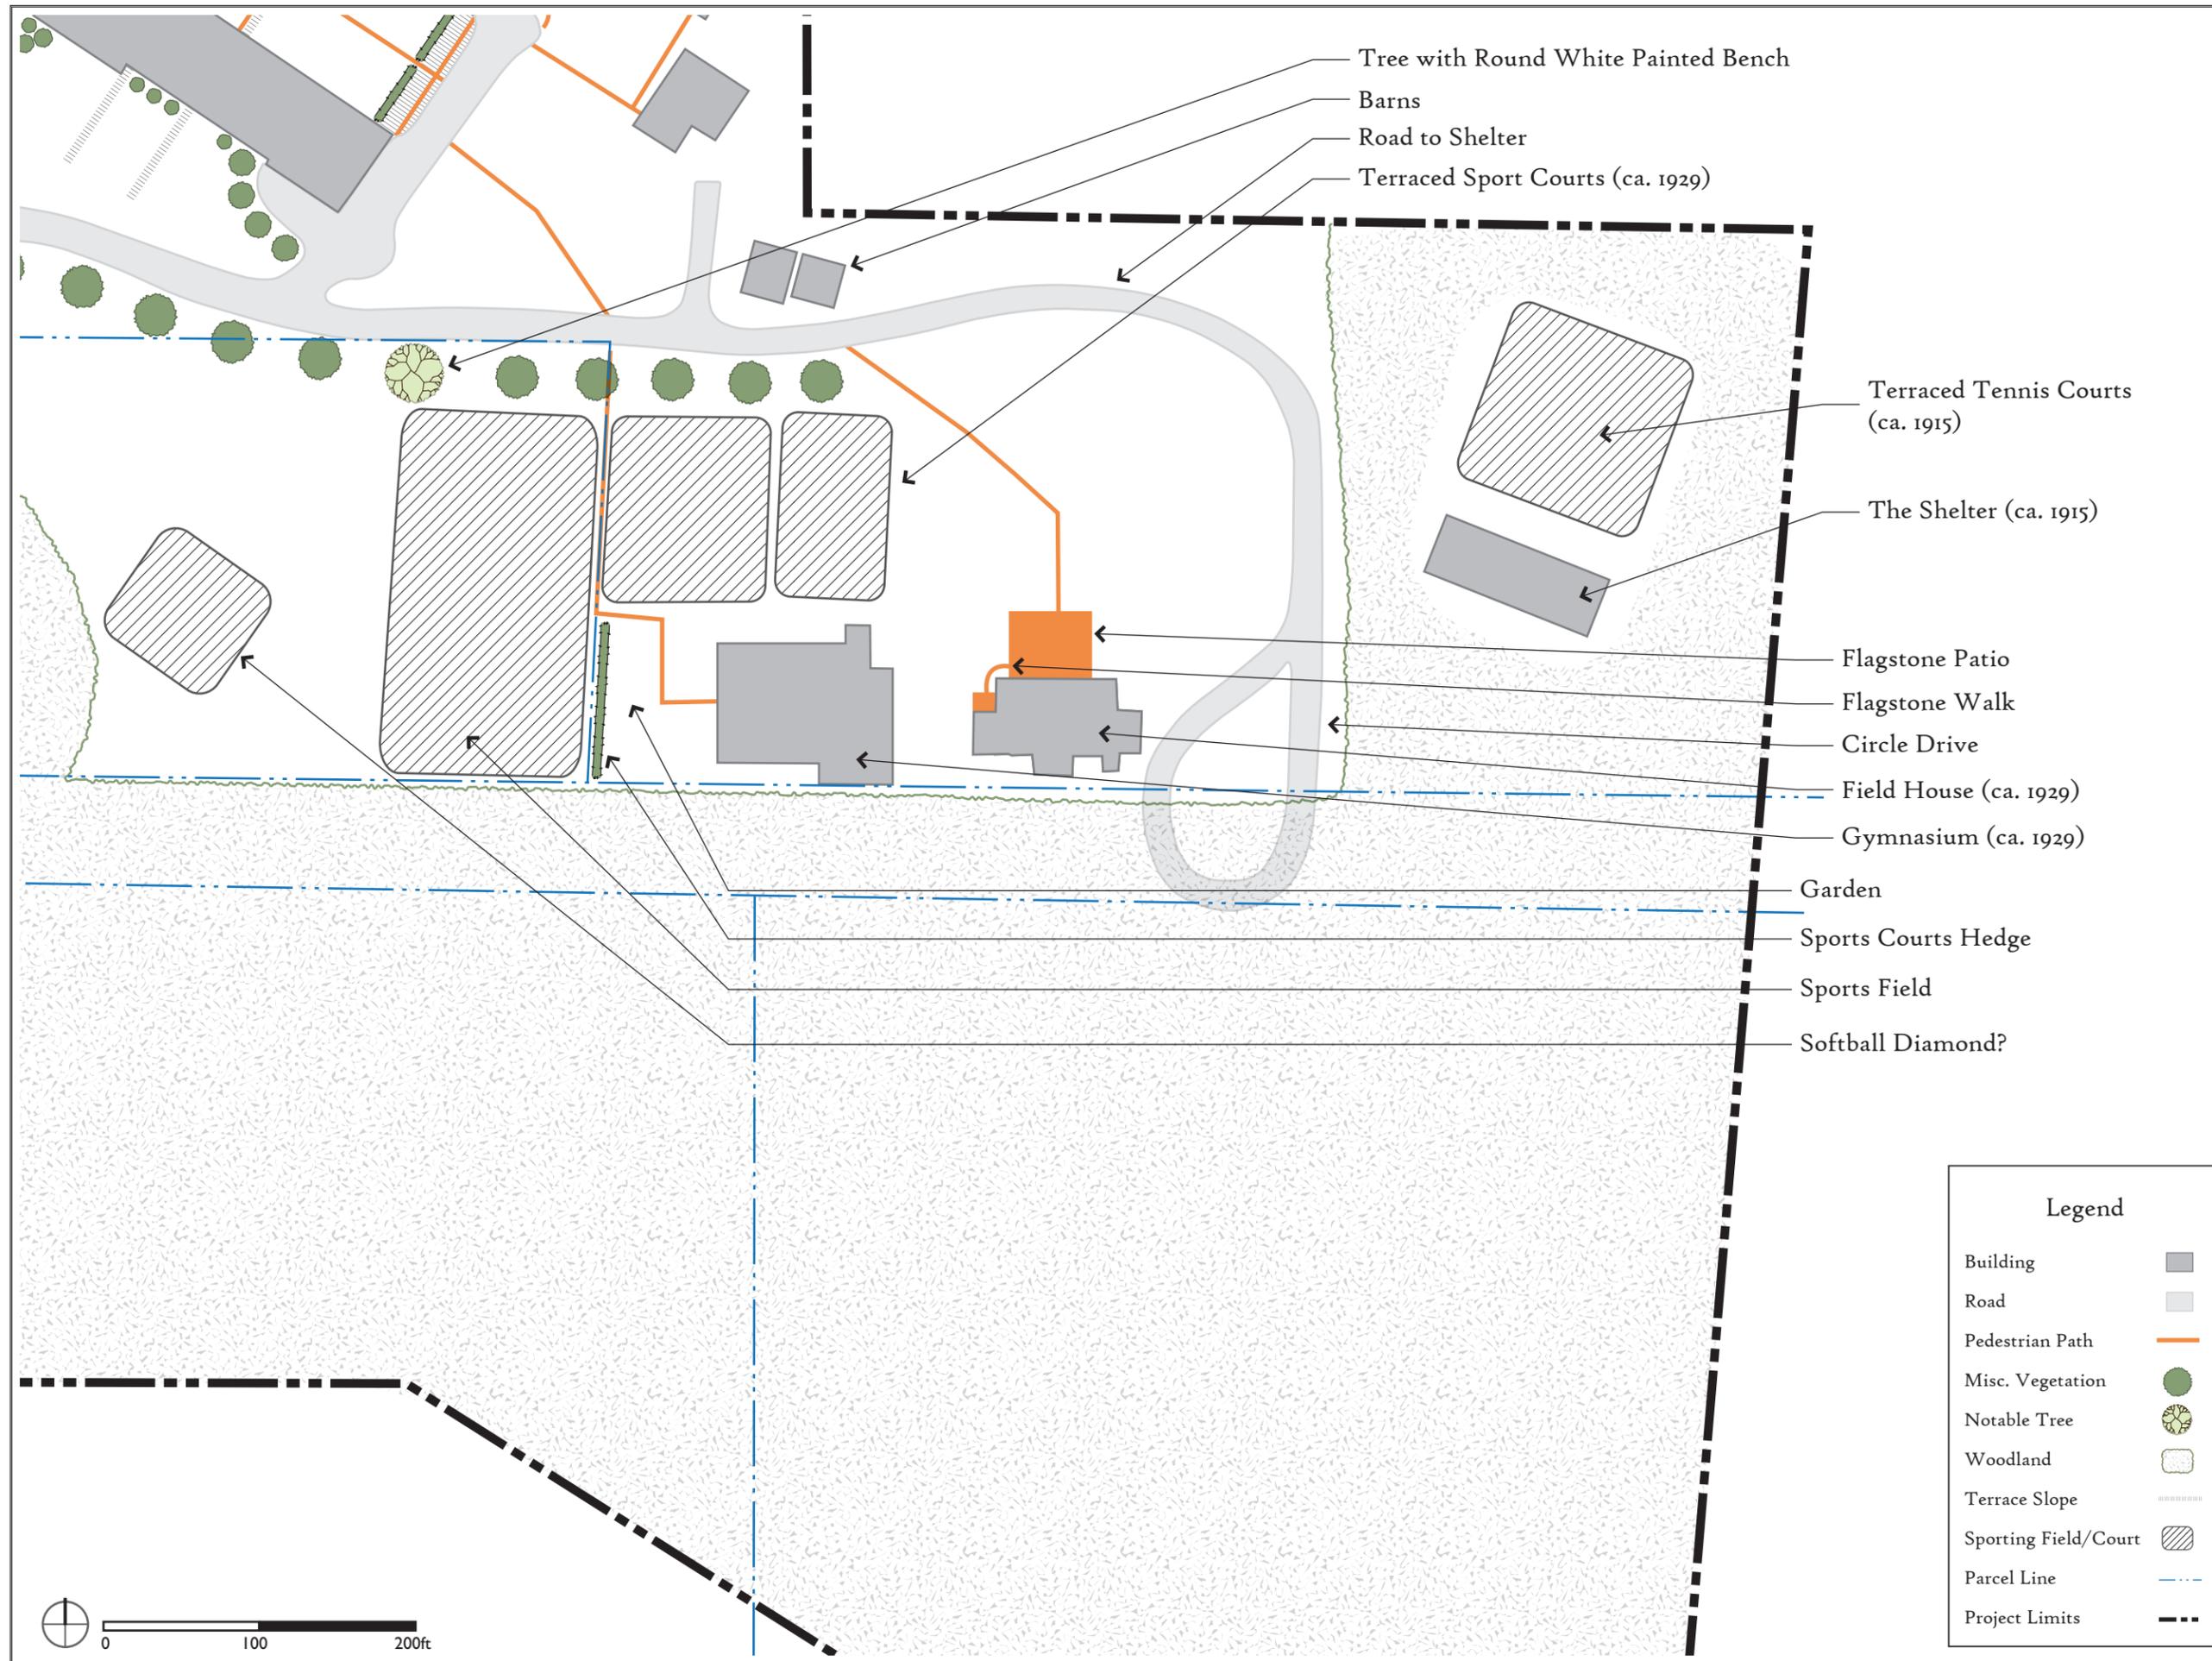
**Map 2-2.**  
Period Plan:  
1916-1942  
Front Parcel Detail

- Tree with Round White Painted Bench
- Barns
- Road to Shelter
- Terraced Sport Courts (ca. 1929)
- Terraced Tennis Courts (ca. 1915)
- The Shelter (ca. 1915)
- Flagstone Patio
- Flagstone Walk
- Circle Drive
- Field House (ca. 1929)
- Gymnasium (ca. 1929)
- Garden
- Sports Courts Hedge
- Sports Field
- Softball Diamond?

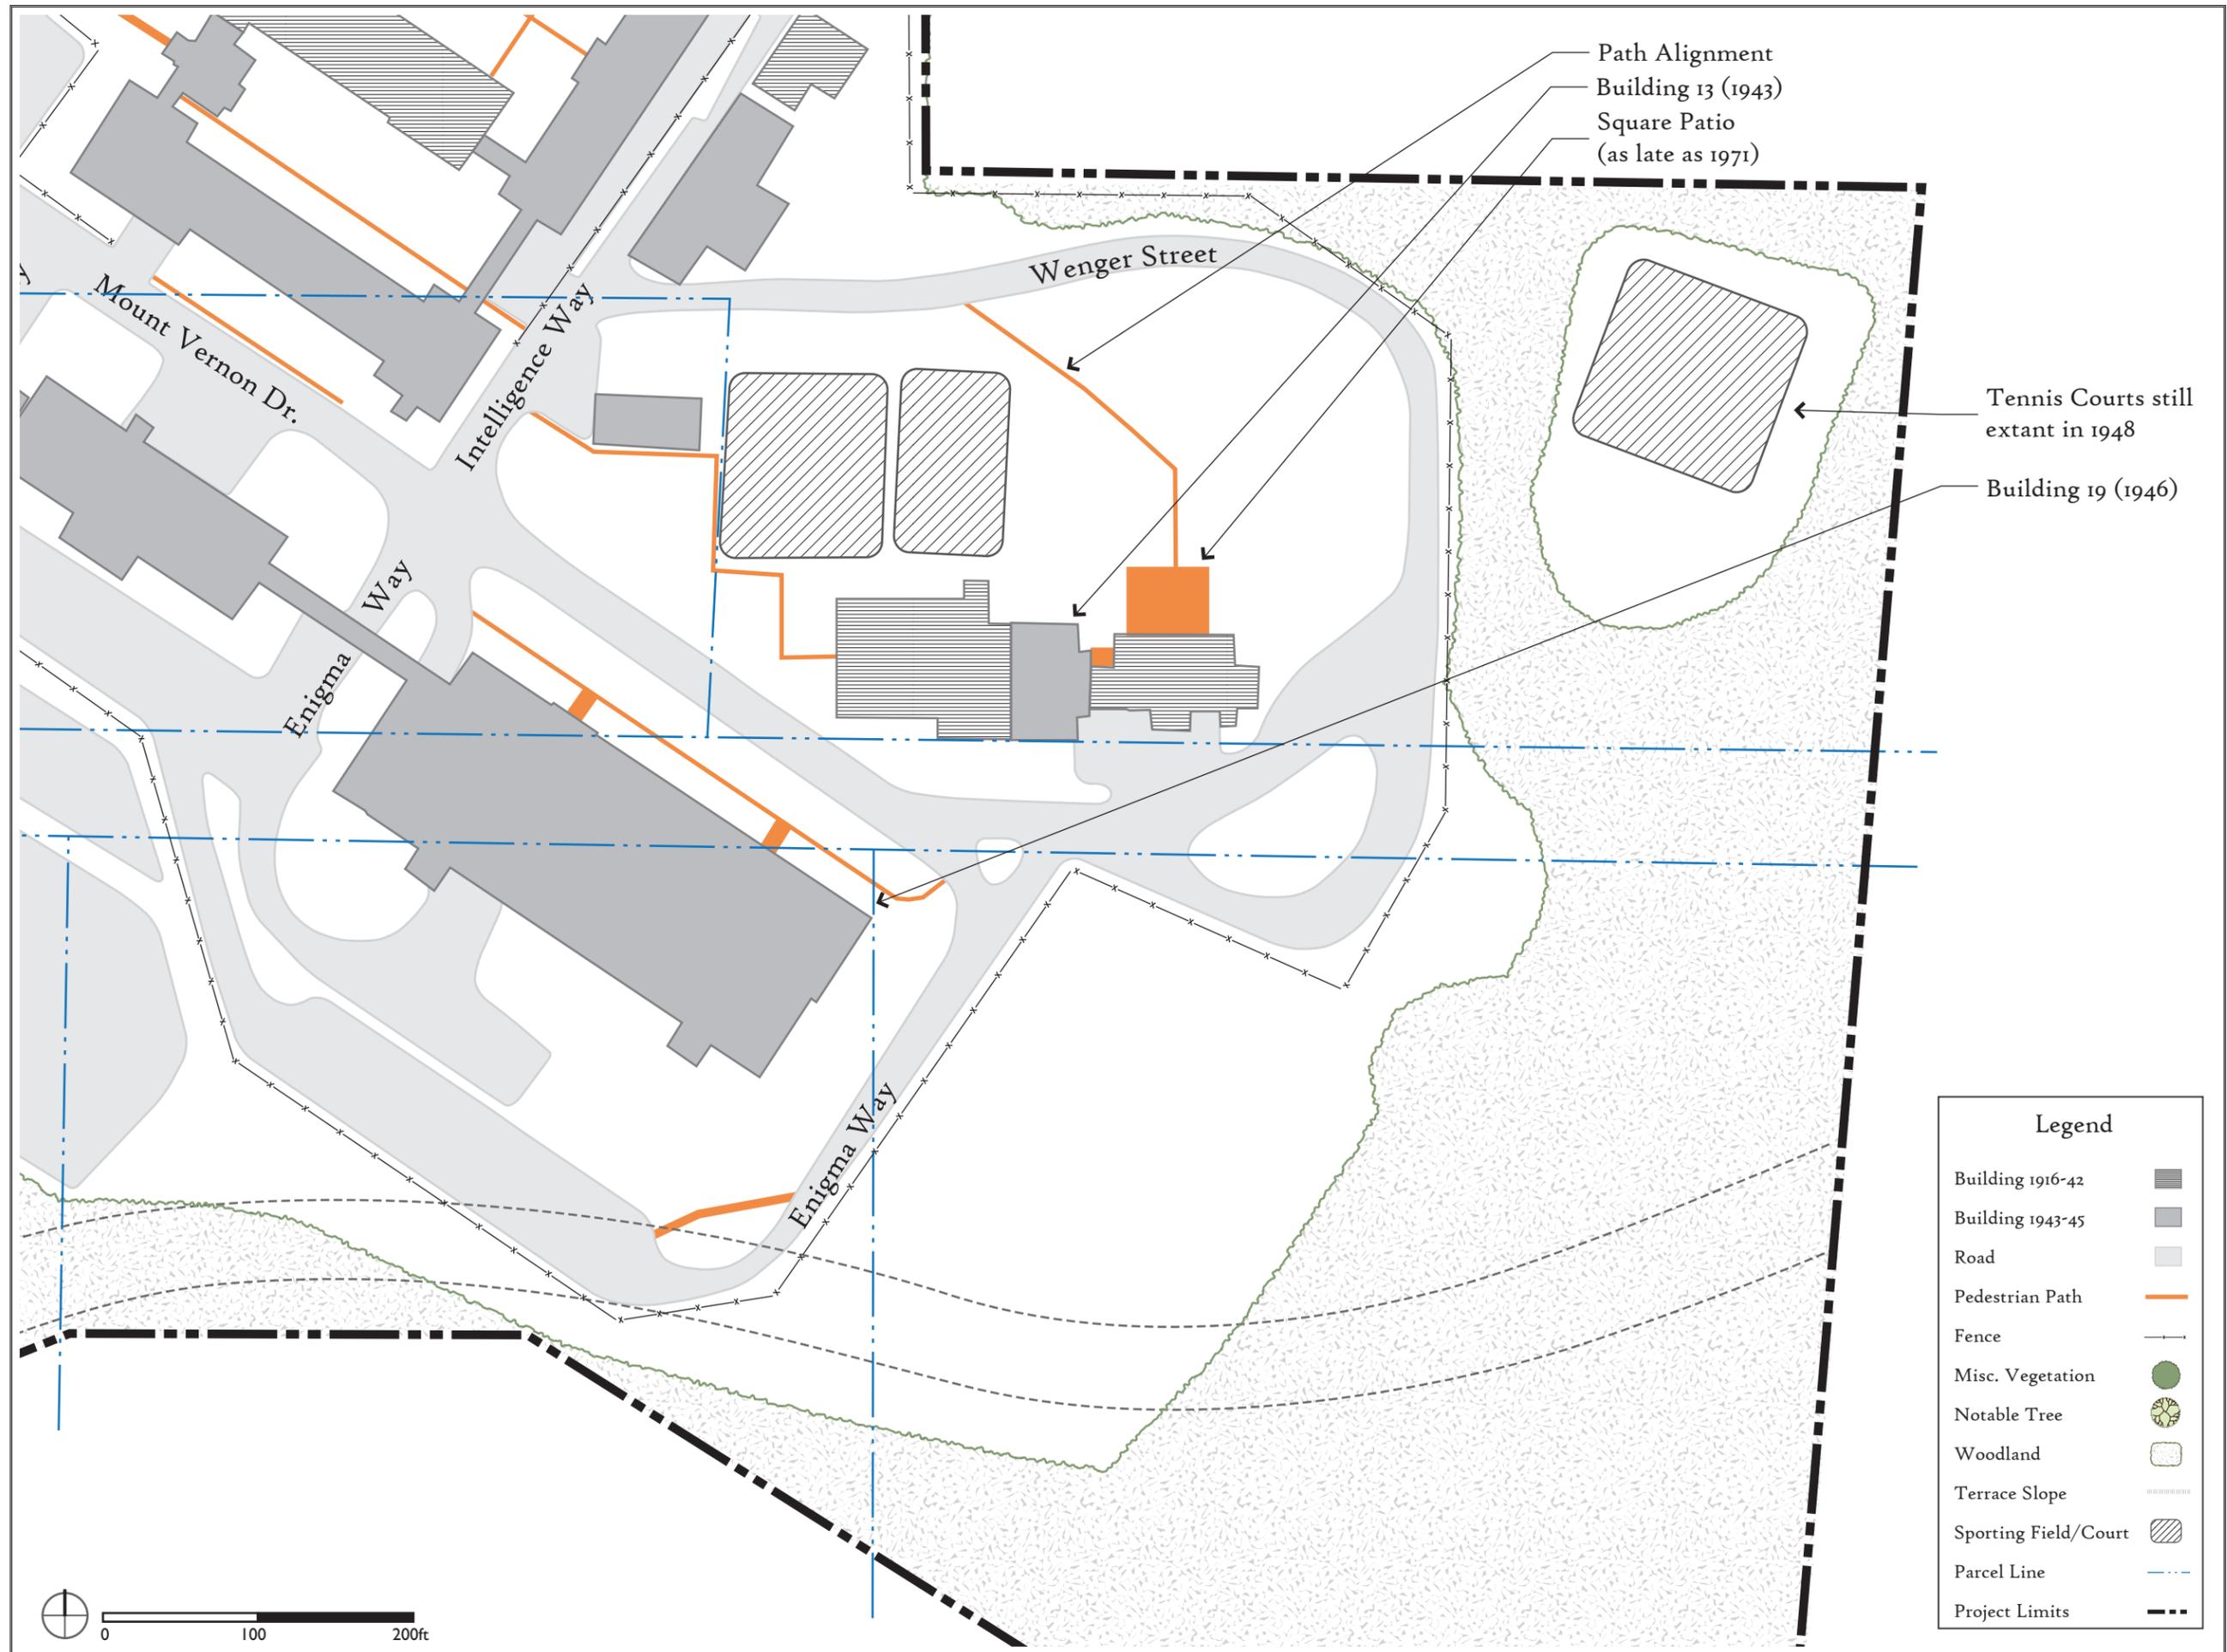
**Map 2-6.**  
Period Plan:  
1943-1952  
Back Parcel Detail

Path Alignment  
Building 13 (1943)  
Square Patio  
(as late as 1971)

Tennis Courts still  
extant in 1948

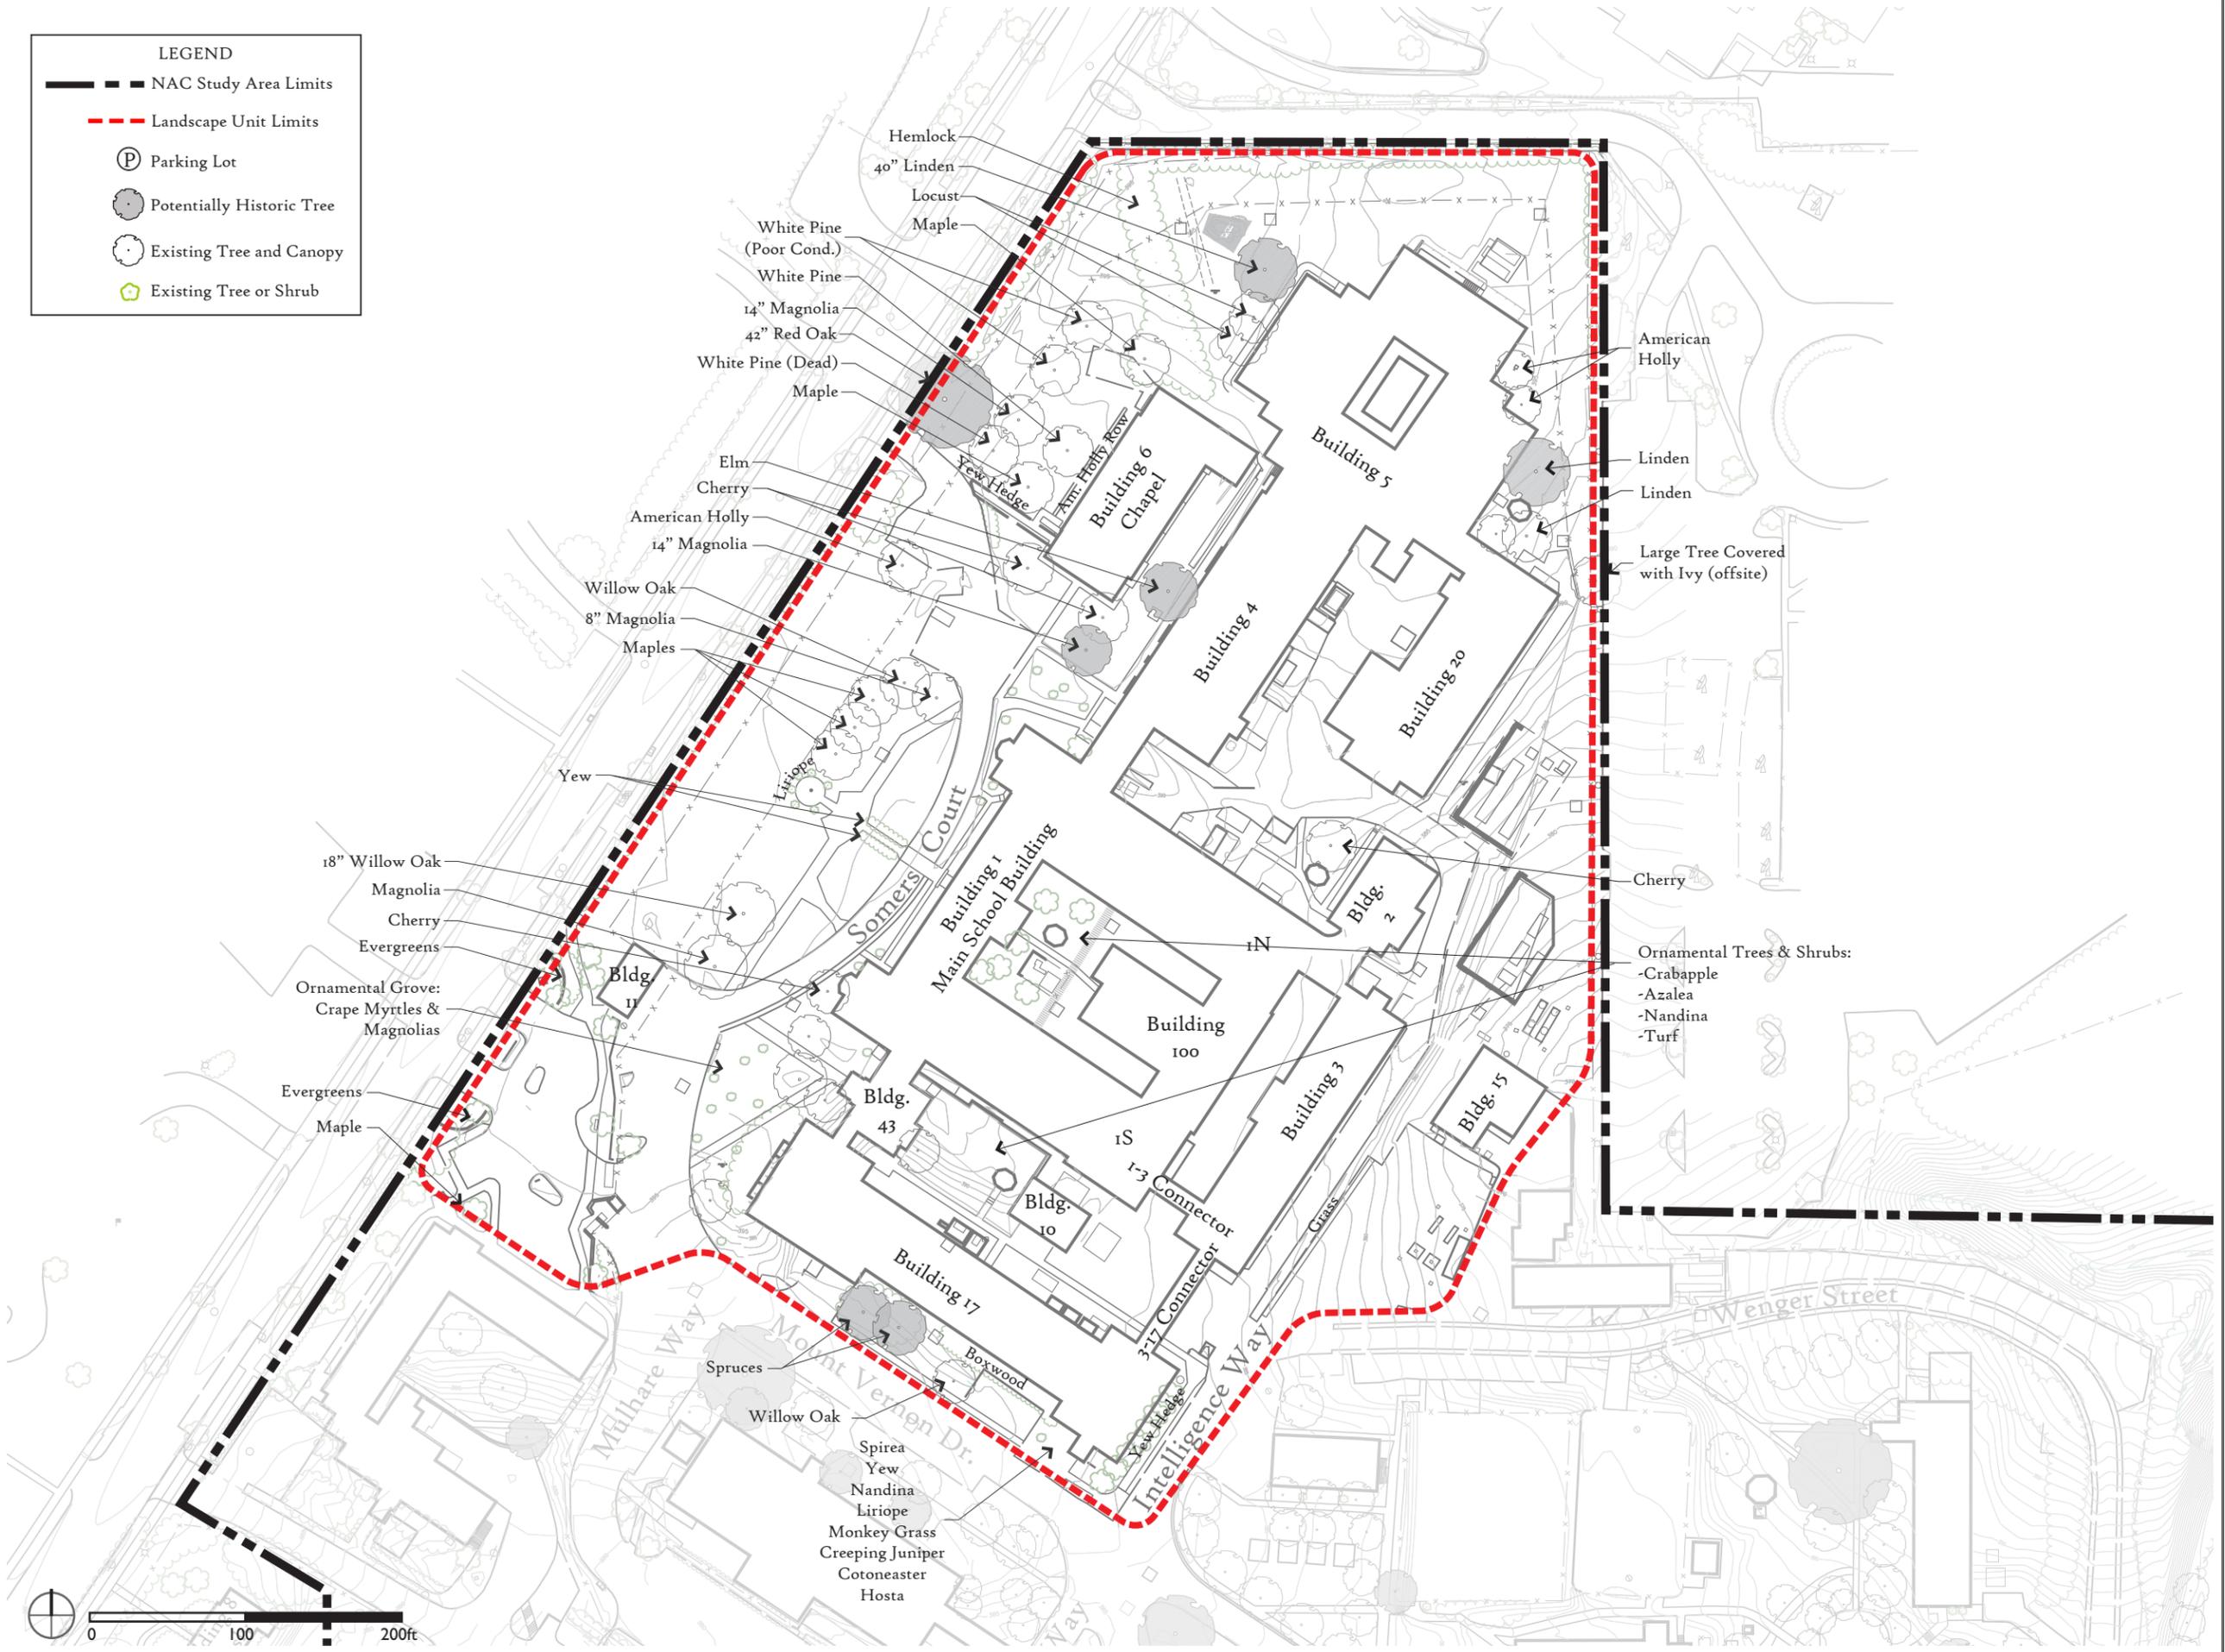
**Map 3-2.**  
**Mount Vernon**  
**Unit**  
**Existing Conditions**

Hemlock  
40" Linden  
Locust  
Maple  
White Pine (Poor Cond.)  
White Pine  
14" Magnolia  
42" Red Oak  
White Pine (Dead)  
Maple  
Elm  
Cherry  
American Holly  
14" Magnolia  
Willow Oak  
8" Magnolia  
Maples  
Yew  
Liriope  
18" Willow Oak  
Magnolia  
Cherry  
Evergreens  
Ornamental Grove:  
Crape Myrtles &  
Magnolias  
Evergreens  
Maple  
Spruces  
Willow Oak  
Spirea  
Yew  
Nandina  
Liriope  
Monkey Grass  
Creeping Juniper  
Cotoneaster  
Hosta

Building 1  
Main School Building  
Building 2  
Bldg. 2  
Building 3  
Building 4  
Building 5  
Building 6  
Chapel  
Building 10  
Bldg. 10  
Building 15  
Bldg. 15  
Building 17  
Building 20  
Bldg. 43  
3-17 Connector  
Intelligence Way  
Wenger Street  
Milhare Way  
Somers Court  
Yew Hedge  
Am. Holly Row  
Large Tree Covered with Ivy (offsite)  
Ornamental Trees & Shrubs:  
-Crabapple  
-Azalea  
-Nandina  
-Turf

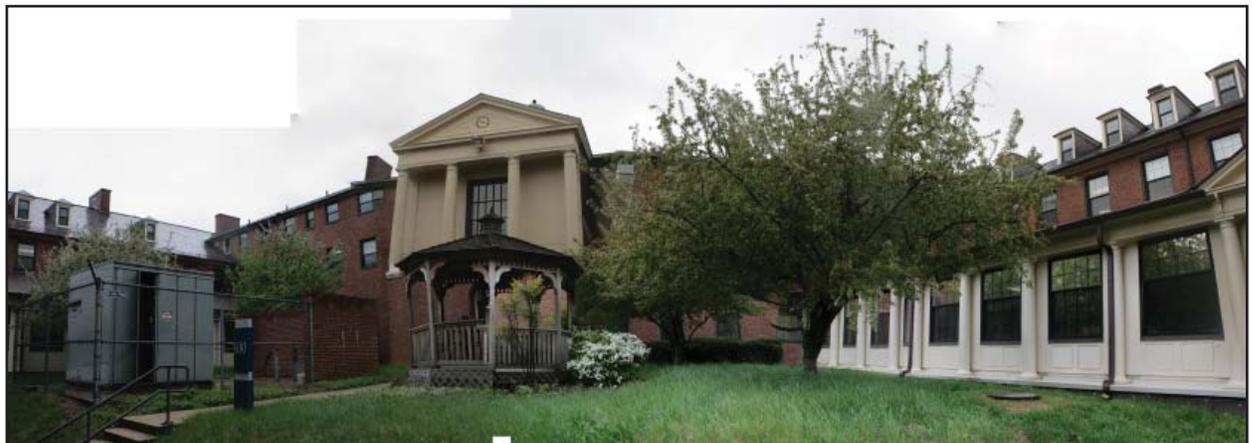
**Figure 3-2.** The existing conditions at the Building 1 courtyard, including the remnants of the upper terrace and sidewalk, a metal railing, a gazebo, a building identification sign, HVAC equipment and ornamental plantings. Also note that the colonnade is enclosed and not open as it was during the first period of significance. *Source: JMA 2010.*

Located on the crest of a hill overlooking the Potomac River, the Mount Vernon Unit is generally organized by axes related to the alignment of Nebraska Avenue. Building 1 faces Nebraska Avenue and is a symmetrical structure arranged on an axis perpendicular to the road (Figure 3-1). Two wings extend to the southeast to enclose what was an interior courtyard, but this space was disrupted by the construction of Building 100 in 1990 (Figures 3-2 and 3-3).

Long views within this unit are limited by vegetation and building mass. Views of the façade of Building 1 are only available intermittently (Figure 3-14). The vista between the central door of Building 1 and the flagpole area is extant from the period of significance, as is the axial view to the Chapel from the semi-circular drive (see Figures 3-1 and 3-15). Views into the courtyard of Building 1 and other views that were possible during the first period of significance have been almost entirely eliminated due to the construction of other buildings, particularly Building 100 (see Figure 3-2).

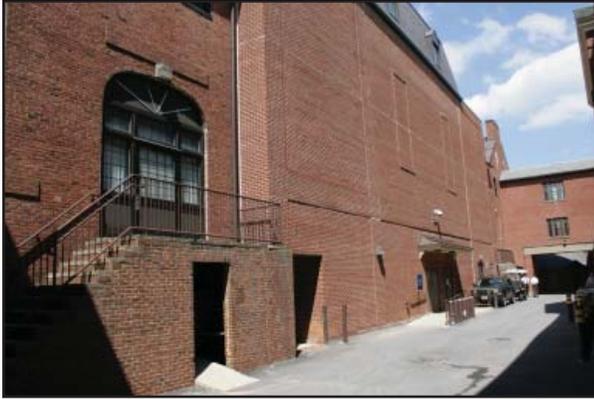
**Figure 3-3.** The placement of Building 100 interferes with the historical spatial organization of Building 1. *Source: JMA 2010.*

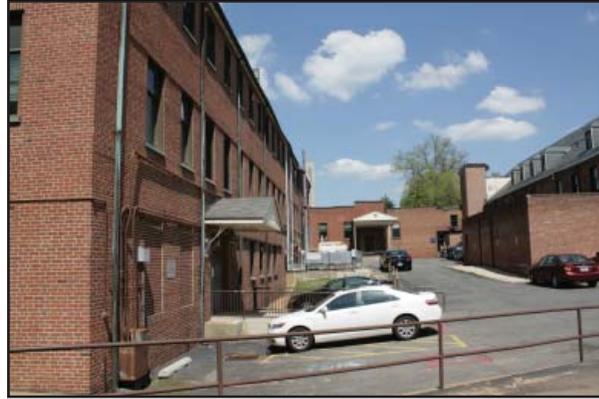
**Figure 3-4.** Courtyard surrounded by Buildings 4, 5 and 20. *Source: JMA 2010.*

Subsequent additions to the campus during the second period of significance were designed around a series of parallel-and cross-axes that complemented the original design and, in many cases, creating interior service courts (Figures 3-4 and 3-5). The integrity of the service court between Buildings 1 and 17 was disrupted with the construction in 1997 of Building 10. Additional spaces were formed with addition of buildings and other structures.

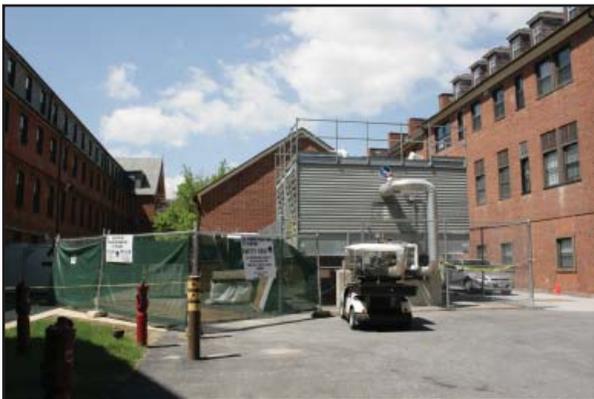
**Figure 3-5.** Courtyard surrounded by Buildings 1, 17 and 43. Building 10 is located within the courtyard. *Source: JMA 2010.*

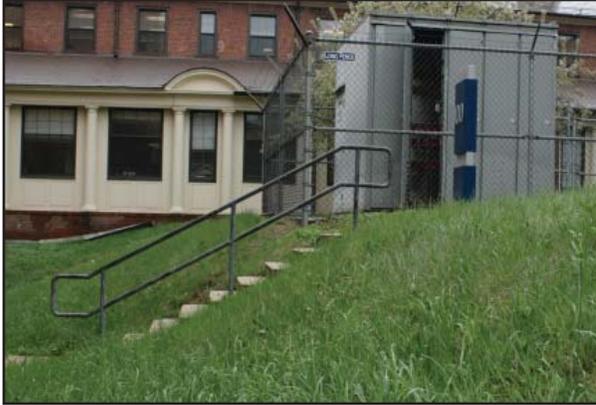
**Figure 3-9.** Remnant earthen terrace in Building 1 courtyard. *Source: JMA 2010.*

During the first period of significance, topographic modifications within the Mount Vernon Unit occurred primarily in the form of earthen terracing, developed to create flat outdoor spaces in which the school developed gardens and lawns to accommodate outdoor uses. A remnant of this terracing is located within the Building 1 inner courtyard (Figure 3-9). A portion of a retaining wall associated with the one of the outer terraces on the south side of Building 1 is present in the courtyard formed between it and Building 17 (Figure 3-10).

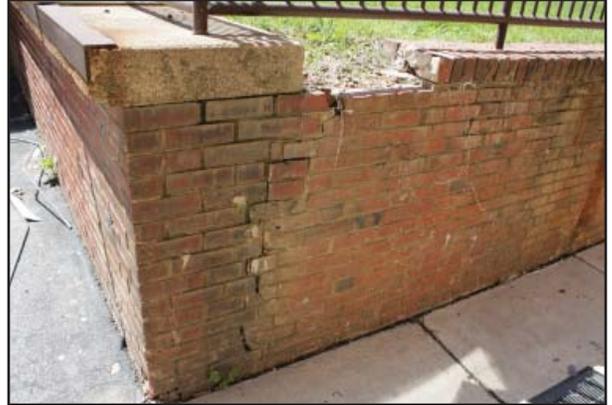
**Figure 3-10.** Retaining wall within courtyard between Buildings 1 and 17. *Source: JMA 2010.*

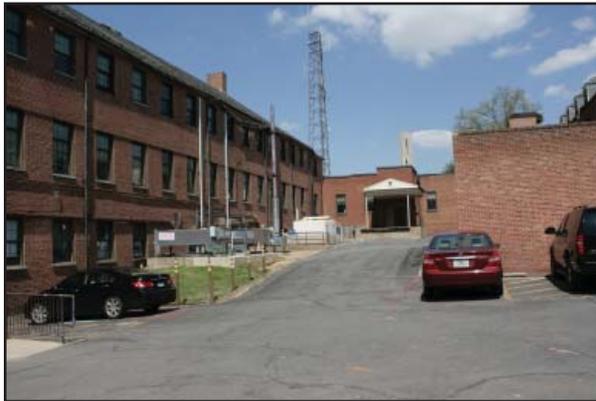
**Figure 3-11.** Grading used to provide service access to the rear of Buildings 4 and 5 and to support utilities. *Source: JMA 2010.*

Subsequent topographic alterations made during the second period of significance were implemented primarily to accommodate building pads, utility structures, storm water drainage and internal vehicular circulation (Figure 3-11). Most of these modifications are present in the landscape today. More recent modifications include raised areas for utility pads in service areas and a detention pond near Building 5 (Figure 3-12). The scattering of utility pads within the service areas detracts from the historic character of these areas (Figure 3-13).

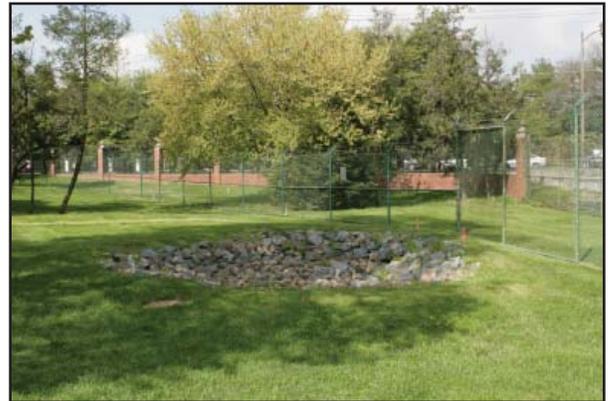
**Figure 3-12.** Dry detention pond near Building 5. *Source: JMA 2010.*

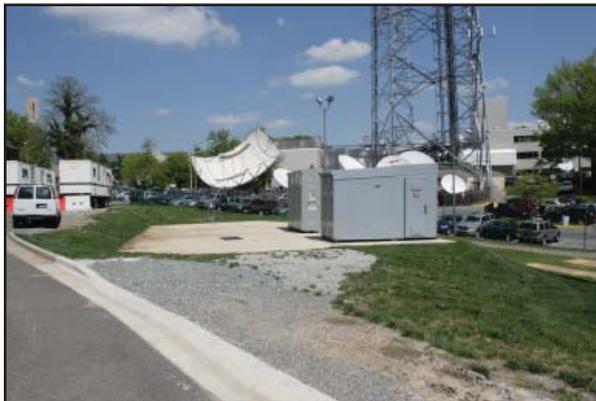
**Figure 3-13.** Concrete pad for utilities behind Building 20. *Source: JMA 2010.*

In addition to these structures, throughout the site can be found concrete pads that were built to support various exterior utility units. These are not considered historically significant and are intrusive elements in the historic landscape.

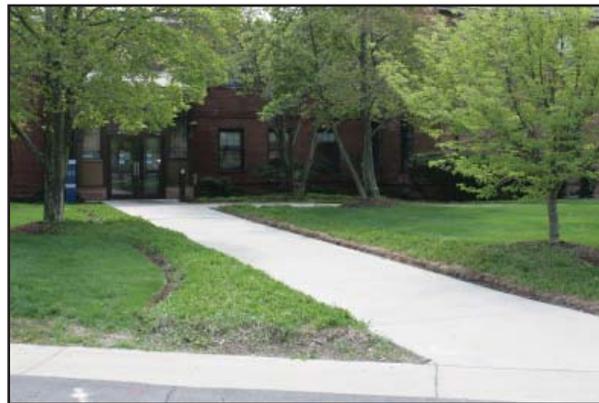
**Figure 3-18.** Sidewalks around U.S. Navy buildings. *Source: JMA 2010.*

Sidewalks connect the semi-circular drive to Building 6 and run parallel to the front of Building 1 (Figures 3-18 and 3-19). They are paved in either concrete or brick, although their alignment remains true to both periods of significance when they were paved in bluestone. A small portion of the sidewalk that once extended from the rear of Building 1 to the southeast down a series of terraces within the quadrangle remains close to Building 1 (Figure 3-20). A brick walk and ramp system was installed, likely after the period of significance, to provide access to Building 6 from the Navy Chapel Gate (Figure 3-21).

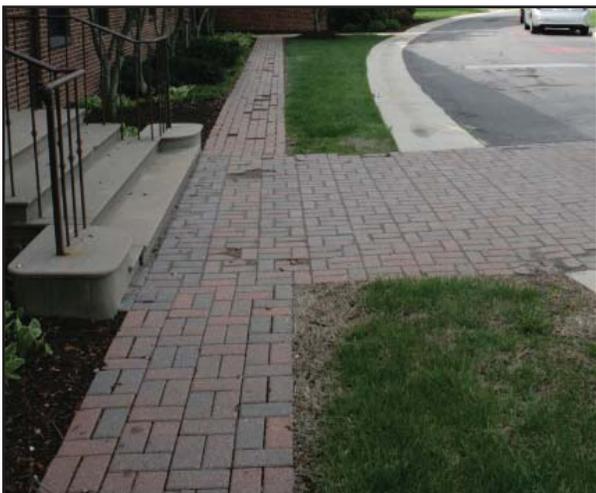
**Figure 3-19.** Brick sidewalk that connects the three front entrances to Building 1. *Source: JMA 2010.*

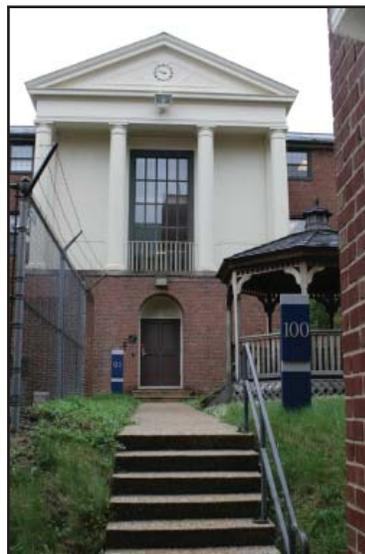
**Figure 3-20.** Portion of sidewalk in the Building 1 courtyard. *Source: JMA 2010.*

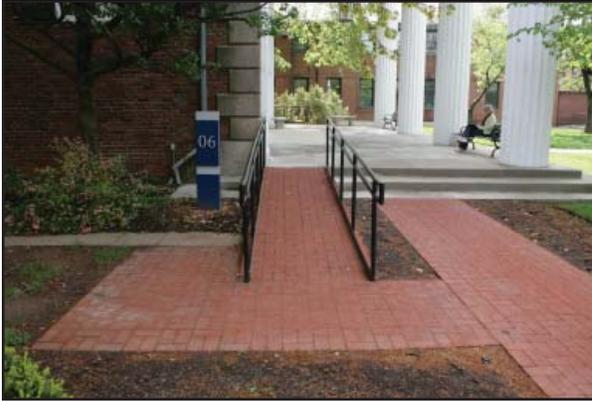
**Figure 3-21.** Modifications to the Chapel (Building 6) entrance to meet ADA requirements. *Source: JMA 2010.*

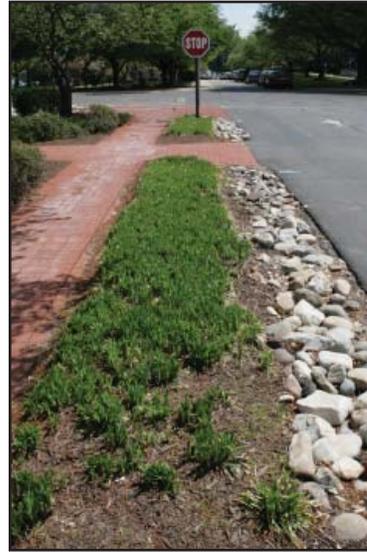
**Figure 3-22.** Brick sidewalk, vegetation and drainage swale along Mount Vernon Drive. *Source: JMA 2010.*

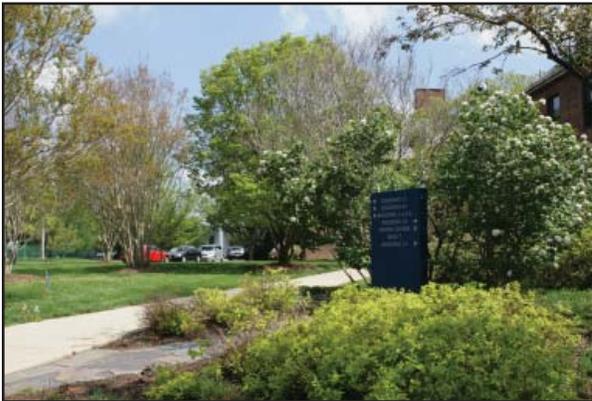
**Figure 3-23.** Concrete sidewalks and wayfinding signage along Mount Vernon Drive. *Source: JMA 2010.*

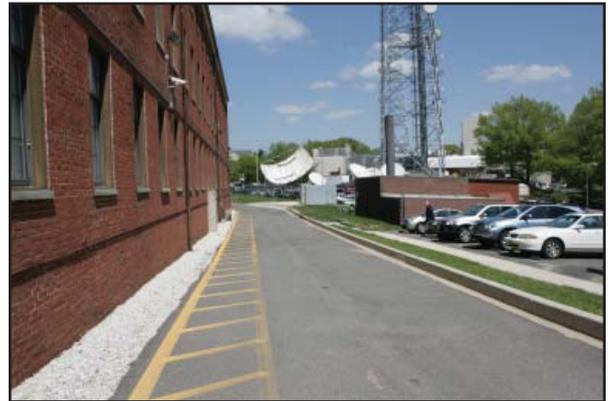
**Figure 3-24.** Intelligence Way, an asphalt drive with concrete curb and gutter on the east side of Building 3. *Source: JMA 2010.*

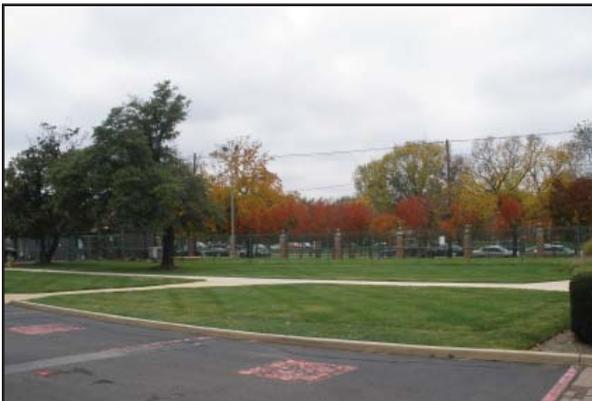
**Figure 3-25.** Concrete sidewalks leading across the demilune lawn. *Source: JMA 2009.*

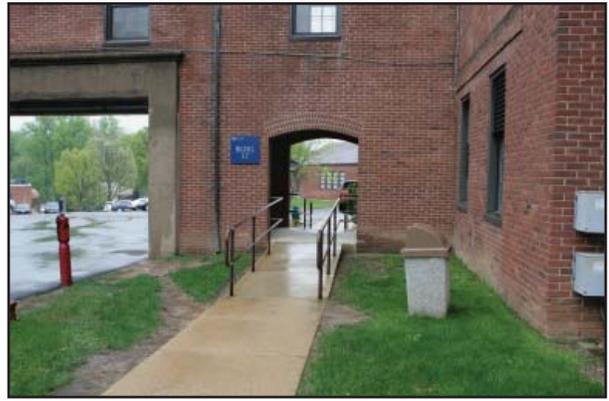
**Figure 3-26.** Vehicular and pedestrian entrances through connector between Buildings 3 and 17. *Source: JMA 2010*

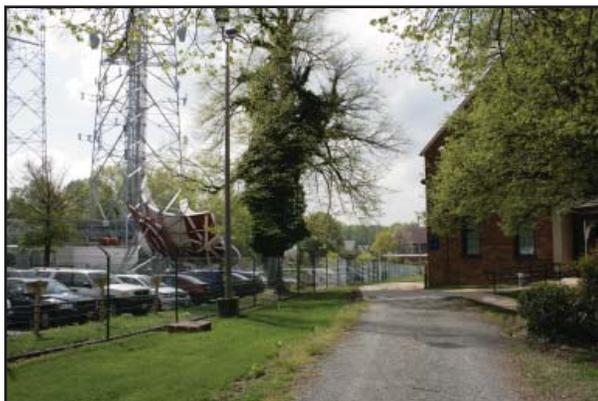
**Figure 3-31.** 2010. Gravel service drive around Building 5. *Source: JMA 2010.*

accessibility needs (Figure 3-30). Additional parking spaces have been provided in the form of small bays constructed off of Somers Court and a gravel service drive was added to provide access to the back of Building 5 (Figure 3-31).

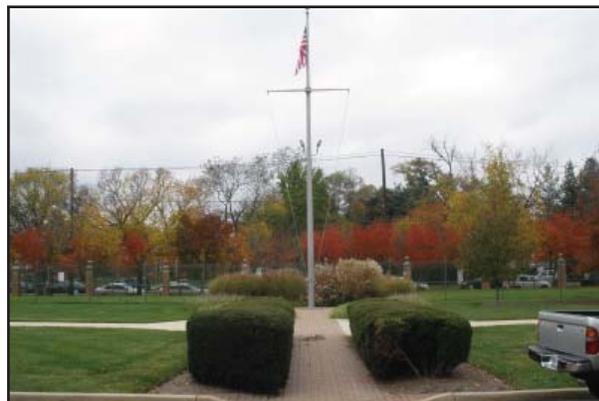
**Figure 3-32.** Pattern of ornamental shrubs (yews) lining the approach walk to Building 1. *Source: JMA 2010.*

The Mount Vernon Unit includes maintained turf areas, shade and ornamental trees and ornamental shrubs and groundcovers. Species frequently observed include Norway spruce (*Picea abies*), littleleaf linden (*Tilia cordata*), magnolia (*Magnolia sp.*), black walnut (*Juglans nigra*), cherry and pin oak. Turf, shrubs and perennial plantings are used as borders along fences and sidewalks (Figure 3-32).

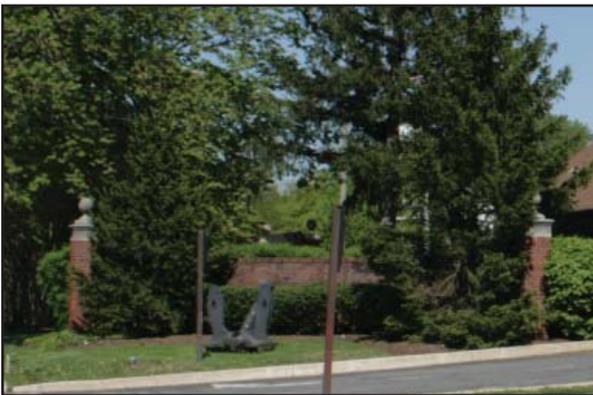
**Figure 3-53.** Hensley Memorial Gate and anchor (north half). *Source: JMA 2010.*

One of the most notable landscape structures within the Mount Vernon Unit is the Adelia Gates Hensley Memorial Gate (Figure 3-53). Located at the south entrance of Somers Court, the brick gateway consists of two brick piers topped with sandstone orbs, with a curved brick wall in between. It is paired with a matching composition that is either the original south portion of the gateway that was moved about twenty feet to the south or completely reconstructed in that location (Figure 3-54).

Small-scale features persisting since the end of the period of significance include the U.S. Navy flagpole located in the front of Building 1, a small concrete bench that is one of the two that flanked the birdbath in the circular feature at the front of Building 1 during the first period of significance (see Figures 3-32 and 3-61). It is now located on the porch of Building 6 along with non-historic wood and metal park benches (Figure 3-62). Also of particular note are the two anchors that ornament the main entrance on Nebraska Avenue, although the year of their installation is unknown (see Figures 3-53 and 3-54).

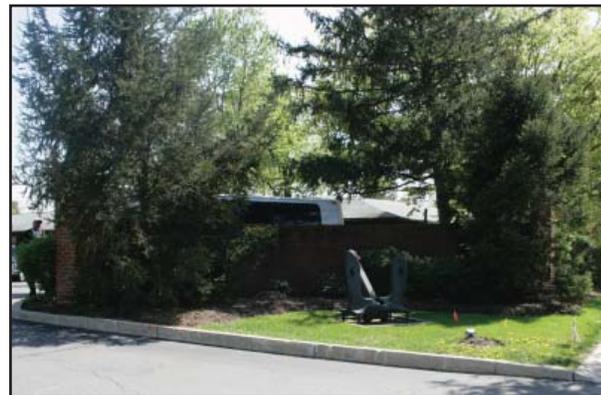
**Figure 3-54.** The composition and location of the south half of the south entrance has likely been refigured since the period of significance. *Source: JMA 2010.*

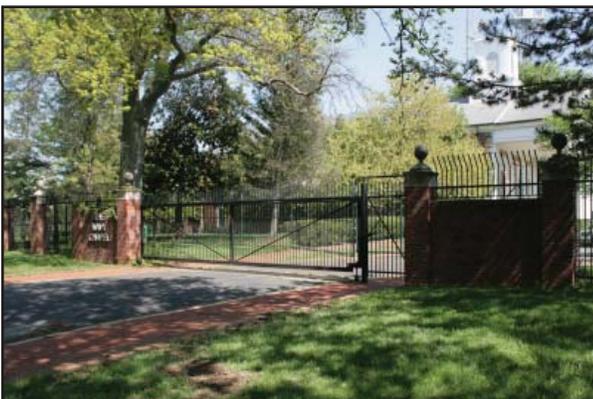
**Figure 3-55.** The Navy Chapel gateway and north entrance to the semi-circular drive. *Source: JMA 2010.*

A second brick wall-and-pier composition surviving from the 1920s flanks the northern end of the semi-circular drive (Figure 3-55). It has a straight brick wall rather than a curved wall, but it is surmounted by a sandstone cap and the four gate piers support sandstone orbs similar to those on the Hensley Gate. Attached to the north wall is attached aluminum lettering that reads "The Navy Chapel."

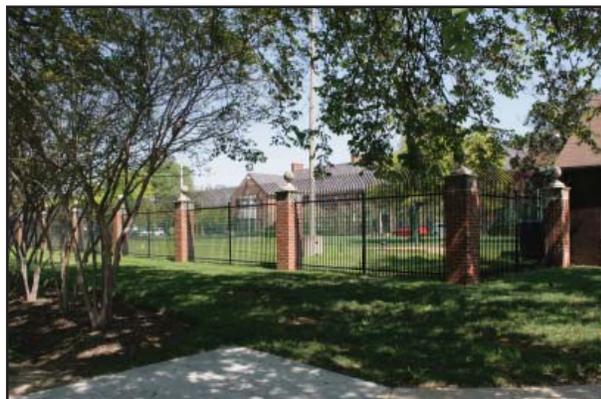
**Figure 3-56.** Brick, stone and iron boundary fence along Nebraska Avenue. *Source: JMA 2010.*

The design vocabulary used for the Hensley Memorial Gate was repeated years later with the construction of the piers supporting the boundary fence on the street side of the complex sometime in the 1960s (see Figure 3-14 and Figure 3-56).

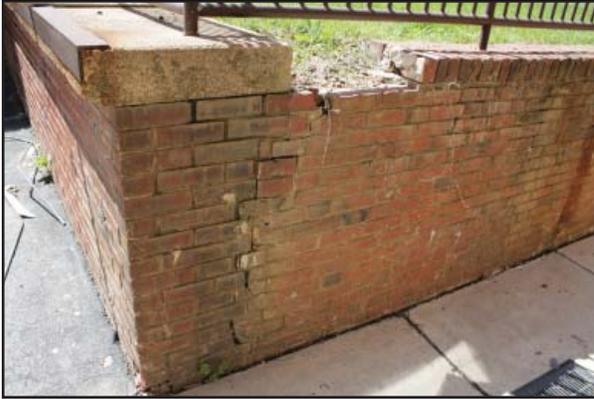
**Figure 3-57.** Remnant retaining walls adjacent to Building 1 (south side). *Source: JMA 2010.*

A remnant terrace retaining wall exists within the courtyard between Buildings 1 and 17 (Figure 3-57). The wall supports a turf courtyard that was once elevated above one end of a parking court but is now tucked in between Buildings 1 and 10.
