# U.S. Department of Homeland Security Nebraska Avenue Complex Master Plan DRAFT ENVIRONMENTAL IMPACT STATEMENT

# Cultural Landscape Report

# NEBRASKA AVENUE COMPLEX Cultural Landscape Report

Washington, D.C.

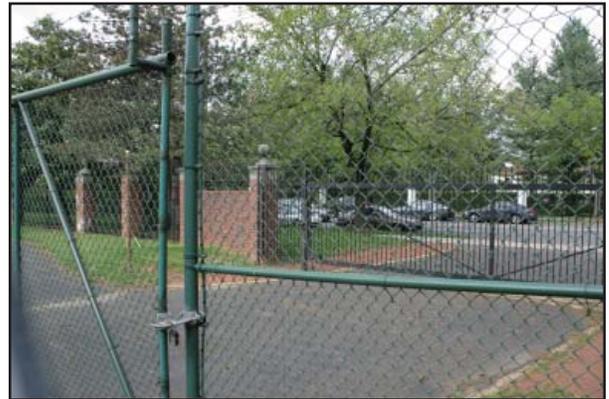
**Figure 3-60.** Chain link security fencing inside the boundary fence along Nebraska Avenue. *Source: JMA 2010.*

The entire NAC campus, including the Mount Vernon Unit, is secured by fencing (Figure 3-60). Most of the fencing in this unit is chain link with the exception of the metal fence supported by brick piers along Nebraska Avenue. Much of the chain link fencing is in the same location in which it was originally installed by 1945. Other lengths of the fence structure have been relocated, demolished, or added since that time.

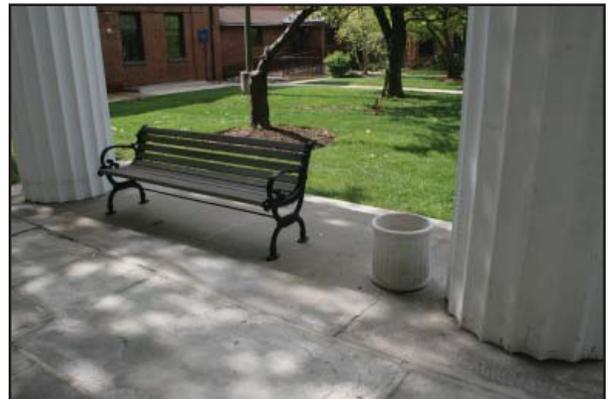
**Figure 3-62.** Metal and wood park bench and trash receptacle at the Chapel. *Source: JMA 2010.*

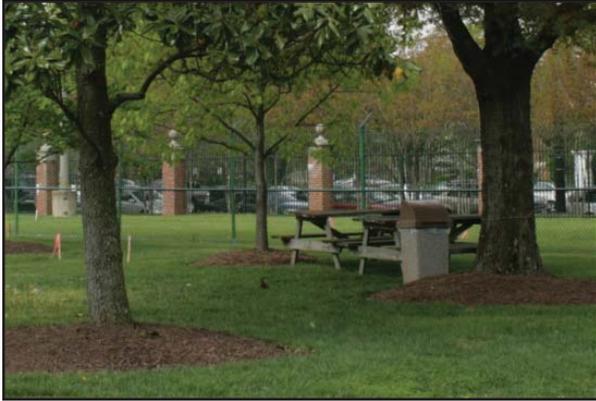
**Figure 3-63.** Wooden picnic tables and aggregate and plastic trash receptacle in front of Building 1. *Source: JMA 2010.*

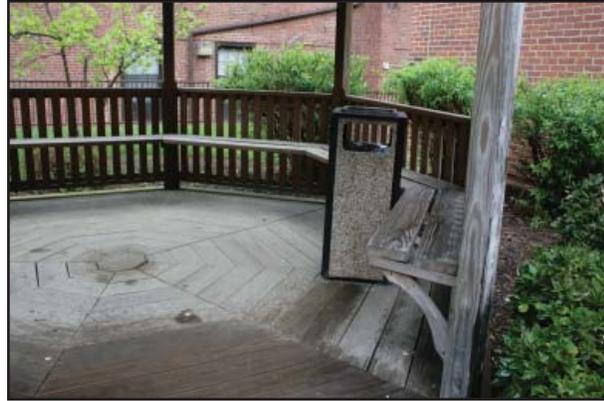
**Figure 3-64.** Steel and concrete panel trash receptacles. *Source: JMA 2010.*

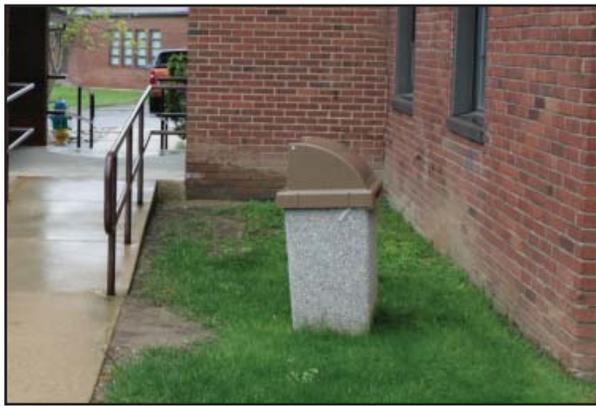
**Figure 3-65.** Exposed aggregate and plastic trash receptacles. *Source: JMA 2010.*

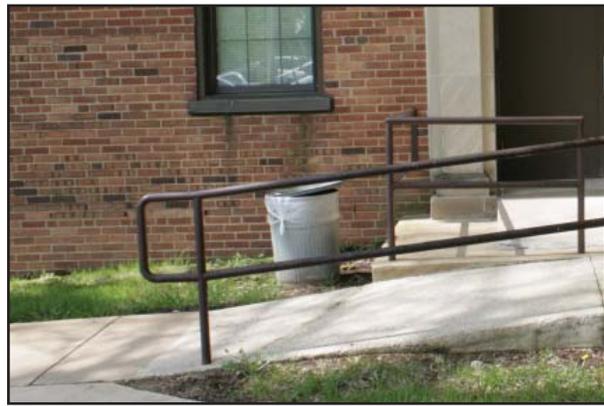
**Figure 3-66.** Steel trash receptacle and metal handrail. *Source: JMA 2010.*

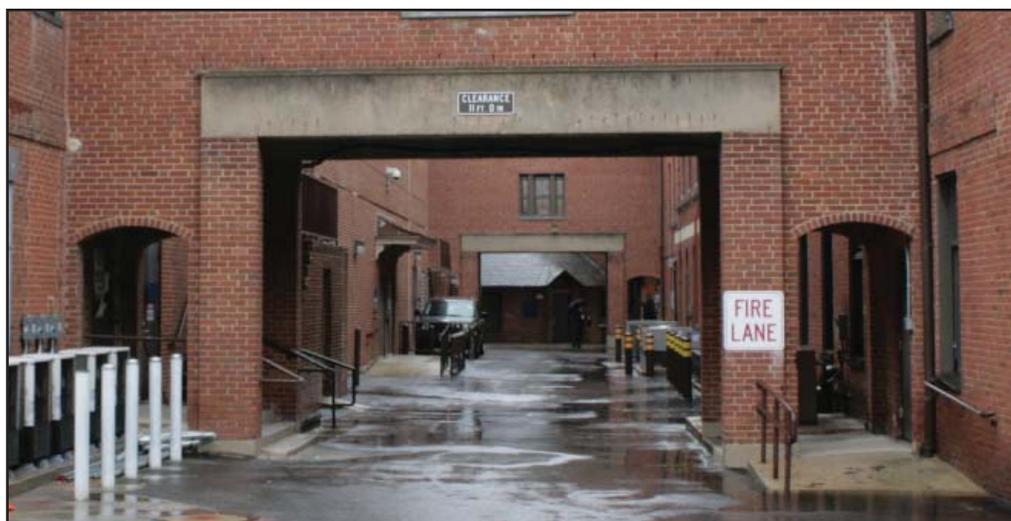
**Figure 3-67.** Concrete and steel bollards protect utility units and entrances in the service court between buildings 3 and 100. Painted steel handrails along ramps and stairs protect and assist pedestrians. *Source: JMA 2010.*

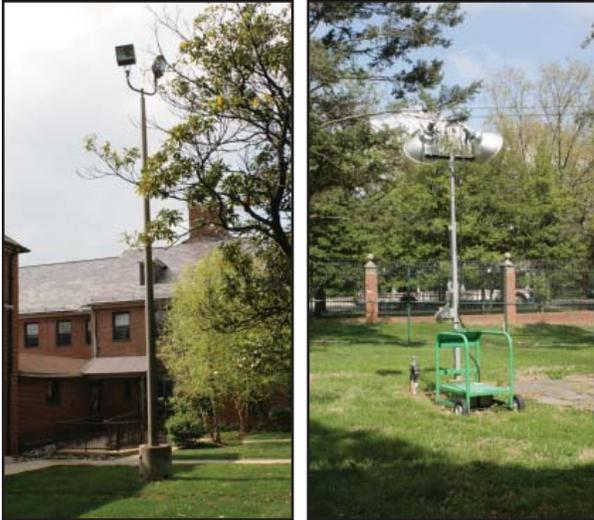
**Figure 3-68.** Security lighting. *Source: JMA 2010.*

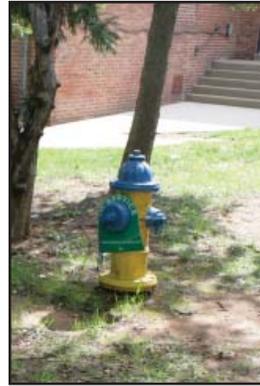
**Figure 3-69.** Fire hydrants in the Mount Vernon Unit. *Source: JMA*

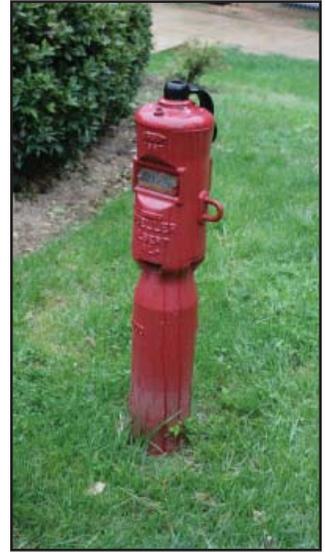
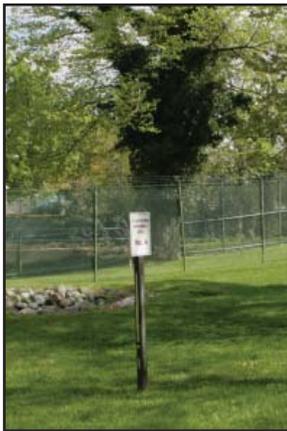
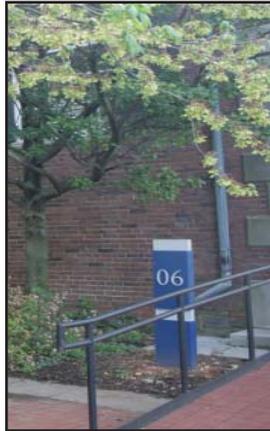
**Figure 3-70.** Evacuation assembly area identification sign and building identification sign. *Source: JMA 2010.*

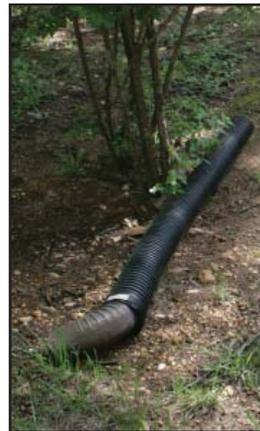
**Figure 3-71.** Above-ground storm drain system. *Source: JMA 2010, 2010.*

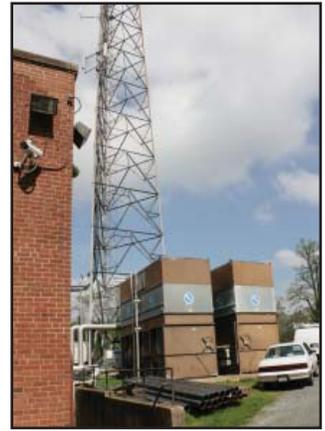
**Figure 3-72.** Communications utilities. *Source: JMA 2010.*

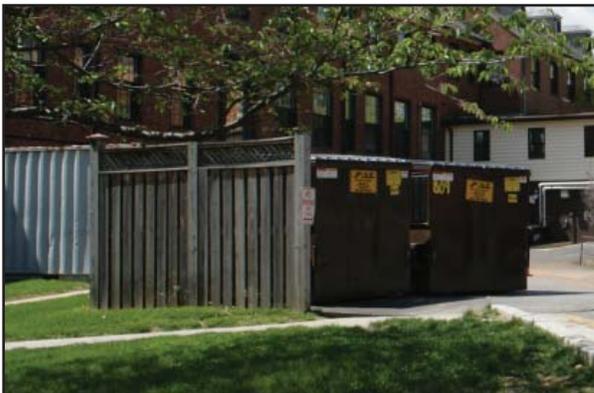
**Figure 3-73.** Dumpsters and dumpster enclosure in Buildings 1, 4, 5 and 20 service court. *Source: JMA 2010.*

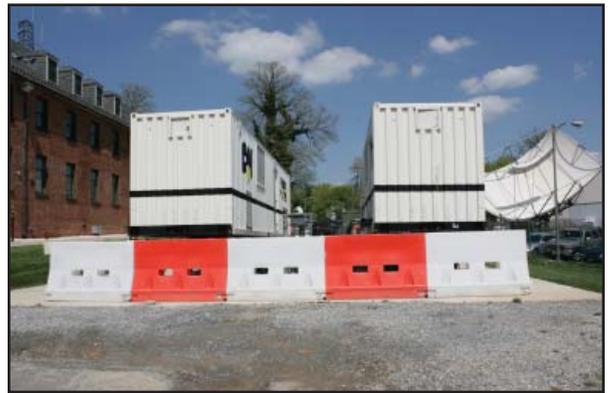
**Figure 3-74.** Utility trailers. *Source: JMA 2010.*

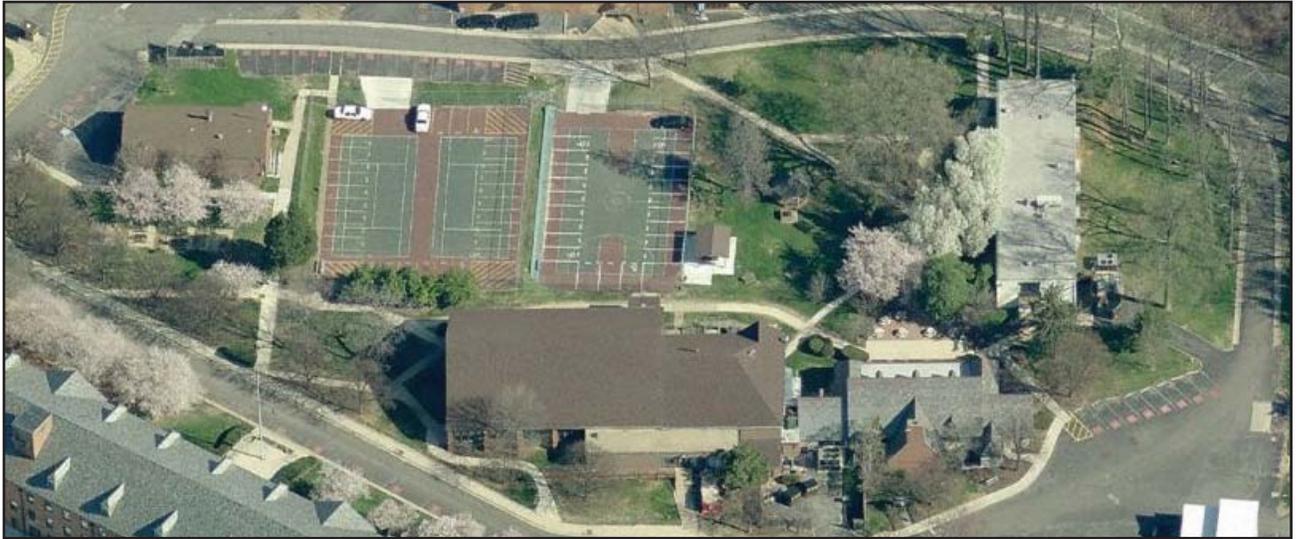
**Figure 3-75.** Buildings 12-14 (bottom), Building 81 (right) and Building 21 (left) enclose the open lawn and sports space that have survived on the site since the first period of significance. *Source: Bing Maps, accessed 7/12/10. 2010.*

The Recreational Unit is organized around what now functions as the "Village Green" of the complex, that is, the sports courts and adjacent open lawn to the east, both surviving from the first period of significance (Figure 3-75). These features were placed within the original linear lot (north of the former Quebec Street right-of-way) acquired by Somers in 1916 (see Figure 4-1). The site slopes generally to the east-north-east and is partially terraced to accommodate the sports courts and the open lawn located between the sports courts, Building 12-14, Building 81 and the north arm of Wenger Street. The lawn is crossed by a network of pedestrian paths, both historic and non-historic and contains a number of smaller features that distract from the historic character of the area, such as recently installed picnic shelters (Figure 3-76). Parking along Wenger Street is also an intrusive element in this historic landscape (Figure 3-77).

The Recreational Unit includes a number of ornamental trees throughout and a small grove of what appears to be remnant forest in the eastern end of the unit, possibly from when that portion of the NAC site was wooded (see Figure 3-75). Notable large tree specimens, all of which are likely historic, include a spruce at the northern corner of Building 14 that is proposed to be removed as a result of proposed utility line work, a grove of large tulip poplars (*Liriodendron tulipifera*) located to the east of Building 81, a large willow oak (*Quercus phellos*) in front of Building 81, a 24" maple near Building 12, an Eastern red cedar (*Juniperus virginiana*) at the southwest corner of the sports courts, two saucer magnolias on the service side of Building 14 and a row of hollies on the south side of the tennis court (Figure 3-87 through 3-92 and see Figures 3-78 and 3-81).

Buildings and structures within the Recreational Unit include those constructed in the first and second periods of significance and a few after 1952. Built on the land purchased for the Seminary in the 1920s, Buildings 12 and 14 were built in 1929 and the Navy added Building 13 in 1943 (see Figure 3-75 and Figures 3-102 and 3-103). The other buildings were constructed after the end of the second period of significance: Building 21 in 1953, Building 59 in 1958, Building 81 in 1965 and Building 94 in 1974 (Figures 3-104 through 3-108). For detailed descriptions of these buildings, refer to the NAC Historic Structures Report.

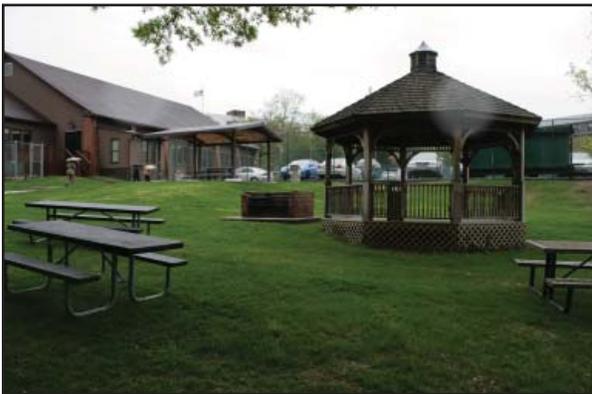
**Figure 3-76.** Photo of Field House lawn, showing recently-installed structures and small-scale features that are intrusive elements in this historic landscape. *Source: JMA 2010.*

system of chain link fencing, as well as the location of the Building 14 terrace (shape and materials recently changed). More recently built structures include the wooden gazebo (1980s) and a picnic shelter (ca. 1990) and the wooden deck and ramp systems associated with Buildings 13, 14 and 81 (Figures 3-109 through 3-112 and see Figures 3-76, 3-83 and 3-98). Security fencing in the area also appears to be of recent vintage.

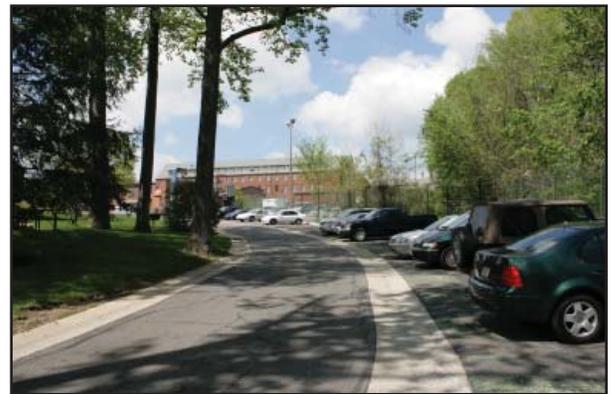
**Figure 3-77.** Parking areas along Wenger Street that are intrusive elements in this historic landscape. *Source: JMA 2010.*

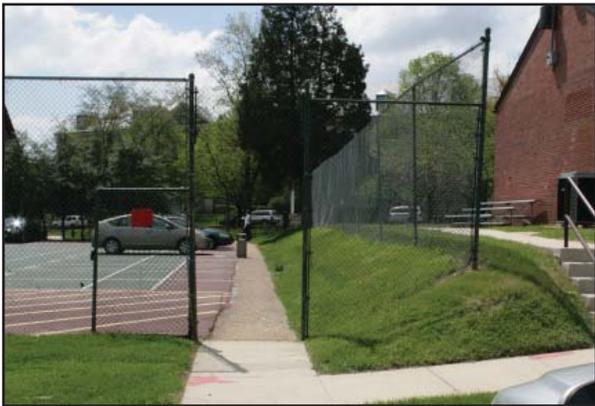
**Figure 3-82.** Earthen terraces supporting the sports courts. *Source: JMA 2010.*

The Recreational Unit slopes dramatically from west to east. Terraces were set into the hillside to provide level surfaces for the sport courts that remain today and are currently used for parking (Figure 3-82). A more recent modification to the topography in the area of the sports courts includes an extension of the lower terrace to support a picnic shelter (Figure 3-83). Within the lawn, more subtle topographic modifications have been added to promote adequate stormwater drainage (Figure 3-84).

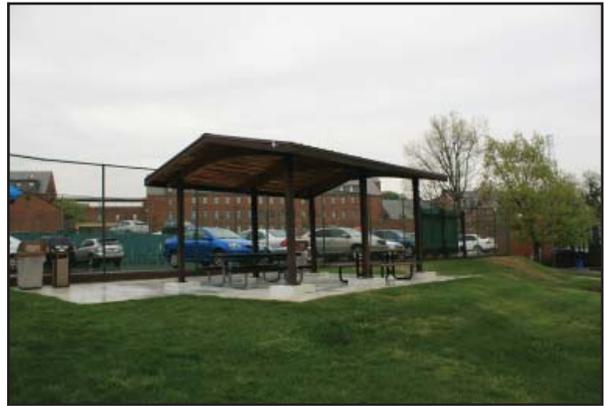
**Figure 3-83.** Fill installed to support this picnic shelter negatively impacts this historic earthen terrace. *Source: JMA 2010.*

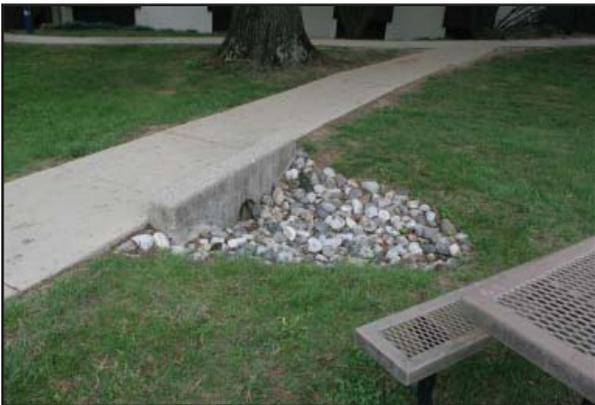
**Figure 3-84.** Stormwater management in the lawn area. *Source: JMA 2010.*

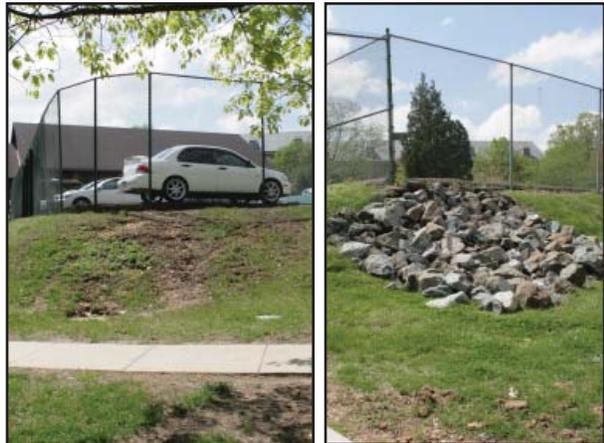
**Figure 3-85.** Erosion and this rip rap solution threaten the integrity of the historic earthen terracing. *Source: JMA 2010.*

Exposed soil around the sports court terraces is susceptible to erosion (Figure 3-85). Rip-rap has been used on a corner of the upper court to prevent further deterioration as a result of stormwater runoff (see Figure 3-85).

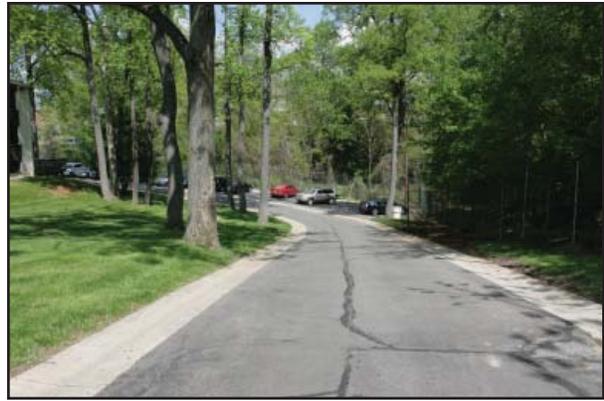
**Figure 3-93.** Eastern end of service road (Wenger Street). *Source: JMA 2010.*

Several circulation routes within the Recreational Unit remain from both periods of significance. A portion of the service road (now Wenger Street) that originally ran from Nebraska Avenue and looped around the Seminary's tennis courts remains today, now paved in asphalt with concrete curb and gutter (Figure 3-93 and see Figure 3-75). The alignment of Mount Vernon Drive remains from the second period of significance (Figure 3-94)

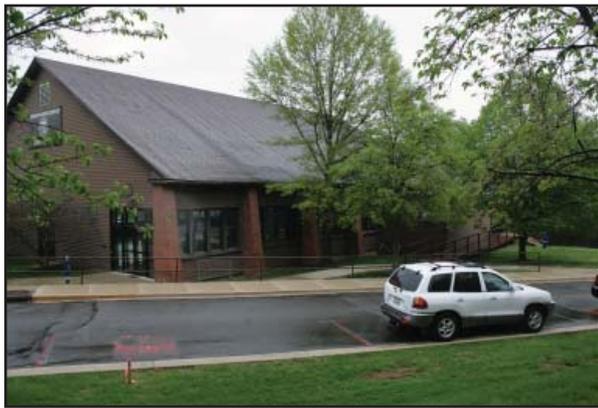
**Figure 3-94.** Mount Vernon Drive as it passes Building 12. *Source: JMA 2010.*

Additionally, the alignment of the sidewalk leading diagonally from the service road through the lawn to Building 14 remains from the first period of significance, as does the sidewalk leading along the south side of the sports courts (Figures 3-94 through 3-96). The flagstone connector by Building 13 remains from the second period of significance and possibly the first (Figure 3-97)

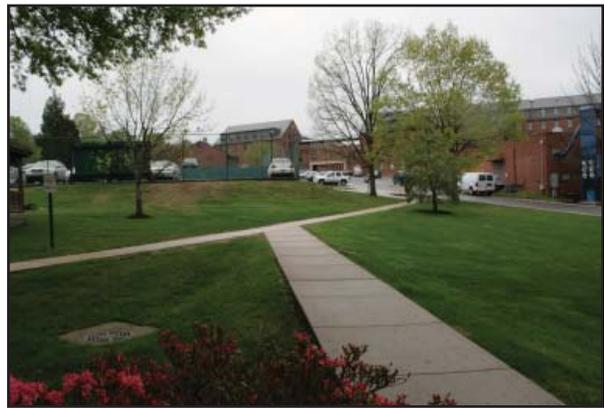
**Figure 3-95.** Pedestrian circulation to the east of the tennis courts. The alignment of the sidewalk running right/left in the image is consistent with the alignment of sidewalks from the first period of significance. *Source: JMA 2010.*

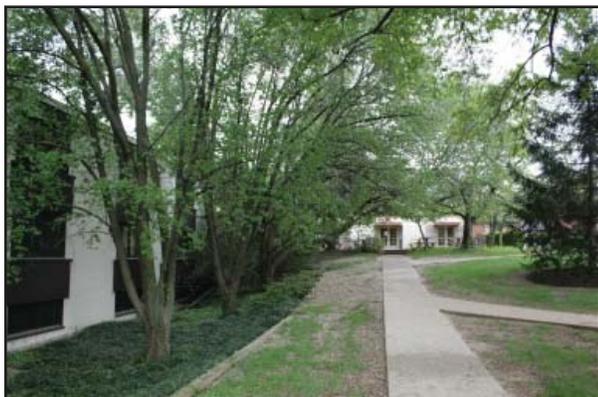
**Figure 3-96.** Sidewalk leading from the Building 14 patio toward Wenger Street. *Source: JMA 2010.*

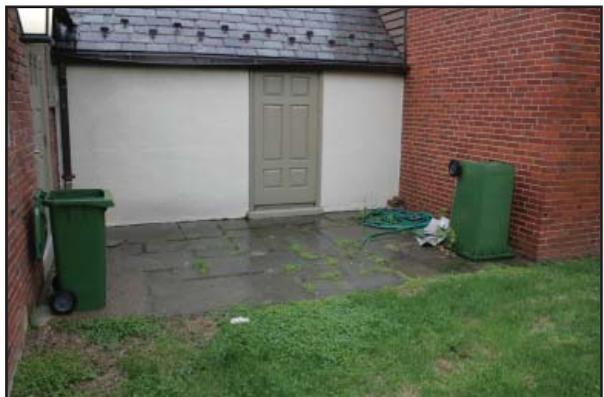
**Figure 3-97.** Flagstone patio between buildings 13 and 14. *Source: JMA 2010.*

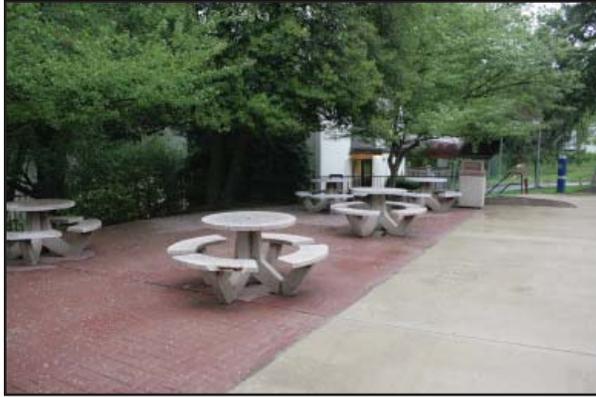
**Figure 3-98.** Building 14 terrace. *Source: JMA 2010.*

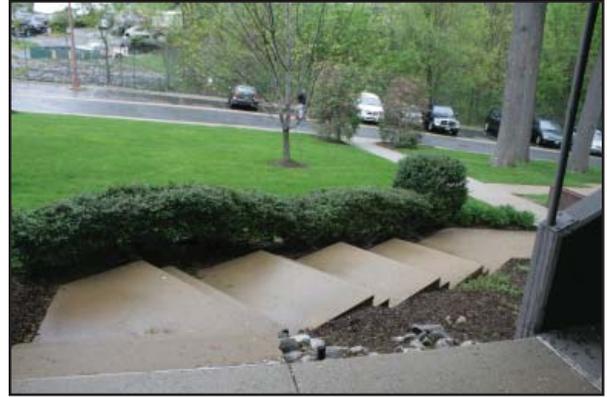
**Figure 3-99.** Recently-installed sidewalks near Building 81. *Source: JMA 2010.*

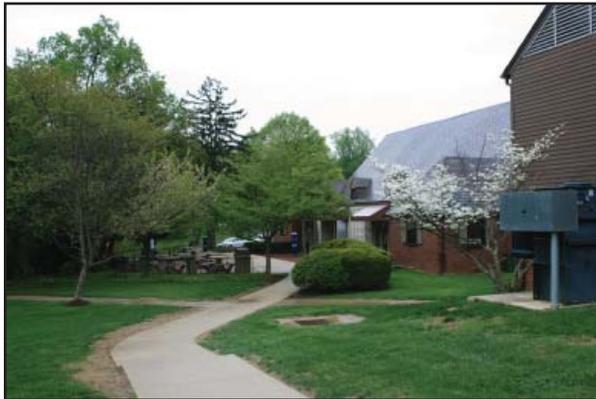
**Figure 3-100.** Concrete sidewalk of recent vintage, likely constructed when original flagstone terrace was replaced. *Source: JMA 2010.*

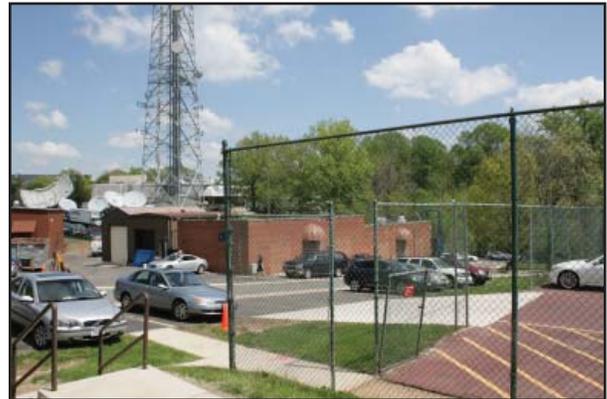
**Figure 3-101.** Parking along Wenger Street, vehicular access to tennis court and Building 59. *Source: JMA 2010.*

- Intrusive views of hazardous waste management structures and parking lots along northern portion of Wenger Street

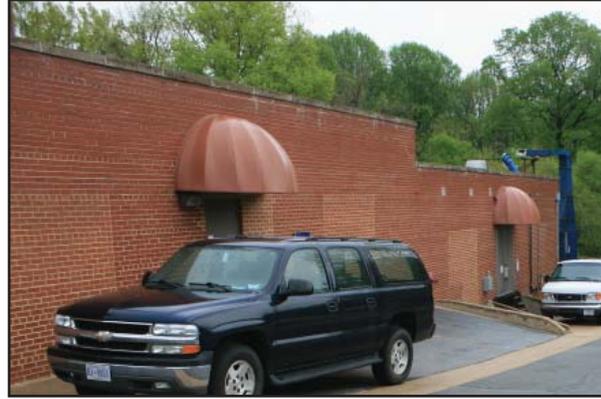
**Figure 3-105.** Building 59 (Classified Waste Destructor).  
Source: JMA 2010.

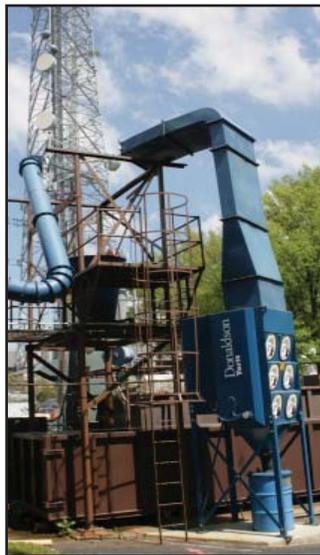
**Figure 3-106.** Equipment associated with Building 59. Source: JMA 2010.

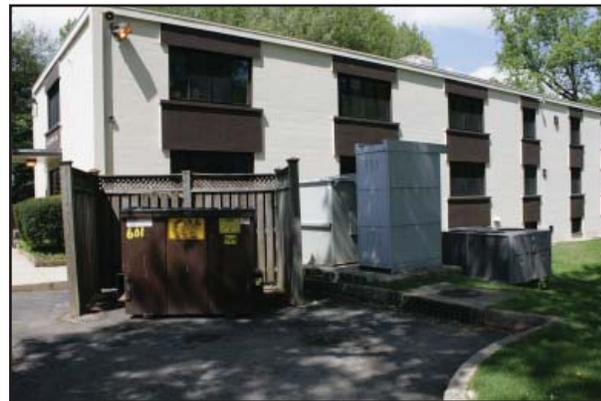
**Figure 3-107.** Building 81 (Bachelor enlisted quarters) and dumpster with wooden enclosure. Source: JMA 2010.

Utilities and dumpsters are intrusive elements within the Sports Unit (Figures 3-121 and see Figure 3-107)). Drainage features fall into this category, as well as HVAC units. Dumpsters are partially screened with wooden privacy fences. These types of features are intrusive in appearance and negatively affect the character of the site.

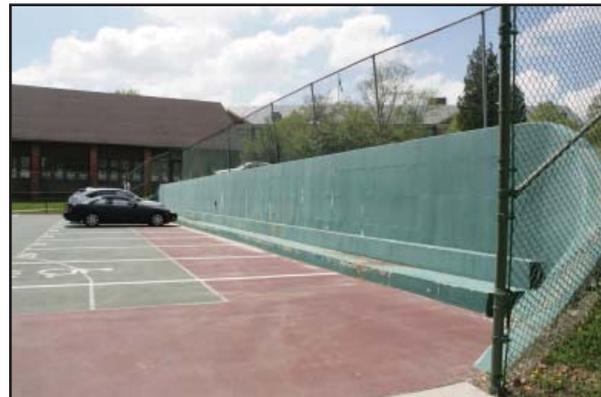
**Figure 3-109.** Retaining wall between the sports courts. Source: JMA 2010.

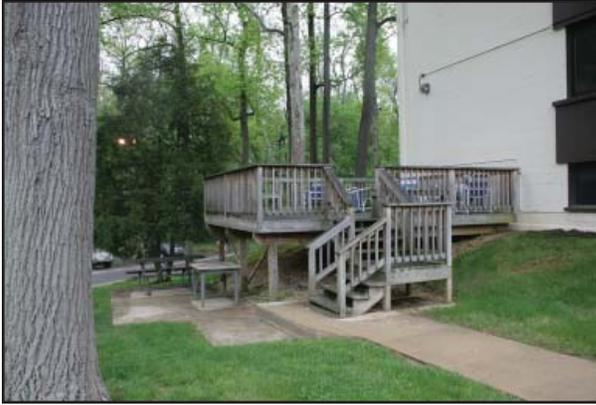
**Figure 3-110.** Deck associated with Building 81. *Source: JMA 2010.*

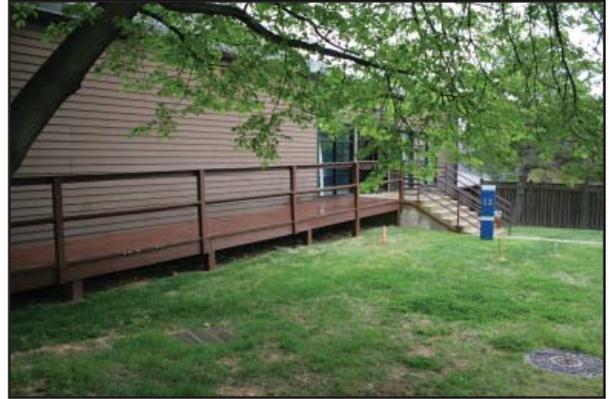
**Figure 3-111.** ADA ramp to Building 12 and building signage. *Source: JMA 2010.*

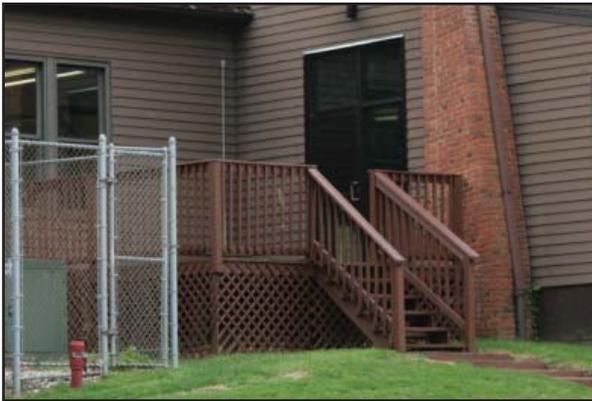
**Figure 3-112.** Deck associated with Buildings 12 and 13. *Source: JMA 2010.*

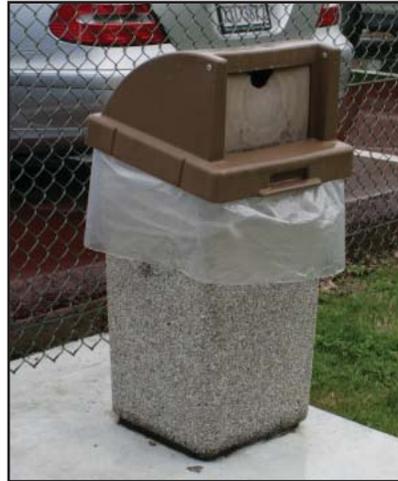
**Figure 3-113.** Exposed aggregate and plastic trash receptacle. *Source: JMA 2010.*

A variety of benches, picnic tables, trash receptacles and BBQ grills, have been set about for the convenience of users of the site (Figures 3-113 through 3-116). Most of the grills are small, metal units on metal posts set within the picnic area south of Building 21, but one grill is a larger brick structure set in the center of the Fieldhouse lawn (see Figure 3-76). A set of aluminum bleachers have been placed above the sports courts and adjacent to Building 21 (Figure 3-117). Steel and concrete bollards have been installed to control internal vehicular access (Figure 3-118). Painted steel tube handrails have been installed in various places to either assist in walking or to prevent falling (see Figures 3-78, 3-82, 3-92 and 3-101). Additionally, the patio by Building 14 has a steel railing (see Figure 3-115). Lights, both ornamental and functional in design, are used for security and wayfinding (Figure 3-119). Signage within the site consists of blue and white building identification signs, street signs and a small number of parking or other regulatory signs (Figure 3-120).

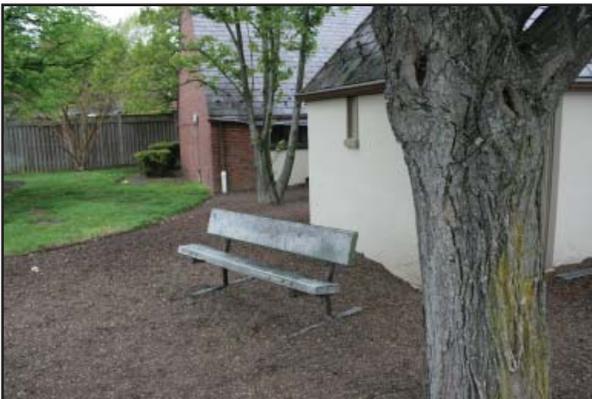
**Figure 3-114.** Fiberglass and metal bench in poor condition, located behind Building 14. *Source: JMA 2010.*

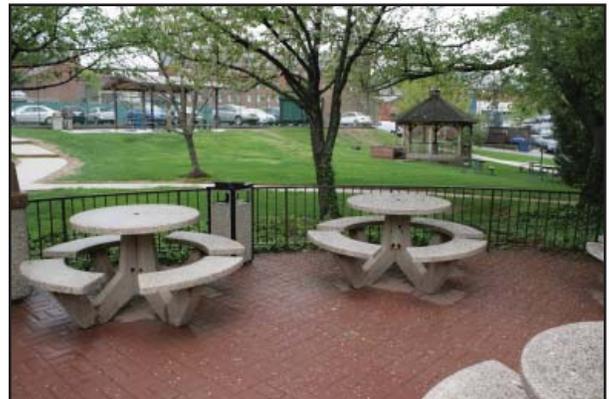
**Figure 3-115.** Steel and concrete panel trash receptacle, metal railing and concrete picnic tables on the Building 14 patio. *Source: JMA 2010.*

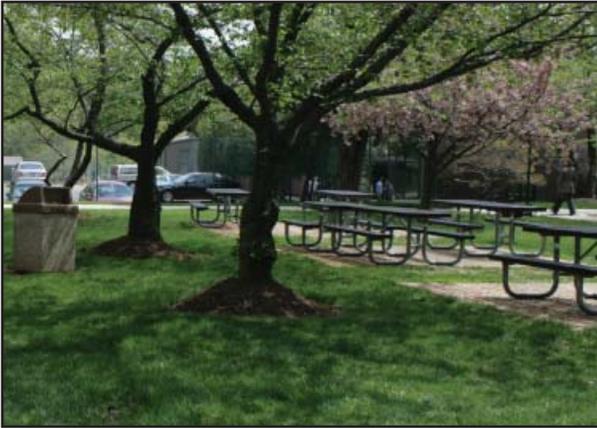
**Figure 3-116.** Wood and steel picnic tables and exposed aggregate concrete and plastic trash receptacle in the picnic area south of Building 21. *Source: JMA 2010.*

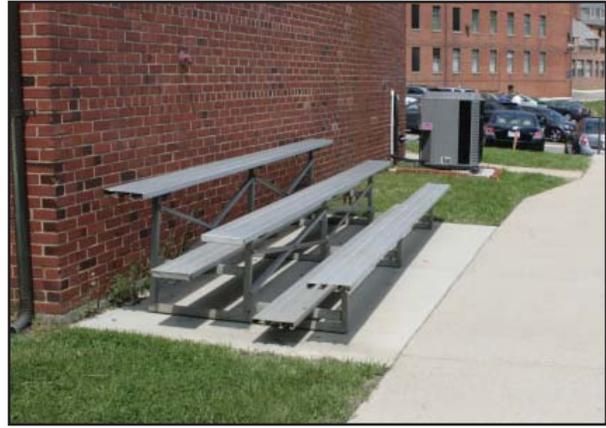
**Figure 3-117.** Aluminum bleachers above sports courts. *Source: JMA 2010.*

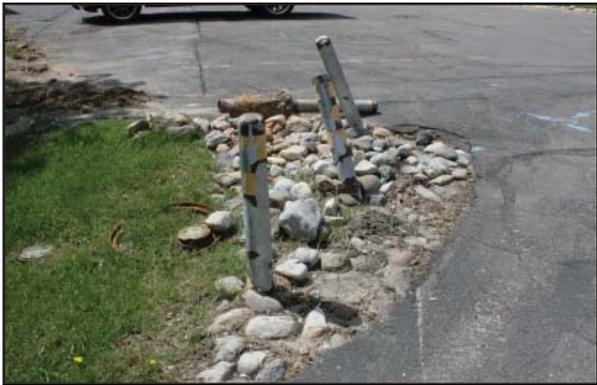
**Figure 3-118.** Metal and concrete bollards and stone road edging. *Source: JMA 2010.*

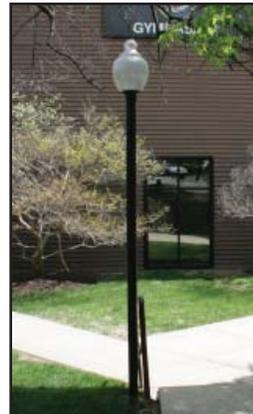
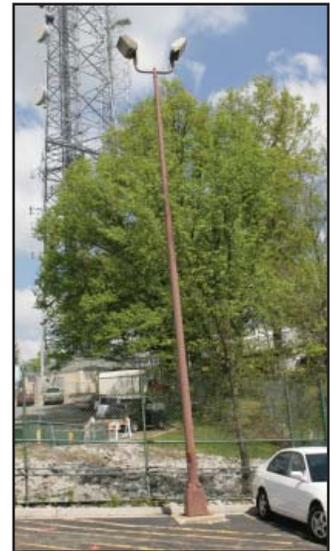
**Figure 3-119.** Light fixture near Building 14 (left) and security lighting (right). *Source: JMA 2010.*

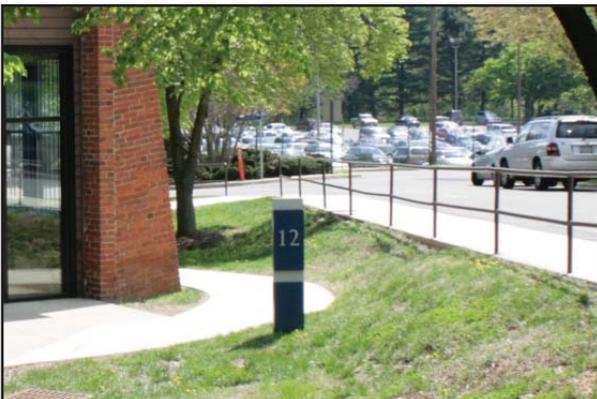
**Figure 3-120.** Building identification sign. *Source: JMA 2010.*

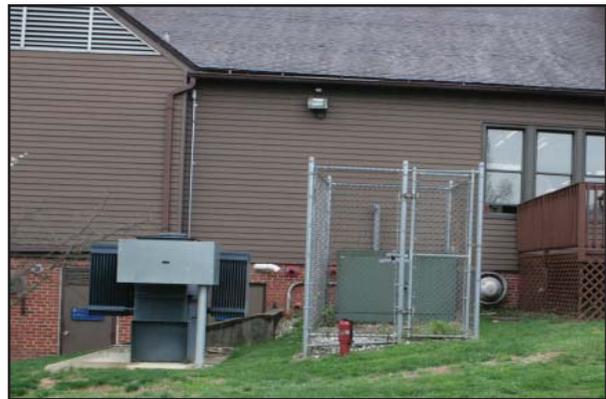
**Figure 3-121.** Utilities adjacent to Buildings 12 and 13. *Source: JMA 2010.*

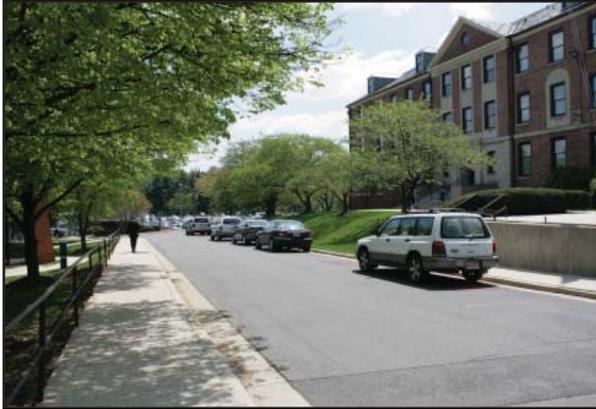
**Figure 3-122.** Strong axis and streetscape of Mount Vernon Drive. *Source: JMA 2010.*

Most buildings of the Cryptanalysis Unit are oriented along Mount Vernon Drive, which follows an axis set perpendicular to Nebraska Avenue (Figure 3-122). Most related parking areas and internal drives are arranged generally parallel to this axis, with the exception of the southwest portion of the unit, which is dominated by a large surface parking lot.

Views and vistas within the Cryptanalysis Unit are directed Mount Vernon Drive and the parallel line of Buildings 7, 18 and 19 and limited by heavy vegetation within and surrounding the property (see Figures 3-122 and 3-123). Vistas created by the arches in the Building 18-19 Connector have been blocked due to the filling in of some of the arches but views are still possible through the one remaining open archway (Figure 3-126).

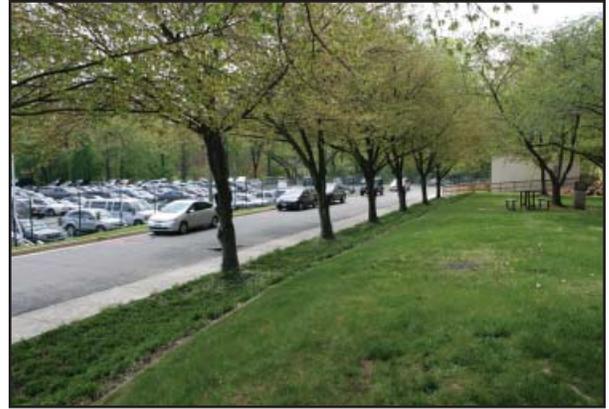
**Figure 3-123.** Earthen terracing for Building 19 and associated landscape, roadways and parking areas. *Source: JMA 2010.*

The earthen terracing created for the buildings, the large trees planted in a row along Mount Vernon Drive and the sidewalks that parallel the drive emphasize the linear quality of this streetscape space, which joins this unit with the Mount Vernon and Recreational units (Figure 3-123).

The slope of the Cryptanalysis Unit trends downwards towards the south and the east, towards Massachusetts Avenue and Glover-Archbold Park. Terracing has been done to create more level parking areas and to support nearby development (see Figures 3-123 and 3-125). A small stream valley defines the southwest corner of the unit.

additions that post-date 1952 (see Figures 3-122 and 3-123). The sidewalks are poured concrete. Several flights of steps are used for pedestrian navigation up the slope from the lower parking lots but were installed after the second period of significance.

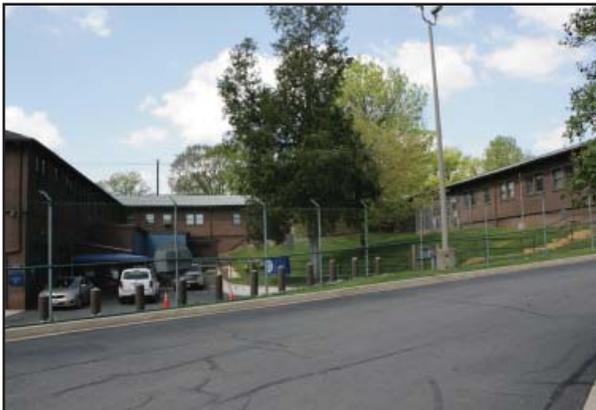
**Figure 3-124.** Building 7 courtyard. *Source: JMA 2010.*

Within the parking and service area, there are smaller spaces created between buildings and also by the earthen terraces that step down the slope towards Massachusetts Avenue. These include the courtyard created by the three wings of Building 7 and the four parking areas separated by the terraces (Figures 3-124 and 3-125).

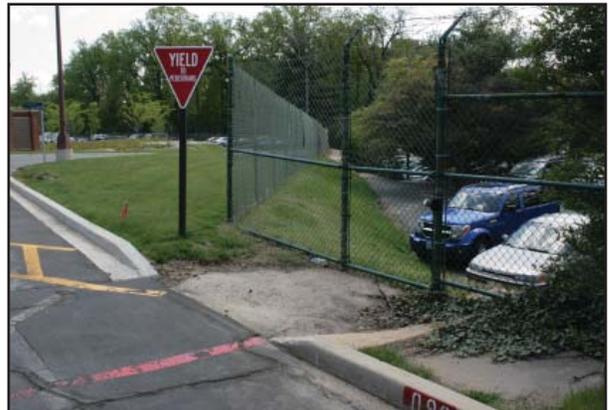
**Figure 3-125.** Terracing for parking lots. *Source: JMA 2010.*

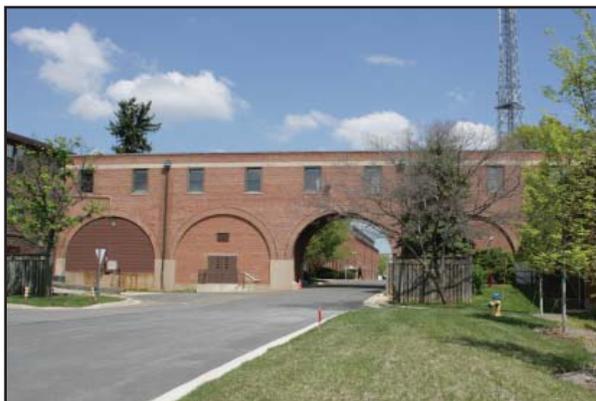
**Figure 3-126.** Open central archway in Building 18-19 connector. *Source: JMA 2010.*

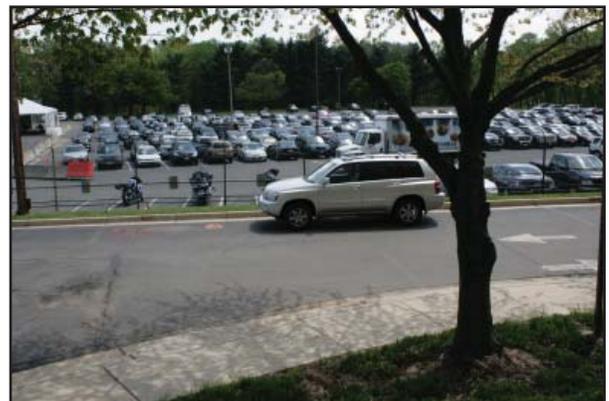
**Figure 3-127.** View of the parking lot at the end of Mount Vernon Drive. *Source: JMA 2010.*

The view down Mount Vernon Drive, once ending in a view of the surrounding woodland, now terminates into the lower parking lot (Figure 3-127).

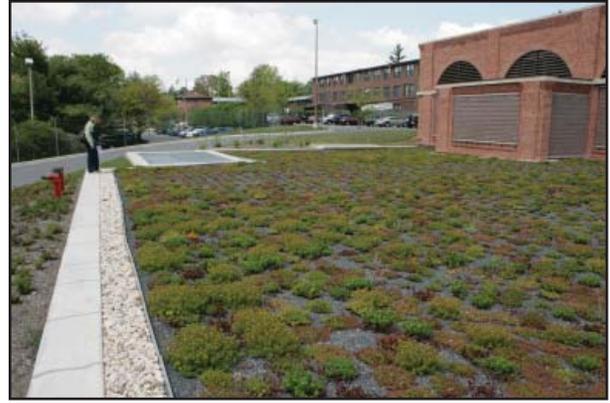
**Figure 3-135.** The green roof behind Building 19. Metal screens to support the growth of vines are located along some of the newly constructed brick walls. *Source: JMA 2010.*

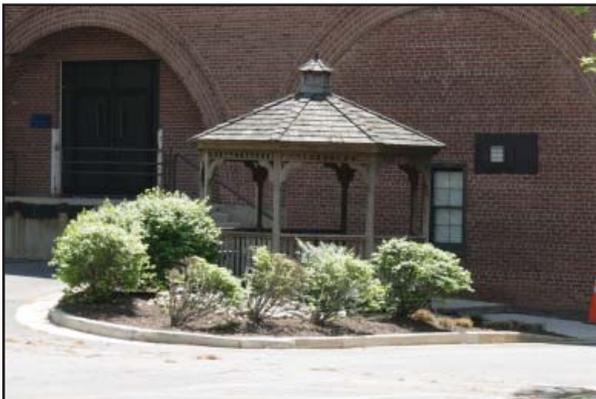
**Figure 3-143.** Building 7 (Dispensary) and associated parking. *Source: JMA 2010.*

While Building 7 (Dispensary) dates to the second period of significance, it has been modified extensively and is no longer considered contributing due to loss of integrity (Figure 3-143). Building 60 was constructed after the second period of significance and thus not considered contributing. Guardhouse 2 secures the vehicular entrance from Massachusetts Avenue and was built in 1995.

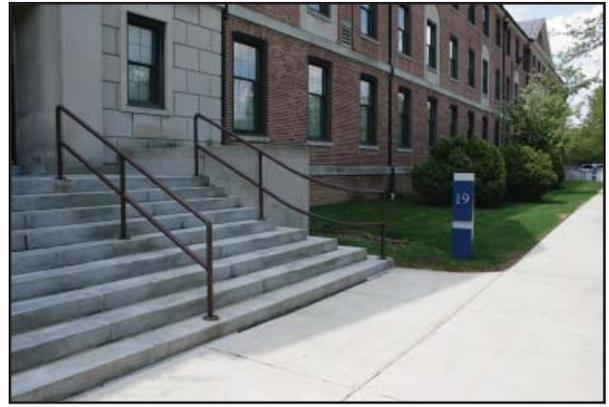
**Figure 3-146.** Concrete retaining wall and stairway to Building 19. Source: JMA 2010.

Structures within the Unit include boundary, security and screening fencing; screening walls; concrete retaining walls and stairway systems; and the stormwater drainage system (Figures 3-146 through 3-151).

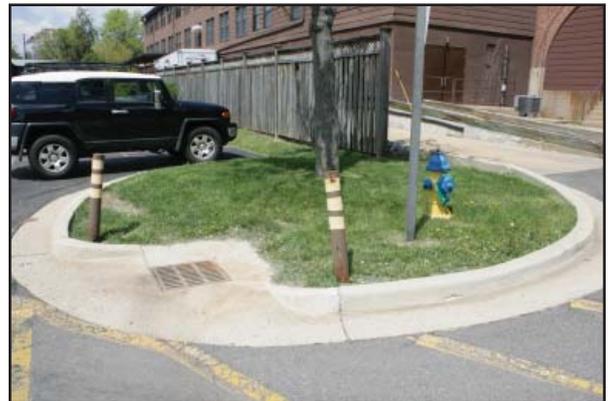
**Figure 3-150.** Stormwater drainage structures. Source: JMA 2010.

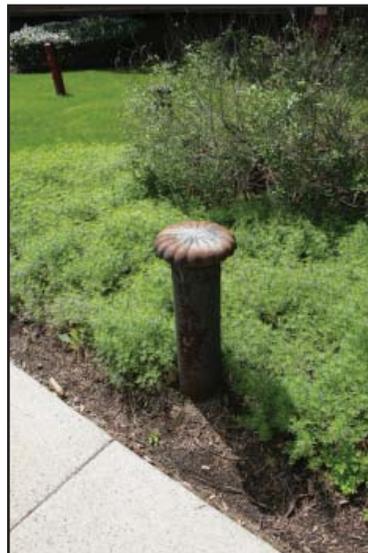
**Figure 3-155.** Metal stand pipe, purpose unknown. Source: JMA 2010.

HVAC and other utility units and features (Figure 3-155) are found throughout the site. Dumpsters are located at various locations within the Cryptanalysis Unit (see Figure 3-149). Sometimes these are screened with wooden privacy fences. These features are visually intrusive and negatively affect the character of the site.

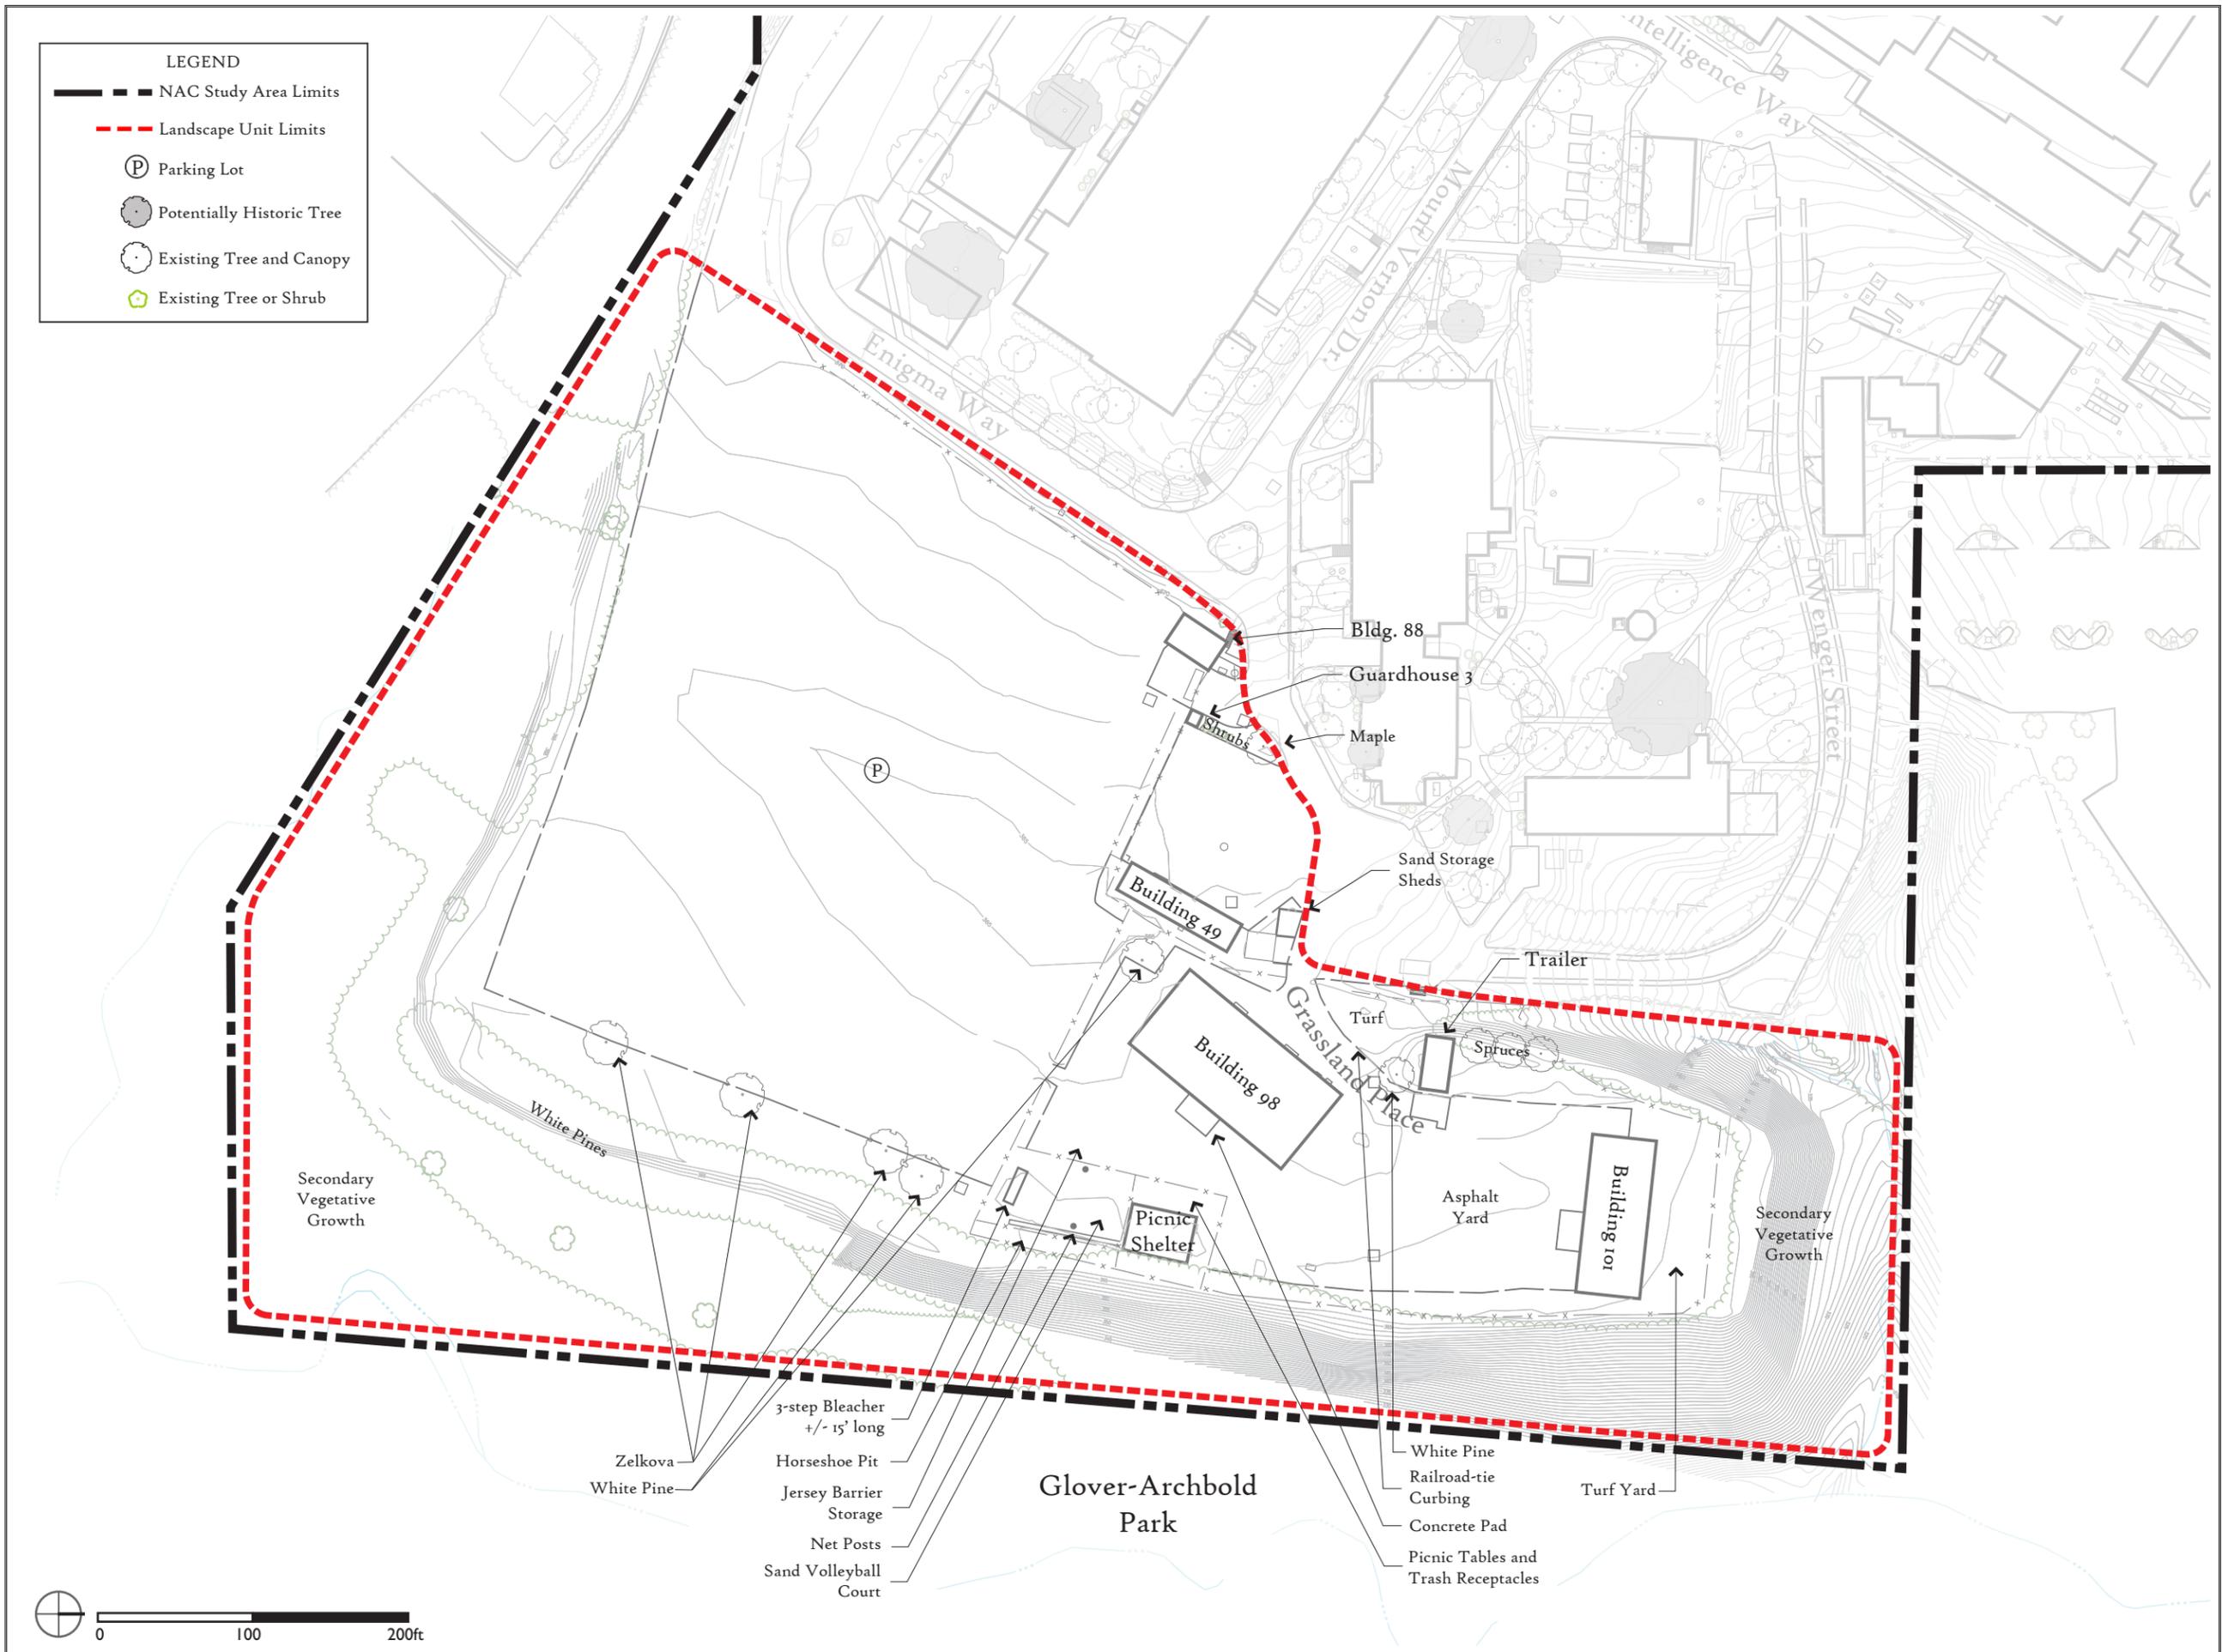
**Map 3-8.**  
East Unit  
Existing Conditions  
& Vegetation

- 3-step Bleacher +/- 15' long
- Zelkova
- White Pine
- Horseshoe Pit
- Jersey Barrier Storage
- Net Posts
- Sand Volleyball Court

- White Pine
- Railroad-tie Curbing
- Concrete Pad
- Picnic Tables and Trash Receptacles

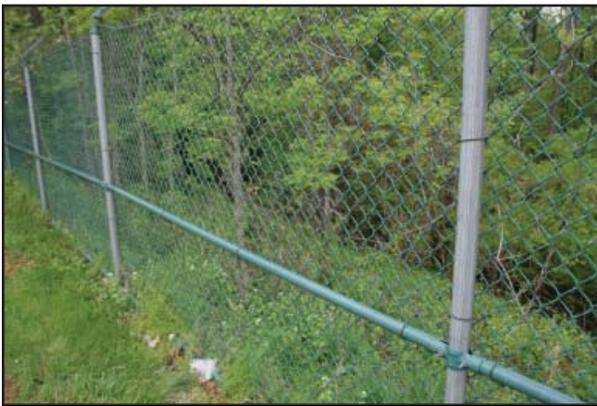
**Figure 3-158.** Edge of the graded terrace that supports Buildings 98, 101 and related service and parking areas. *Source: JMA 2010.*

The topography of the East Unit slopes very gradually to the east up to the edge of the graded terracing that was developed to support the utility buildings and the large parking lot that make up the majority of the unit (Figure 3-158 and 3-159). Fill was brought in during post-1952 construction efforts to help level the area for parking. The steep slopes created are visible in aerial photographs. Glover-Archbold Park, located just to the east of the property limits, includes the remaining riparian corridor and Foundry Branch stream.
