# U.S. Department of Homeland Security Nebraska Avenue Complex Master Plan DRAFT ENVIRONMENTAL IMPACT STATEMENT

# Cultural Landscape Report

# NEBRASKA AVENUE COMPLEX Cultural Landscape Report

Washington, D.C.

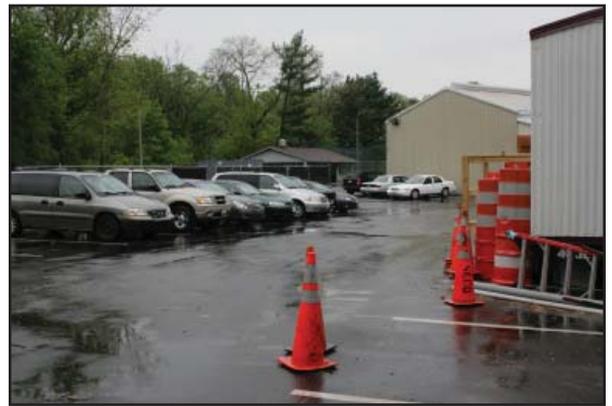
**Figure 3-159.** Parking lot/asphalt yard between buildings 101 and 98. *Source: JMA 2010.*

The topography of the East Unit slopes very gradually to the east up to the edge of the graded terracing that was developed to support the utility buildings and the large parking lot that make up the majority of the unit (Figure 3-158 and 3-159). Fill was brought in during post-1952 construction efforts to help level the area for parking. The steep slopes created are visible in aerial photographs. Glover-Archbold Park, located just to the east of the property limits, includes the remaining riparian corridor and Foundry Branch stream.

Recreational and Cryptanalysis Units (see Figure 3-157). This parking lot and the associated access roads post-date 1952 and is not considered to be historically significant. The northern half of the unit includes parking areas and large paved asphalt areas that facilitate maintenance, service buildings and parking (Figure 3-159). Short lengths of railroad tie curbing are used to define the edges of the paving in a few areas.

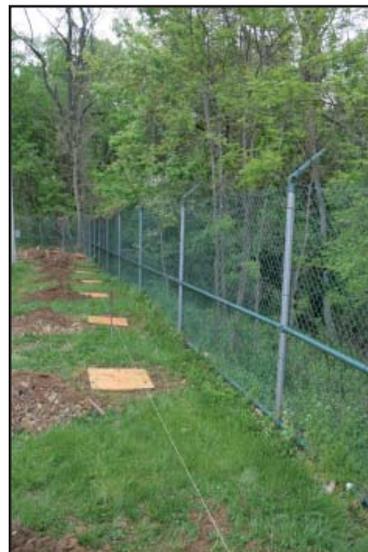
**Figure 3-173.** Chain link fence along Unit boundary, topped with barbed wire. Wood squares mark the locations of holes for new fence posts about to be installed. Source: JMA 2010.

Features associated with the recreation area and picnic shelter can be found around the volleyball and horseshoe courts (Figures 3-167 through 3-172). Chain link fencing also surrounds most of the East Unit boundary (Figure 3-173). Some of the fences are topped with barbed wire.

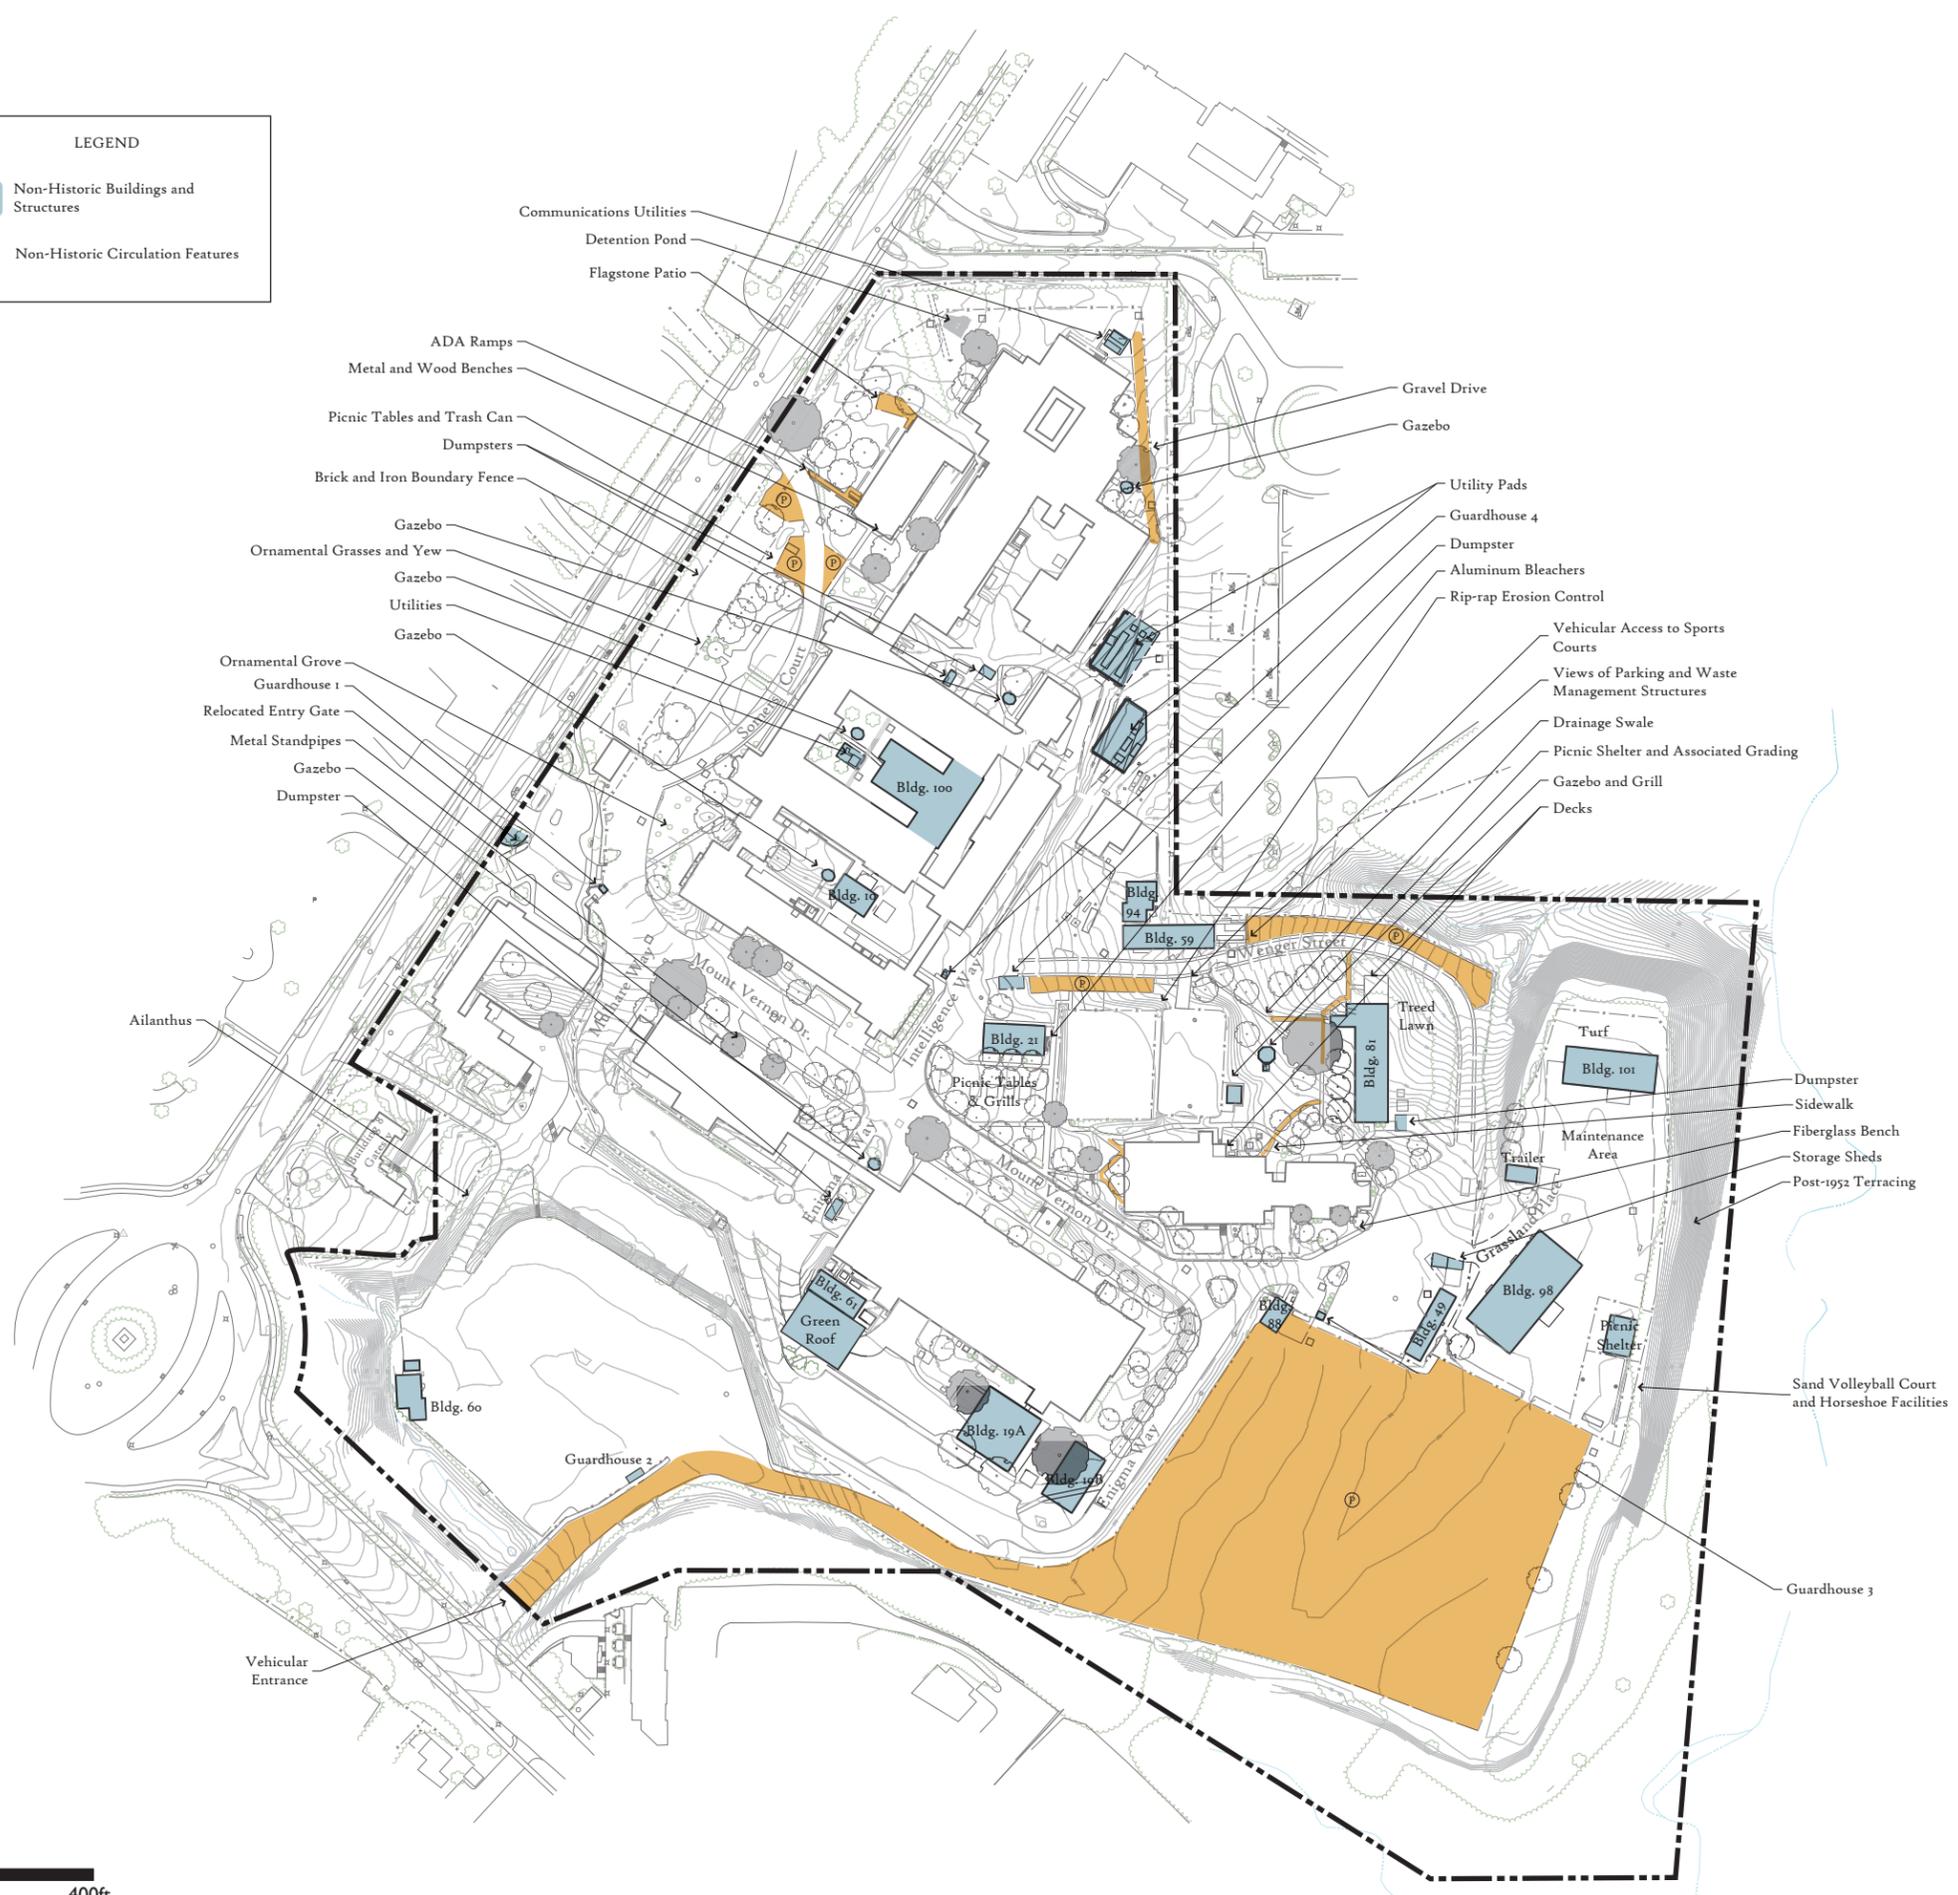
**Map 4-2.**  
Non-historically Significant Features

- Non-Historic Buildings and Structures
- Non-Historic Circulation Features

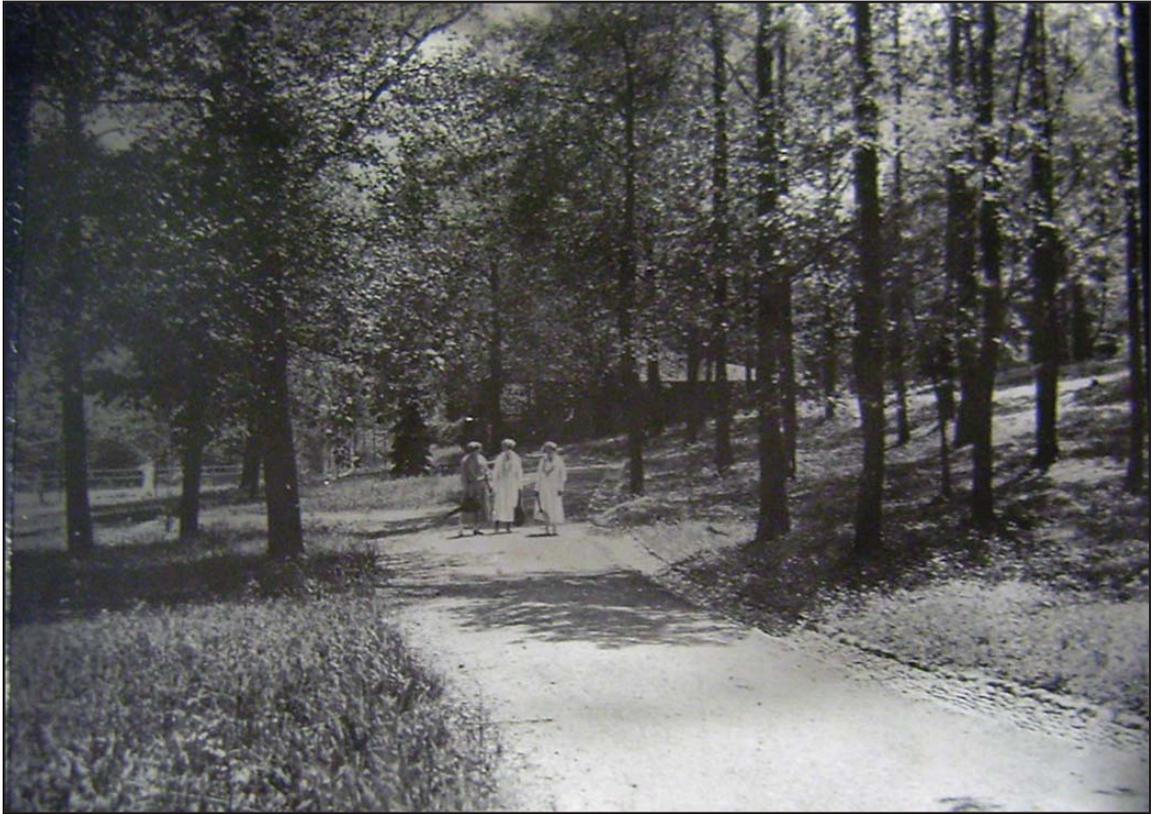
**Figure 4-1.** The return walk from “The Shelter” along Wenger Street. *Source: Mount Vernon Seminary and College Archives, Special Collections Research Center, The Gelman Library, The George Washington University.*

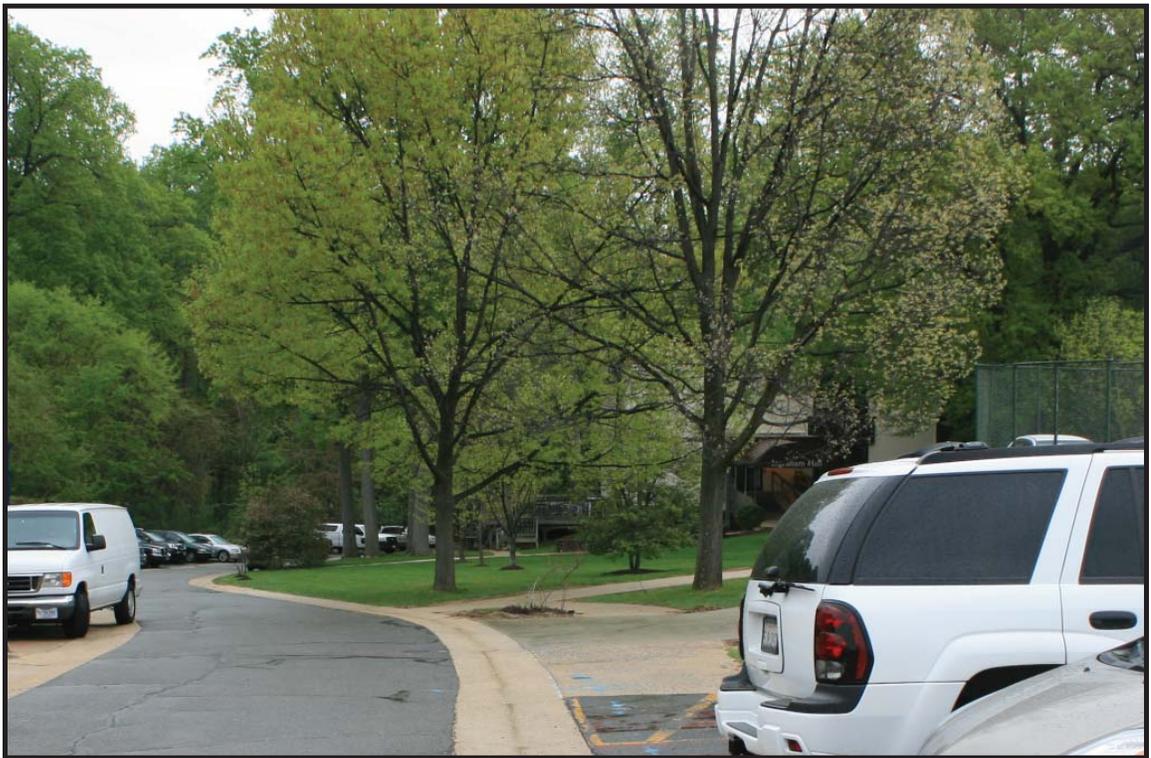
**Figure 4-2.** Wenger Steet ca. 2010. *Source: JMA 2010.*

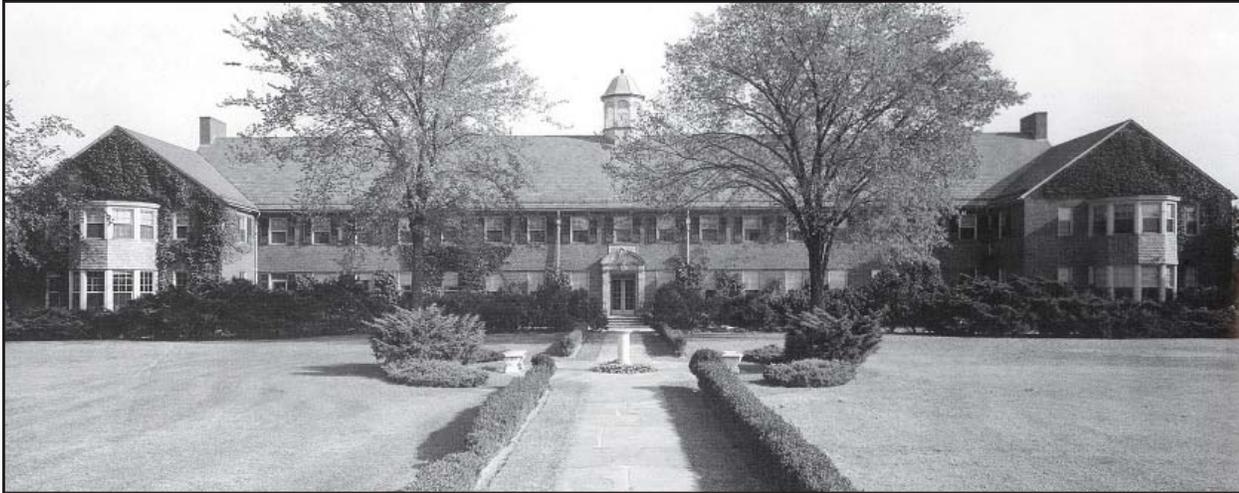
**Figure 4-3.** Axial view from Nebraska Avenue down the linear walk to the front door of Building 1, ca. 1929. *Source: Dear Daughters.*

By the 1930s, the planted vegetation installed in the early years of the seminary had begun to mature. Plantings installed with the construction of the central walk, birdbath garden and pedestrian entrance composition emphasized the axial relationship of the school building with the street (see Figure 4-3). Evergreens, likely **yews** (*Taxus baccata*), were used to outline the flagstone path and vertical evergreens, likely either Eastern red cedar, hemlock or **arborvitae** (*Thuja sp.*), repeated the verticals of the piers of the Hensley Gate. Similar evergreens ornamented the central door into the Main School Building courtyard (Figures 4-25 and 4-26). The hemlock hedge along the west boundary was kept pruned to the height of the gate piers. Throughout the property, deciduous and evergreen trees had filled out and contributed to the comfortable character of the site. At some point in the late 1930s, **deciduous street trees** were planted along Nebraska Avenue (see Figure 2-31).

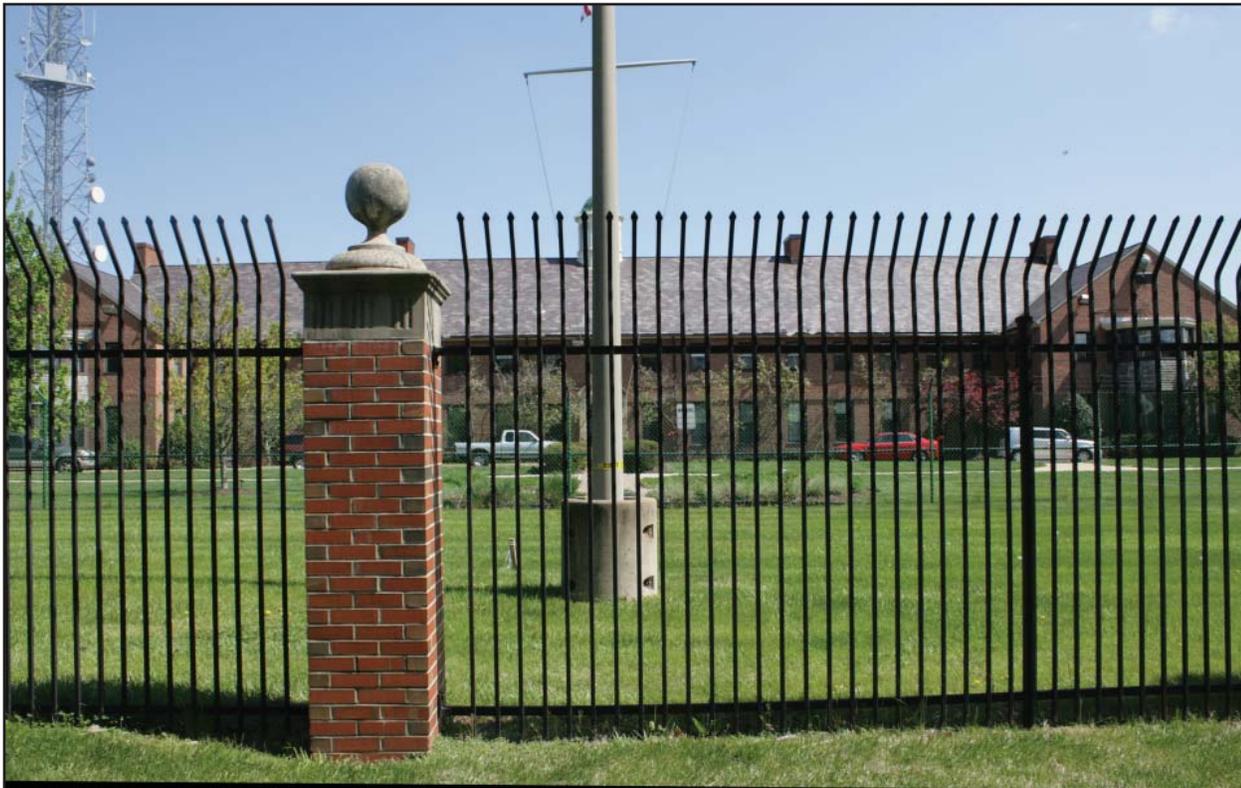
**Figure 4-4.** Similar view, showing that the asymmetry of the placement of the brick fence column, the placement of the security light and flagpole on axis with the central door, the overgrown shrubs, trees planted adjacent to the central door and cars parked along the semi-circular drive are all intrusive elements that de-emphasize the importance of the main building entrance and its axial relationship to Nebraska Avenue. *Source: JMA 2010.*

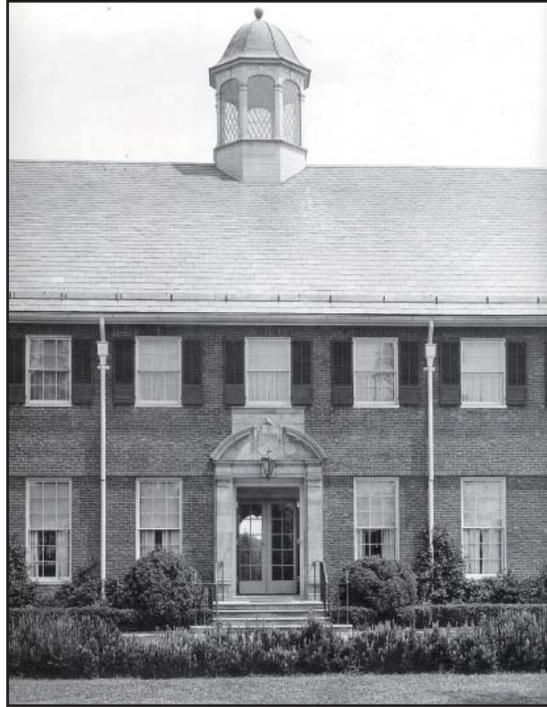
**Figure 4-5.** Axial view from the demilune lawn into and through Building 1 to the courtyard. *Source: Dear Daughters.*

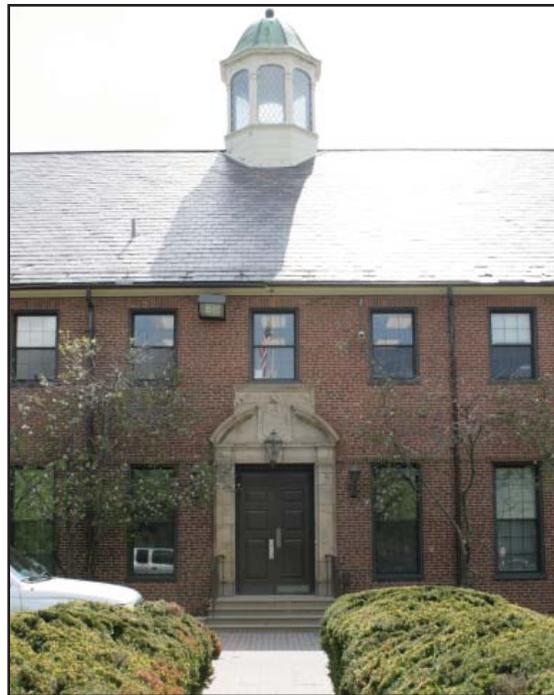
**Figure 4-6.** Similar view. Note that overgrown shrubs, trees planted next to the door and the car parked to the left tend to downplay the importance of the main building entrance. *Source: JMA 2010.*

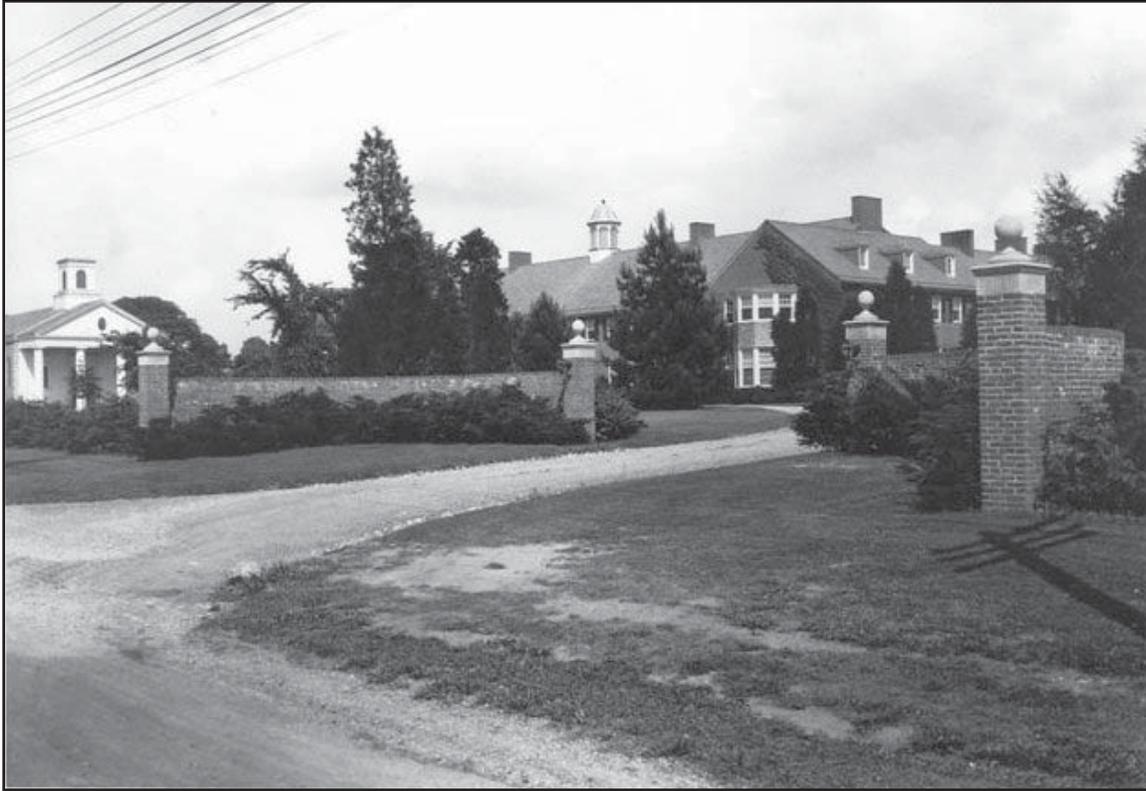
**Figure 4-7.** Entrance with view of Buildings 1 and 6 ca. 1930s. Source: <http://www.navycthistory.com/nsslockert01.html>.

It is likely that one of the first projects was a secured entrance at the Hensley Gate. Building 11, the current guard house, was constructed in 1943 to the side of the north half of the Hensley Gate (see Figures 4-7 and 4-8). An aerial photograph from 1945-46 shows that by that time, the front entrance area had been widened to become an **entry court**, presumably to accommodate turn-arounds in front of the guard house and also to eventually provide parking for Building 17, constructed shortly after (see Figure 2-40). From there extended **Mount Vernon Drive**, the major organizing element of the new circulation system. The strong **axial character** of the drive and the **streetscape space** that was formed between Buildings 17 and 18 are still strongly expressed today.

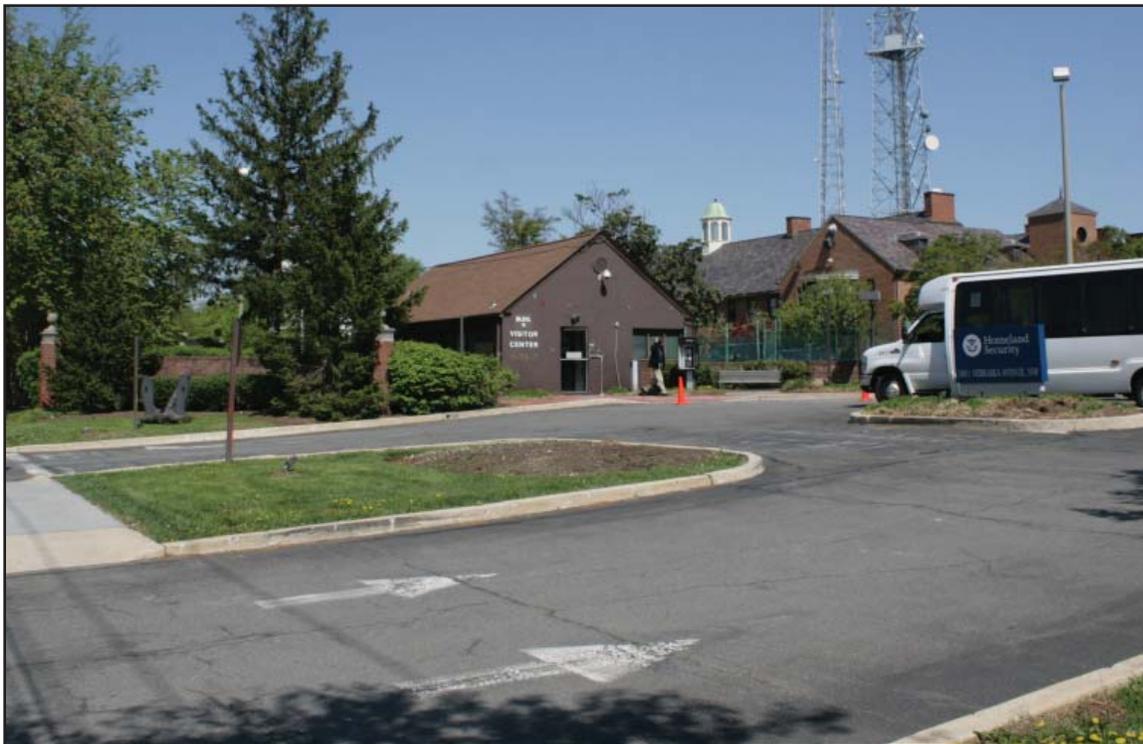
**Figure 4-8.** Entrance with view of Buildings 1 and 11 ca. 2010. Source: JMA 2010.

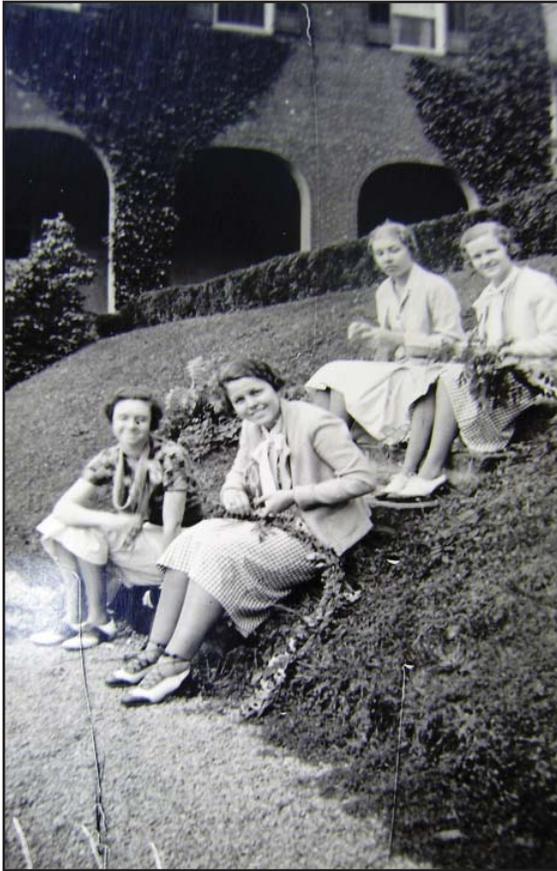
**Figure 4-9.** Mount Vernon Students posed on lower terrace within the courtyard of the Main School Building (Building 1). *Source: Mount Vernon Seminary and College Archives, Special Collections Research Center, The Gelman Library, The George Washington University.*

When construction was completed on the gymnasium, a **garden** was created on its western end (see Figures 4-15 and 4-16). An earthen terrace planted with shrubs enclosed its western side and several trees and shrubs were planted within the garden. **Gymnasium garden paths** included an axial path led to the central door of the gym and another path led at a right angle to connect to the linear path that paralleled the southern side of the sports courts. Another hedge (**sports court hedge**) followed that linear path. There is an Eastern red cedar at the southwest corner of the sports courts that may be the sole survivor of that planting from the 1930s. Other photographs of the campus from the late 1930s shows **English ivy** (*Hedera helix*) ornamenting the walls of Building 1 and a boxwood hedge growing at the top of the lower terrace wall (see Figures 4-9 and 4-10).

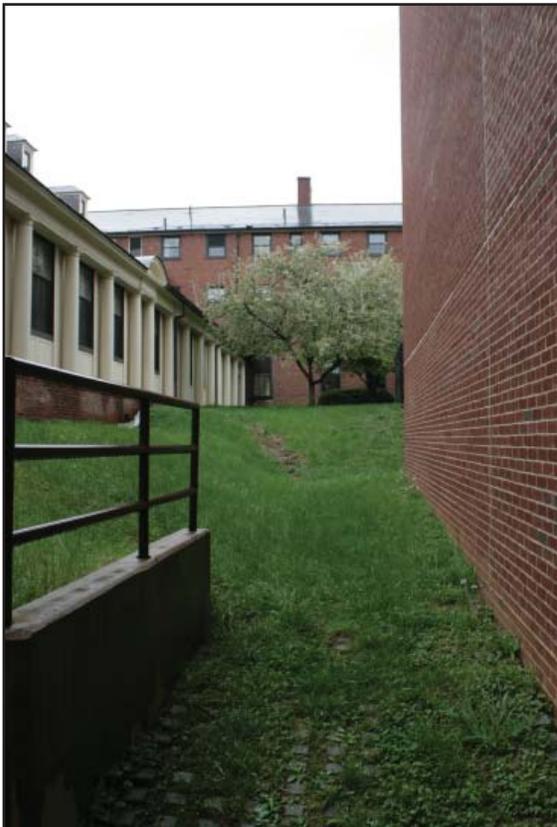
**Figure 4-10.** View of terrace remnants from approximately the same location, showing Building 100 to the right. *Source: JMA 2010.*

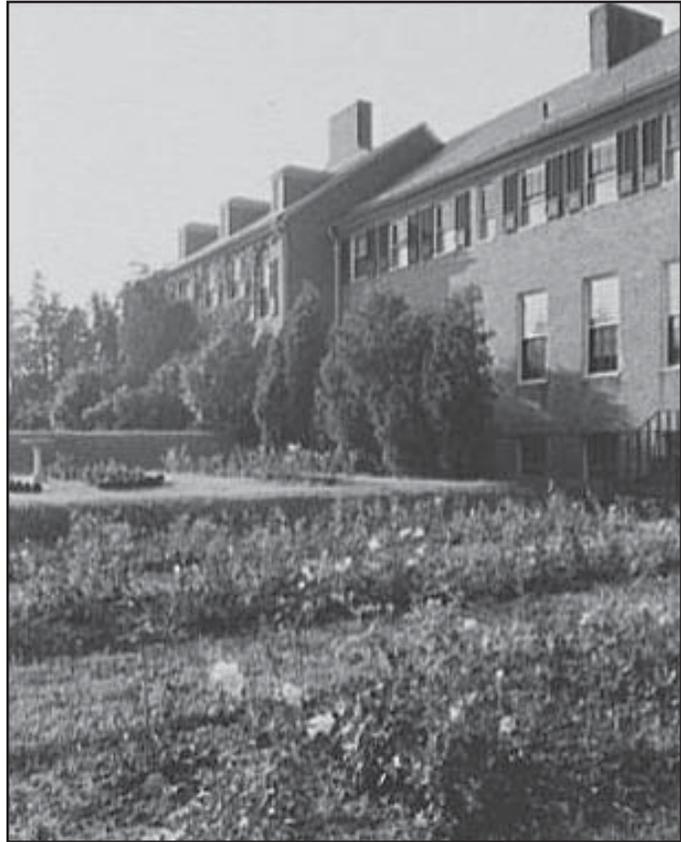
**Figure 4-12.** Similar view showing the removal of the earthen terraces. The exterior stairs have been removed and the door made into a window. Portions of the retaining wall that created a light well are extant in the landscape today. *Source: JMA 2010.*

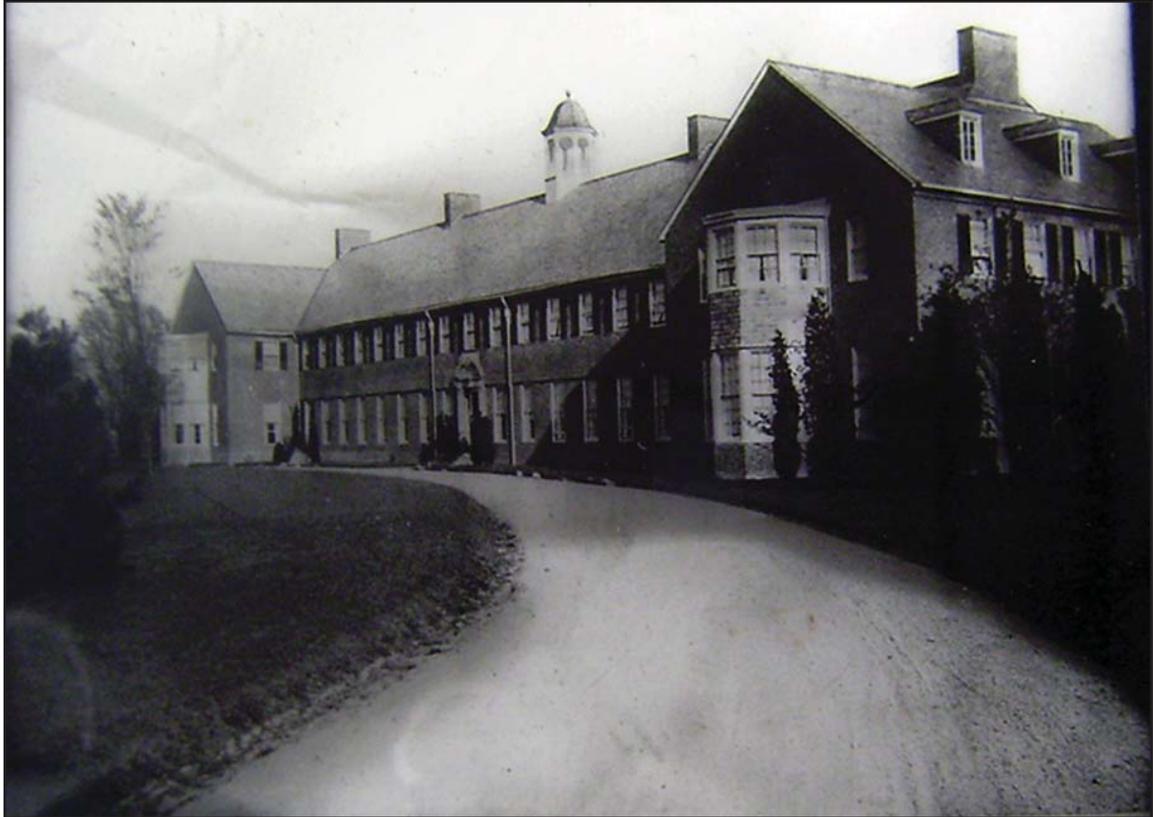
**Figure 4-13.** Building 1 and the curved entry drive ca. 1917-18. *Source: Mount Vernon Seminary and College Archives, Special Collections Research Center, The Gelman Library, The George Washington University.*

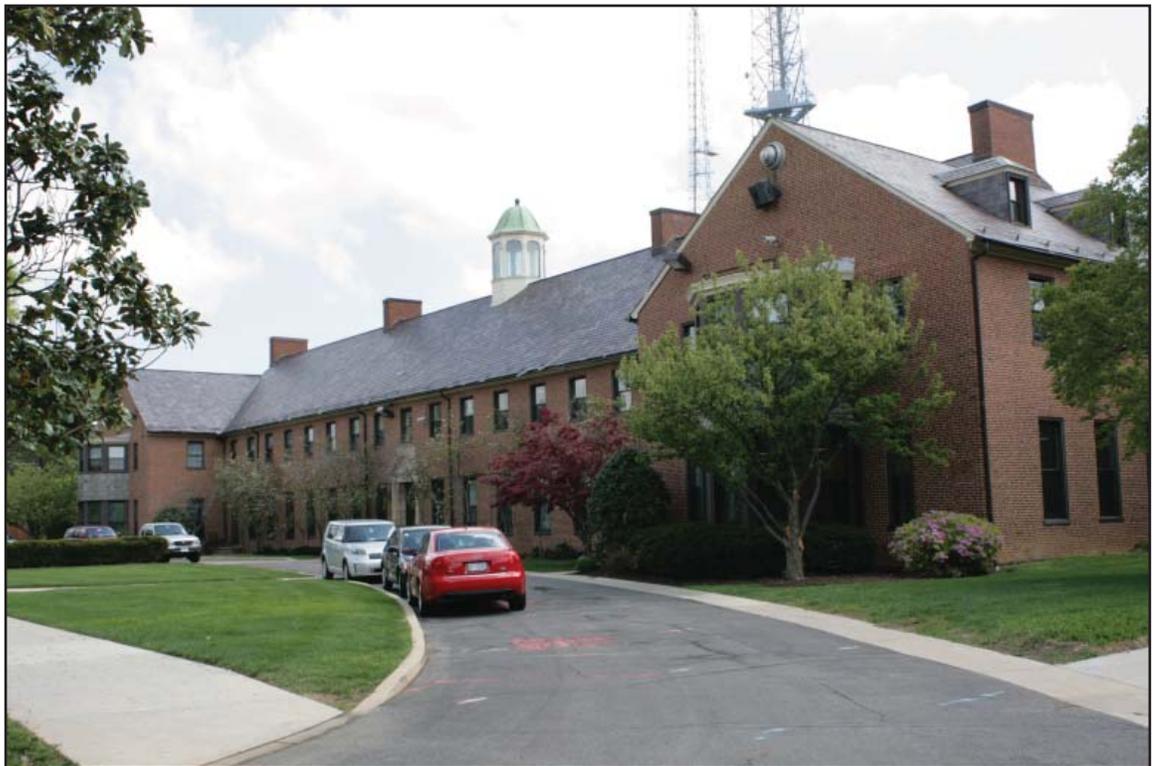
**Figure 4-14.** Building 1 and the curved entry drive ca. 2010. *Source: JMA 2010.*

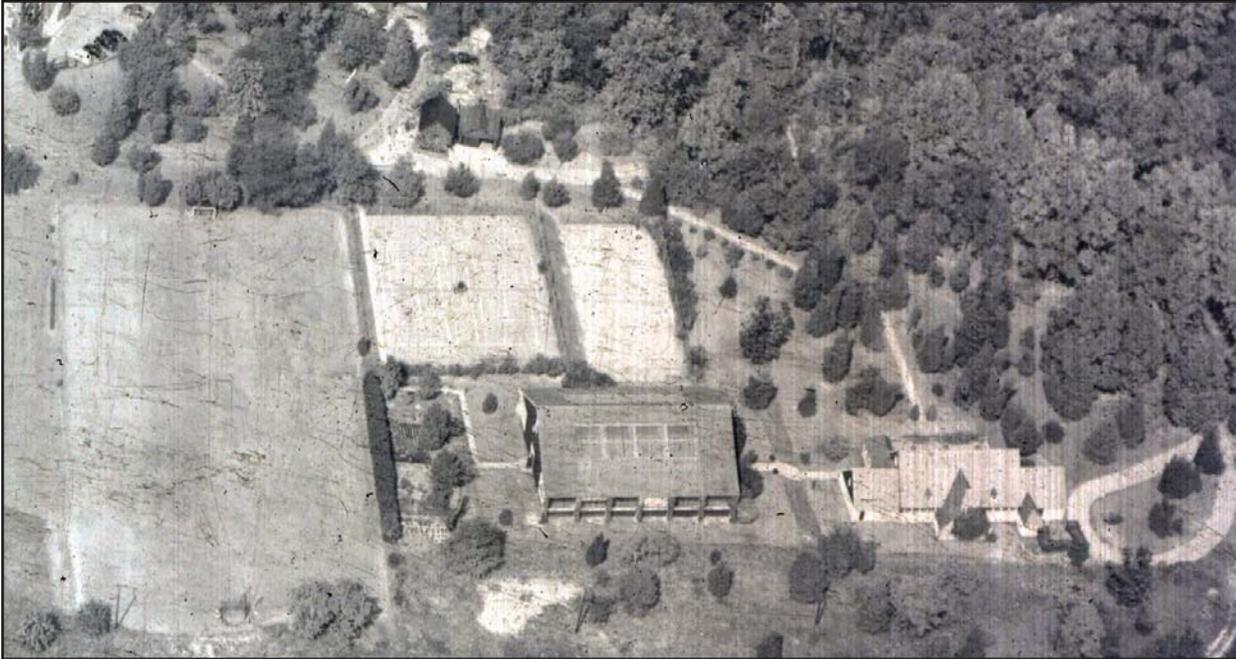
**Figure 4-15.** View of the Recreation Unit in 1942, prior to additions by the U.S. Navy. Notable features include the diagonal walkway leading from the service road and turning towards the Field House dining terrace, the circle drive terminus of the service road, the earthen terracing supporting the sports courts and located between the Field House and the Gymnasium and the garden on the west end of the Gymnasium. *Source: Nebraska Avenue Complex Public Works Archives.*

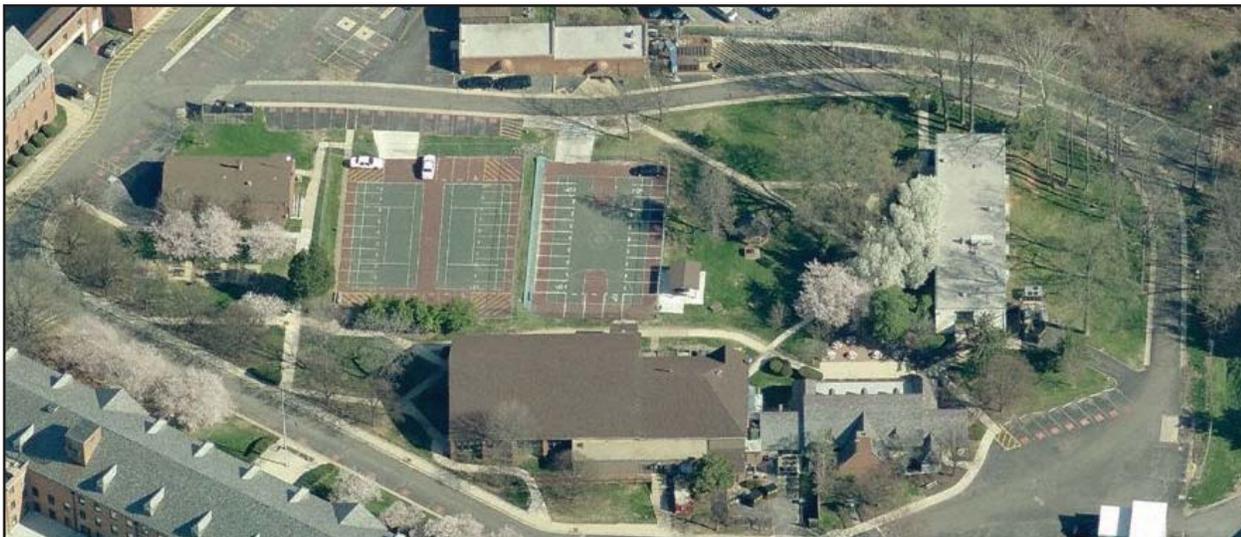
**Figure 4-16.** Similar view of the Recreation Unit, showing the diagonal walk, the trace of the circle drive terminus and the earthen terracing still discernible in the landscape. Note that many trees are extant from 1942, including the grove of tulip poplar at the upper right, the Eastern red cedar at the southwest corner of the tennis courts and the row of hollies along the south side of the tennis courts. *Source: Bing 2010.*

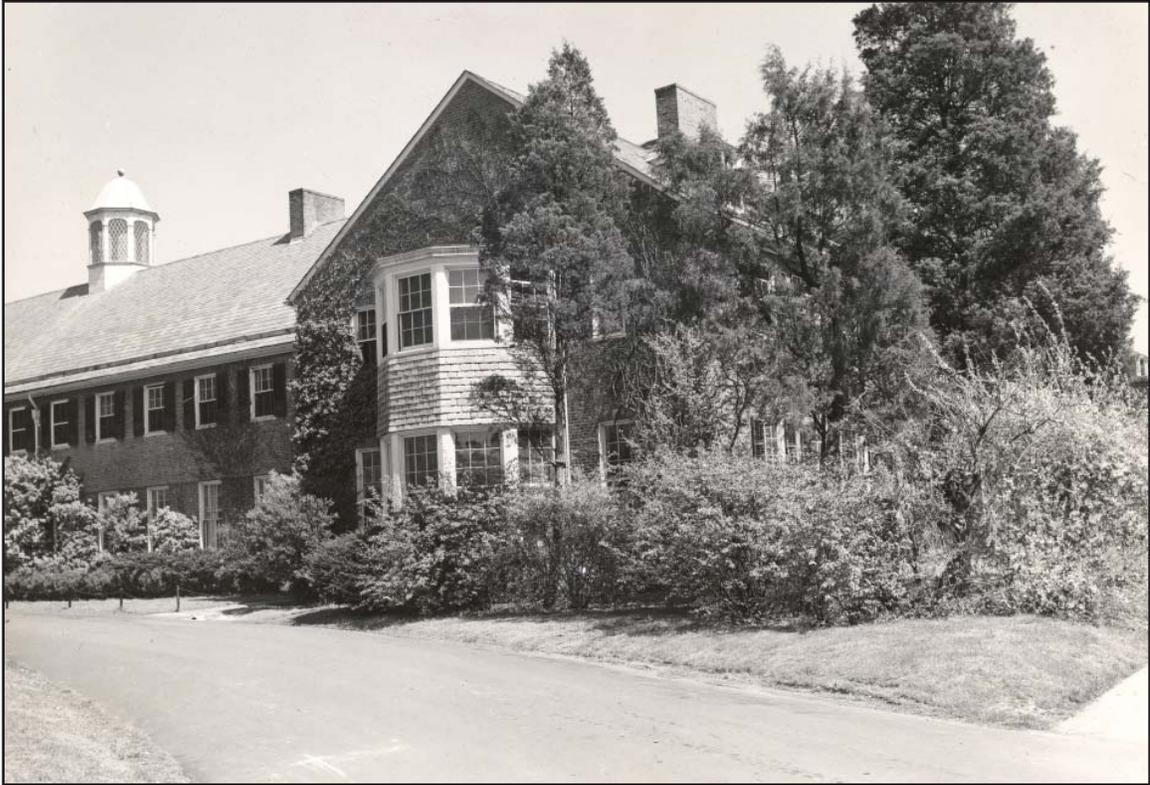
**Figure 4-17.** Building 1. Note that while shrubbery obscures the south side of the building, its bay window is visible.  
*Source: Nebraska Avenue Complex Public Works Archives.*

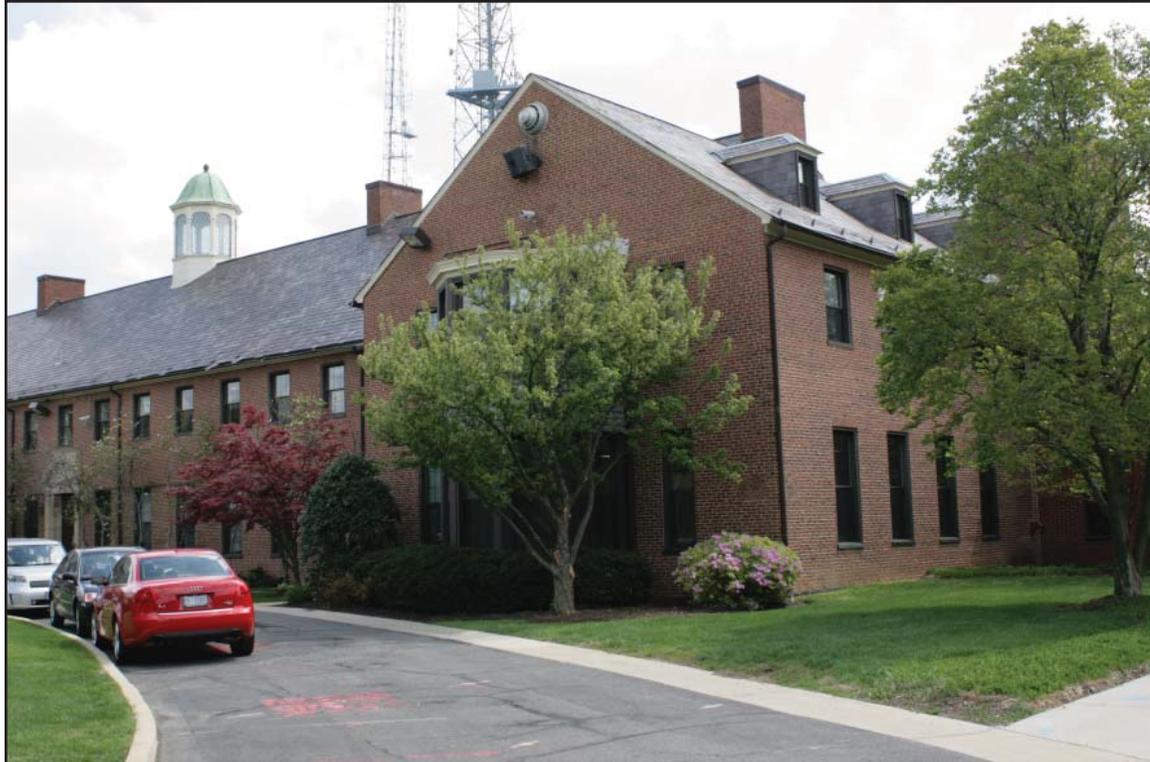
**Figure 4-18.** Similar view, but in this case, the view of the bay window is obscured by the canopy of a small tree.  
*Source: JMA 2010.*

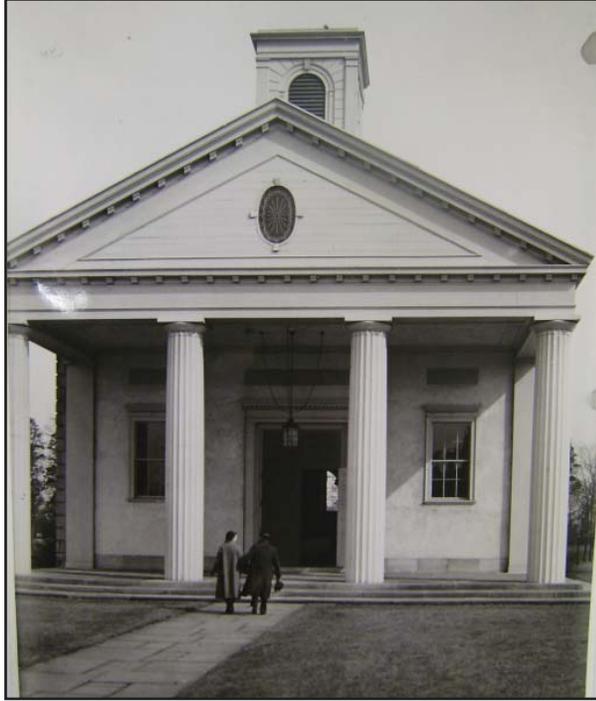
**Figure 4-21.** The Chapel ca. 1925. Note the broad central bluestone flagstone walkway. *Source: Mount Vernon Seminary and College Archives, Special Collections Research Center, The Gelman Library, The George Washington University.*

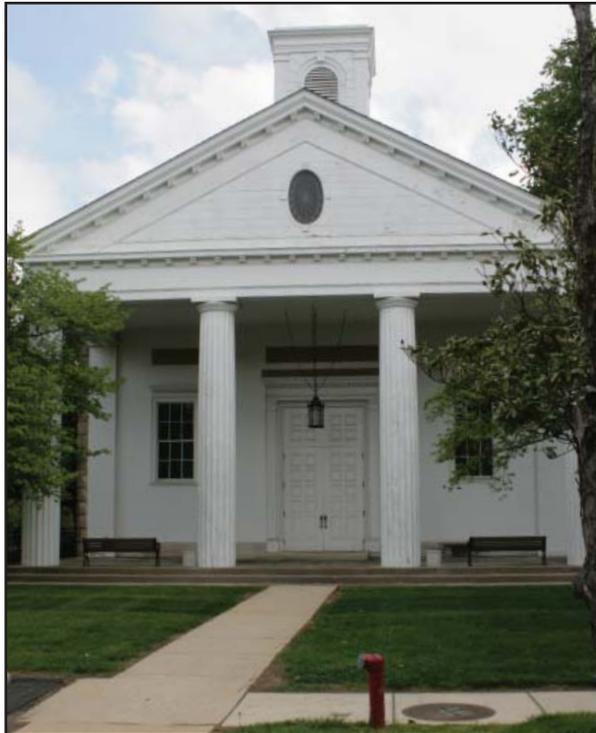
**Figure 4-22.** Similar view showing that the flagstone walkway was replaced with concrete and narrowed by approximately one foot. *Source: JMA 2010.*

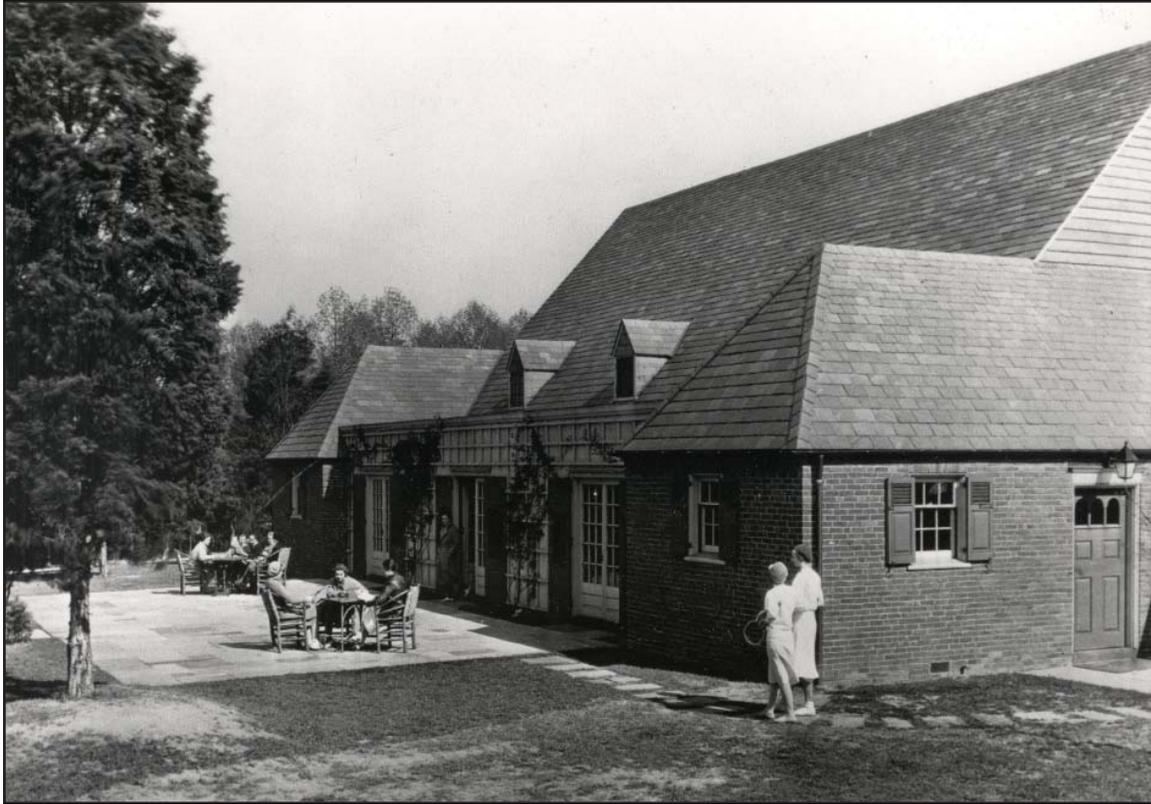
**Figure 4-23.** Building 14 and patio ca. 1942. *Source: Nebraska Avenue Complex Public Works Archives.*

Another photograph shows the **garden trellises** that supported flowering vines on the eastern ends of wings of the school building (Figures 4-27 and 4-28). The trellises were made of wood lathe and painted white. Similar trellises with vines were attached to the northern side of the Field House (see Figures 4-23 and 4-24). Other small-scale features included a number of small metal and wood **garden benches** that were removed by the Navy in the 1940s and

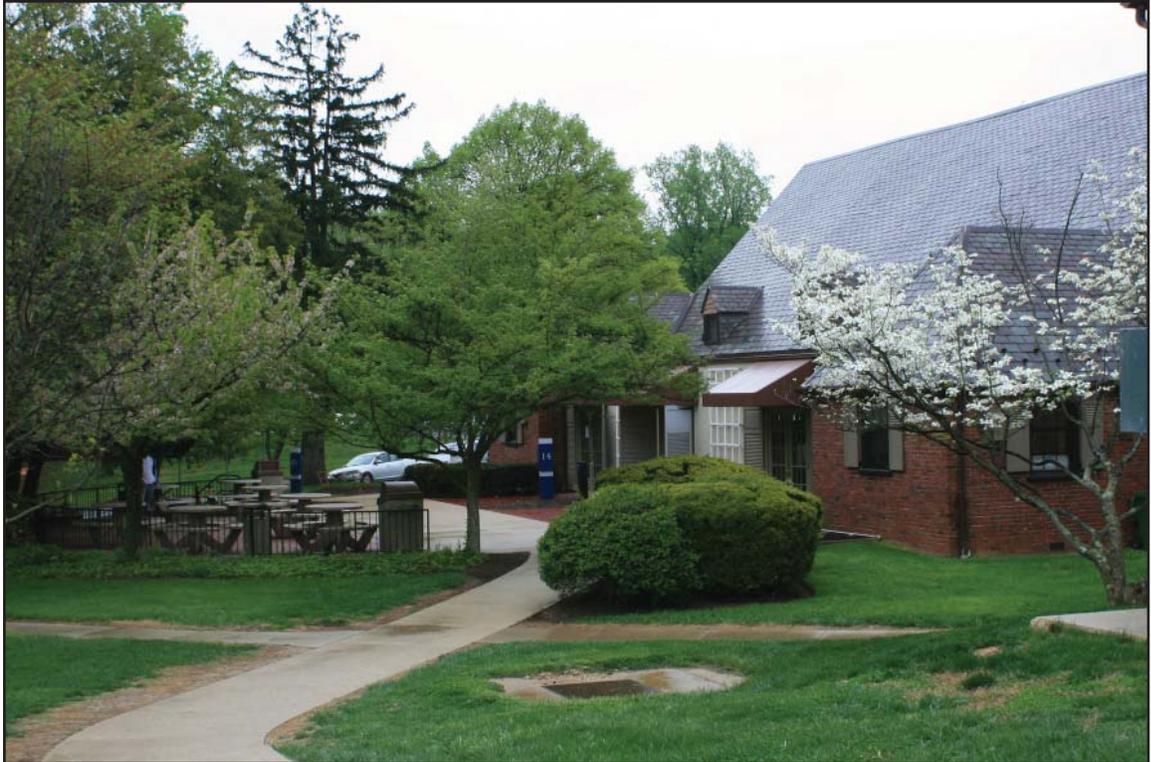
**Figure 4-24.** Building 14 and patio ca. 2010. *Source: JMA 2010.*

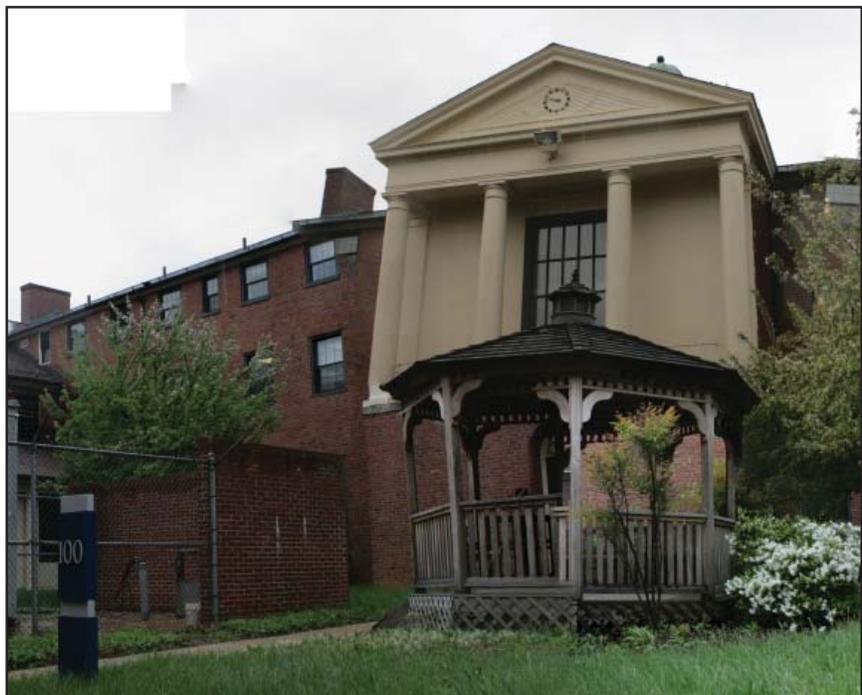
**Figure 4-26.** Similar view, showing a number of changes, including the construction of the brick utility house and the wooden gazebo. The vertical evergreen trees are no longer extant at the entrance. *Source: JMA 2010.*
