# U.S. Department of Homeland Security Nebraska Avenue Complex Master Plan DRAFT ENVIRONMENTAL IMPACT STATEMENT

# Cultural Landscape Report

# NEBRASKA AVENUE COMPLEX Cultural Landscape Report

Washington, D.C.

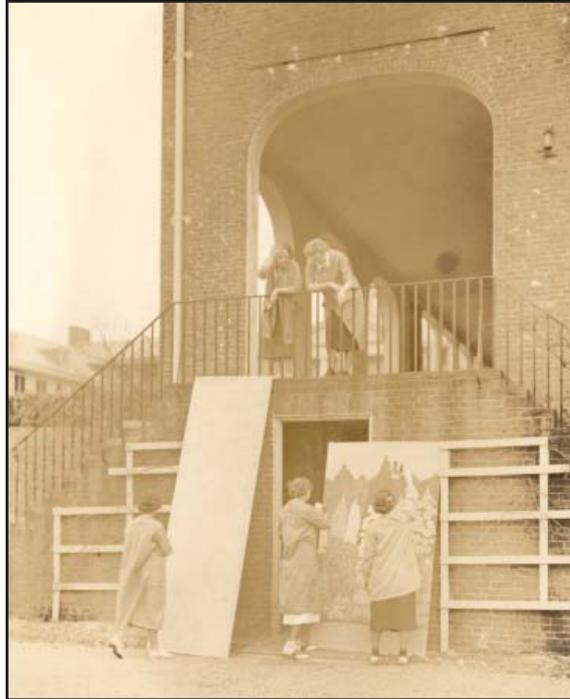
**Figure 4-27.** East end of the north wing of the Main School Building (Building 1). The white wooden trellises supported flowering vines in the spring, summer and fall. *Source: Mount Vernon Seminary and College Archives, Special Collections Research Center, The Gelman Library, The George Washington University.*

Another photograph shows the **garden trellises** that supported flowering vines on the eastern ends of wings of the school building (Figures 4-27 and 4-28). The trellises were made of wood lathe and painted white. Similar trellises with vines were attached to the northern side of the Field House (see Figures 4-23 and 4-24). Other small-scale features included a number of small metal and wood **garden benches** that were removed by the Navy in the 1940s and

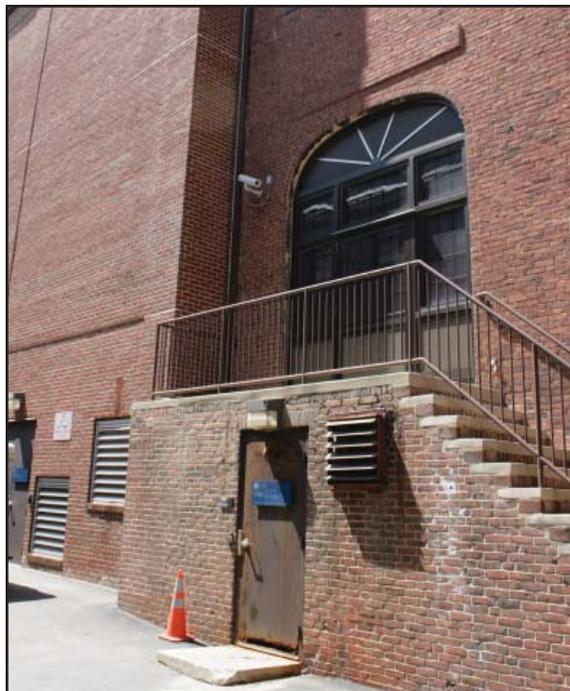
**Figure 4-28.** Similar view showing that the south stairs were removed to accommodate additions to the building, the colonnade opening filled in and the delicate railings replaced with steel pipe. *Source: JMA 2010.*

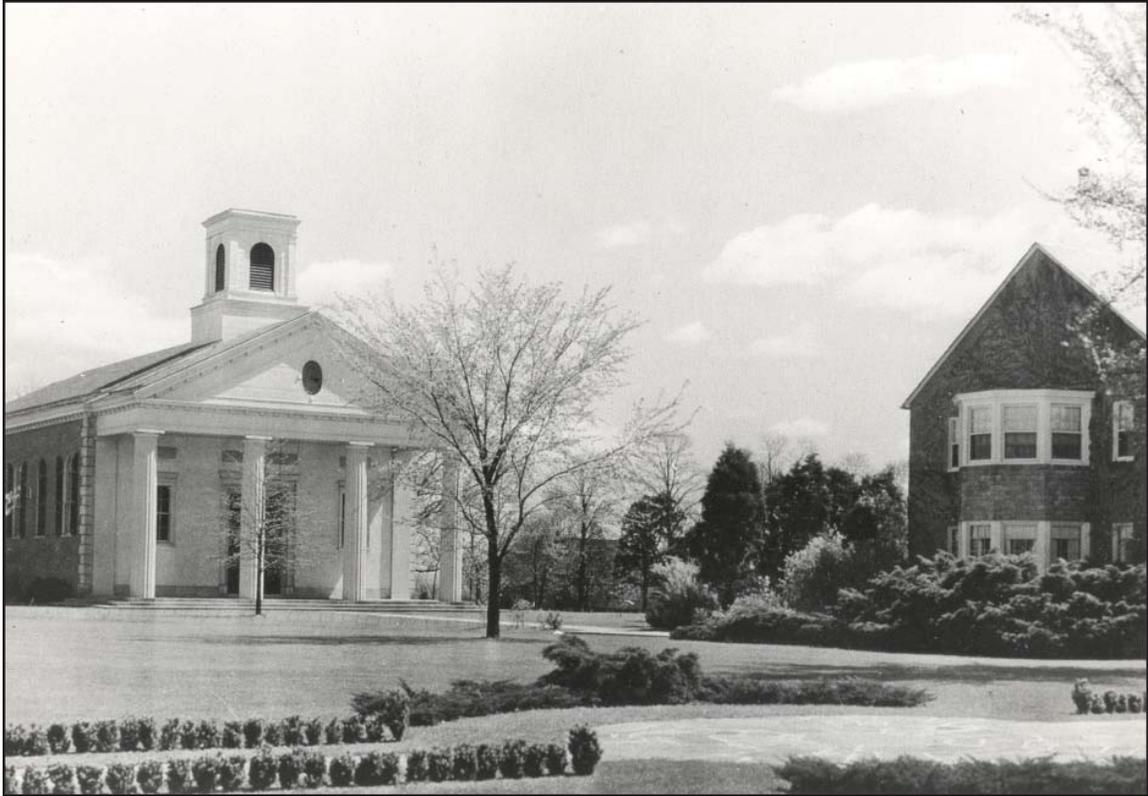
**Figure 4-29.** The Chapel, Building 1 and the front walk. *Source: Nebraska Avenue Complex Public Works Archives.*

By December 1942, the U.S. Navy took possession of the campus. Almost immediately, the Navy erected a double six-foot high chain link security fence around the entire site (see Figure 2-37). During the following three years, the property changed drastically in its spatial configuration, from an open, landscaped campus with a rural feel to a densely built facility, not unlike many suburban office parks. Building interiors, with the exception of the Chapel, were gutted and retrofitted to accommodate offices and other uses and trees and gardens were removed for the erection of **Quonset huts** to house temporary facilities. A **flagpole** was installed in place of the sundial at the center of the flagstone walk and is still in place today (Figure 4-29 and 4-30).

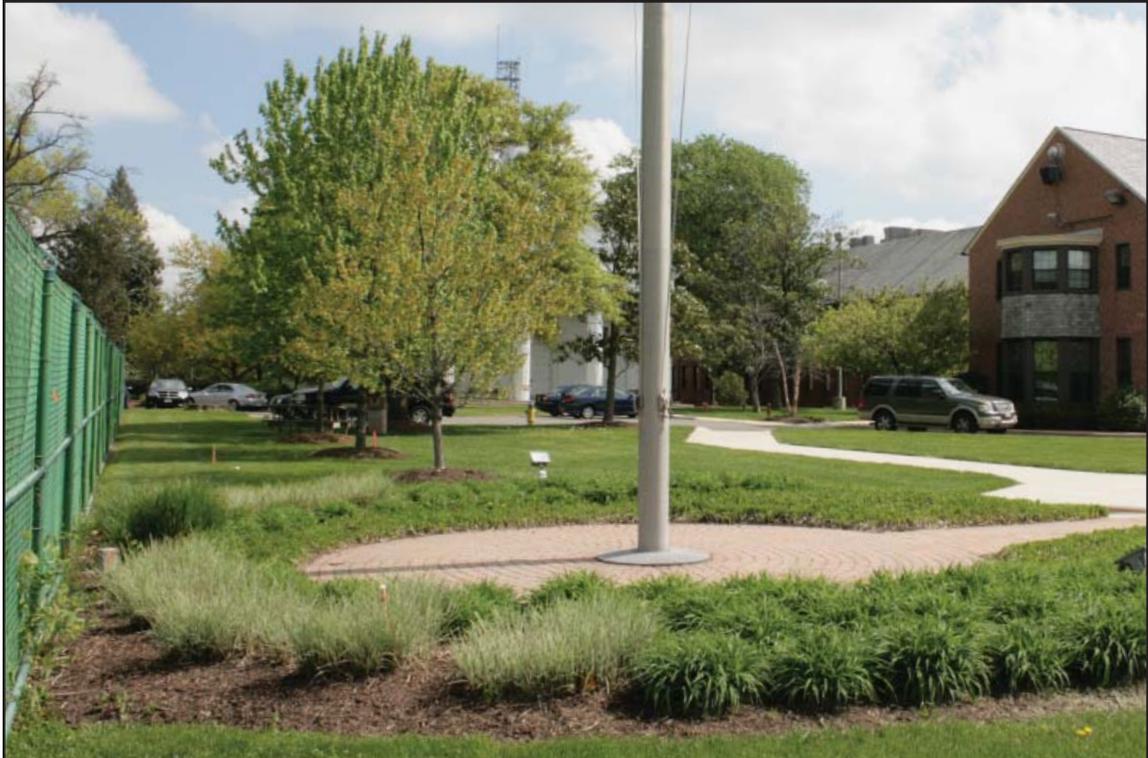
**Figure 4-30.** The Chapel, Building 1 and the front walk. *Source: JMA 2010.*

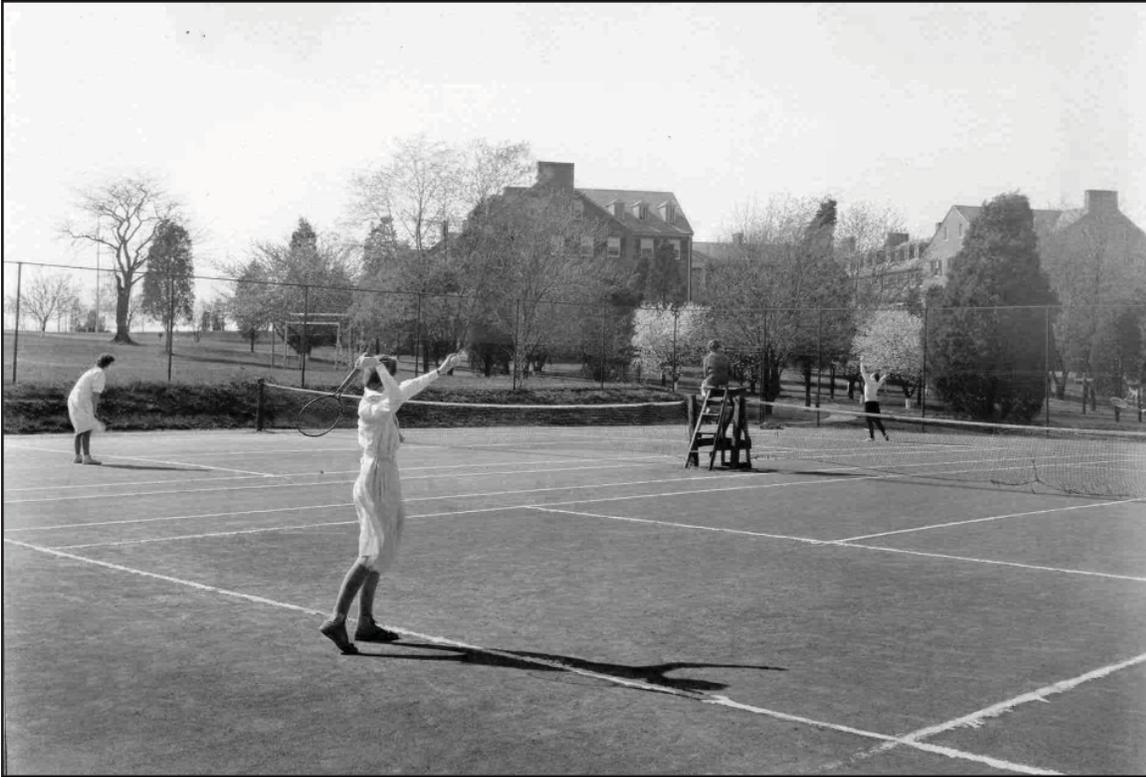
**Figure 4-31.** View of tennis courts and Building 1. *Source: Mount Vernon Seminary and College Archives, Special Collections Research Center, The Gelman Library, The George Washington University.*

connected to it via passageways, was erected in 1943 to house additional offices (Figures 4-31 and 4-32). During the same year, the U.S. Navy also erected **Building 4** for use as a laboratory to house the bombe machines; **Building 7** for use as a dispensary; **Building 11** to serve as a gatehouse; **Building 13**, which connected Buildings 12 and 14, to be used as a mess hall; and **Building 5**, an addition to the laboratory building (Building 4).<sup>6</sup> Another **building**, **rectangular** in shape with a perpendicular addition, was located just to the southeast of Building 3, as it appears in an aerial photograph from 1952 but is non-extant today. A note on one photograph indicates that it was used as a barracks and identified as Building 10.

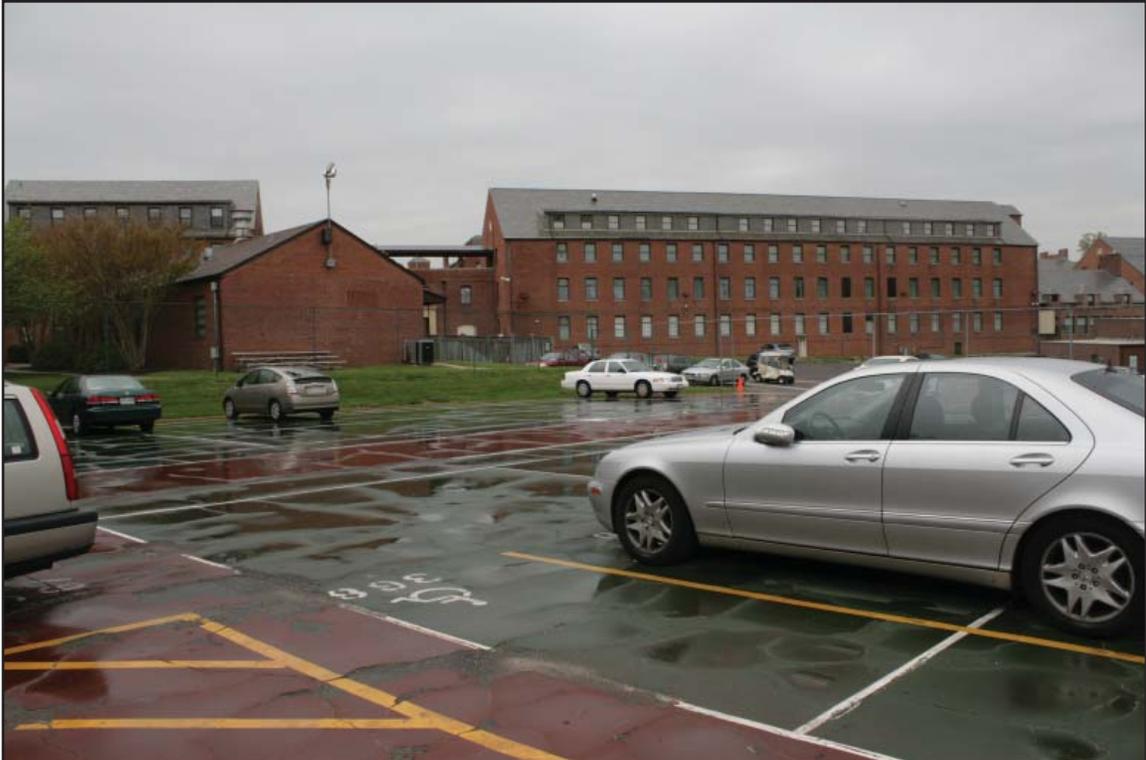
**Figure 4-32.** View of converted tennis courts and Building 3 which blocks the view of Building 1 ca. 2010. *Source: JMA 2010.*

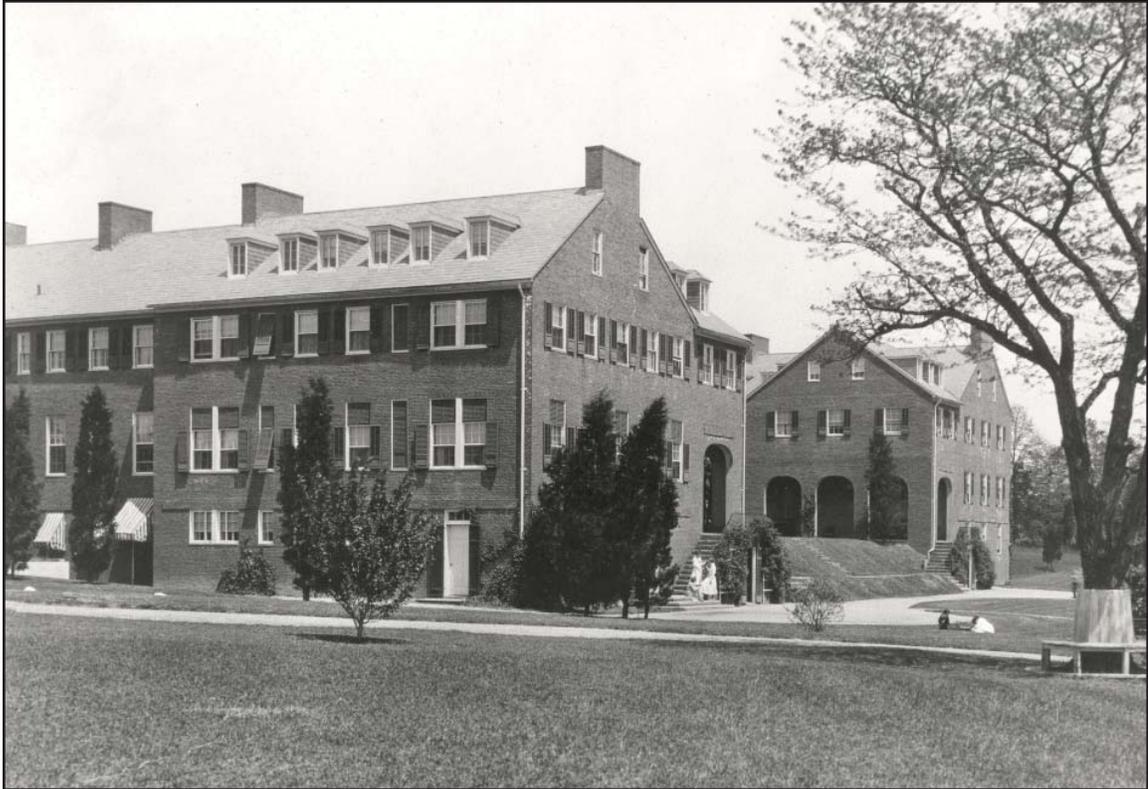
Figure 4-33. View of Building 1 south corner. Source: Nebraska Avenue Complex Public Works Archives.

In 1944, the U.S. Navy erected **Building 17** to house additional offices and **Building 18** to house a code and signal laboratory. A **second-story connector** between Buildings 17 and 3 had both vehicular- and pedestrian-scaled openings that allowed access into the service court there (Figures 4-33 through 4-36). Additional construction took place at the NAC during the final period of World War II. **Building 43** was constructed in 1944 to connect Buildings 1 and 17 and was the last building erected on the property prior to the end of World War II in May 1945. Around the same time, the Navy officially acquired the Quebec Street right-of-way from the District of Columbia and, so, by the end of the war had enlarged its property to 38.6 acres.

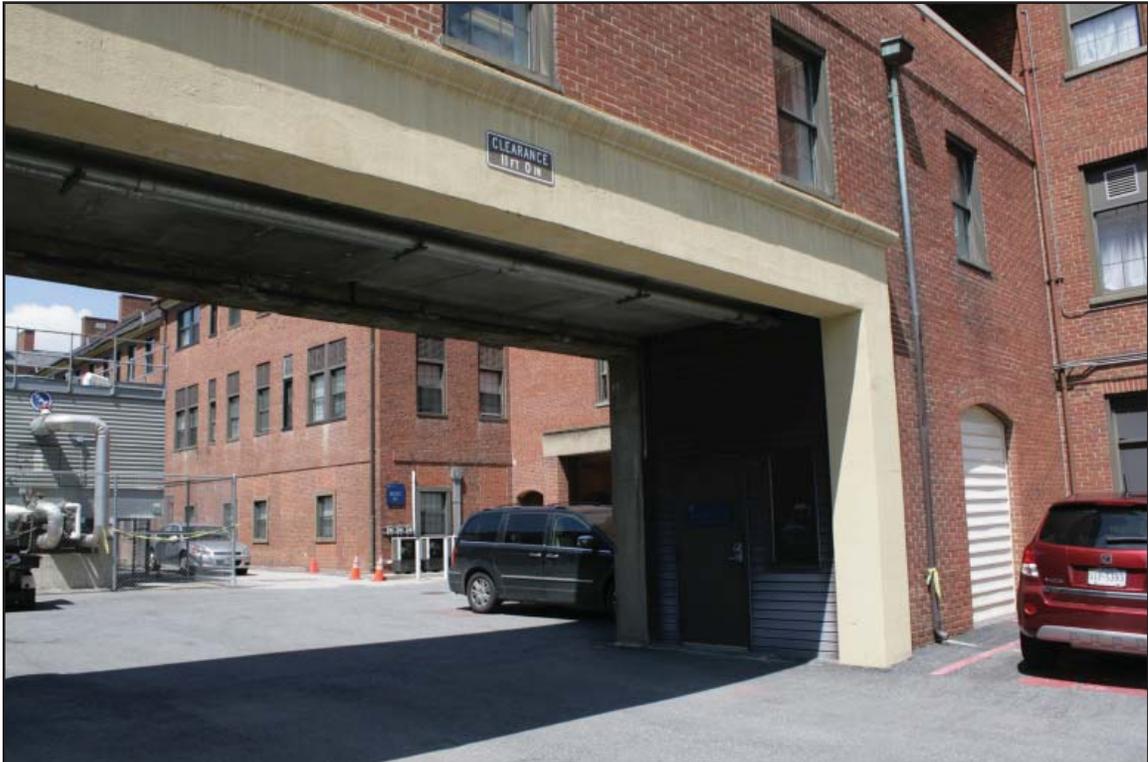
Figure 4-34. View of Building 1 south corner ca. 2010. Source: JMA 2010.

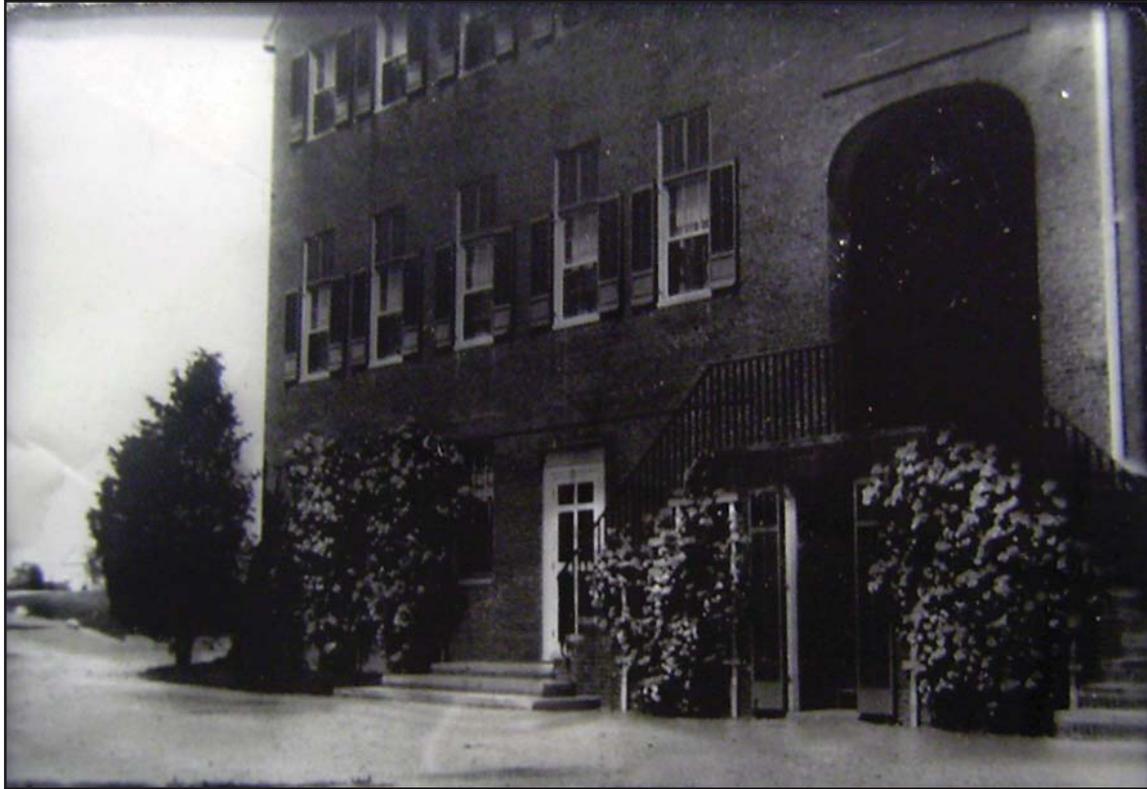
**Figure 4-35.** End of colonnade and Building 1. *Source: Mount Vernon Seminary and College Archives, Special Collections Research Center, The Gelman Library, The George Washington University.*

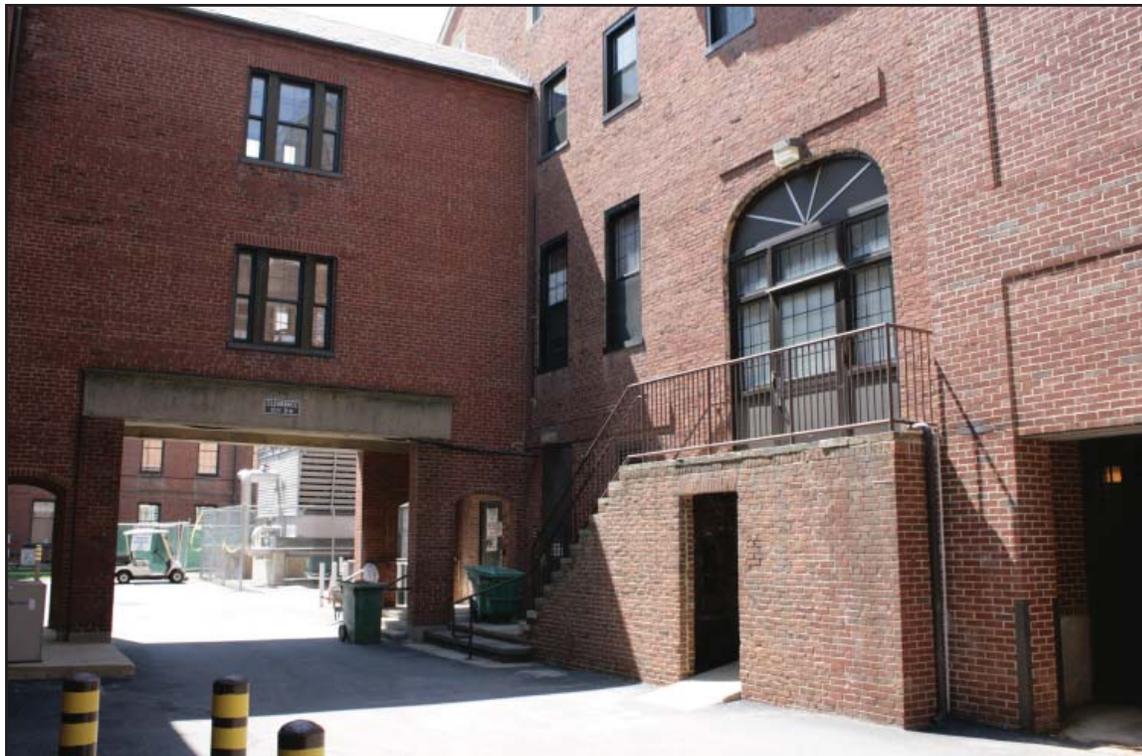
**Figure 4-36.** End of Building 1 ca. 2010. *Source: JMA 2010.*

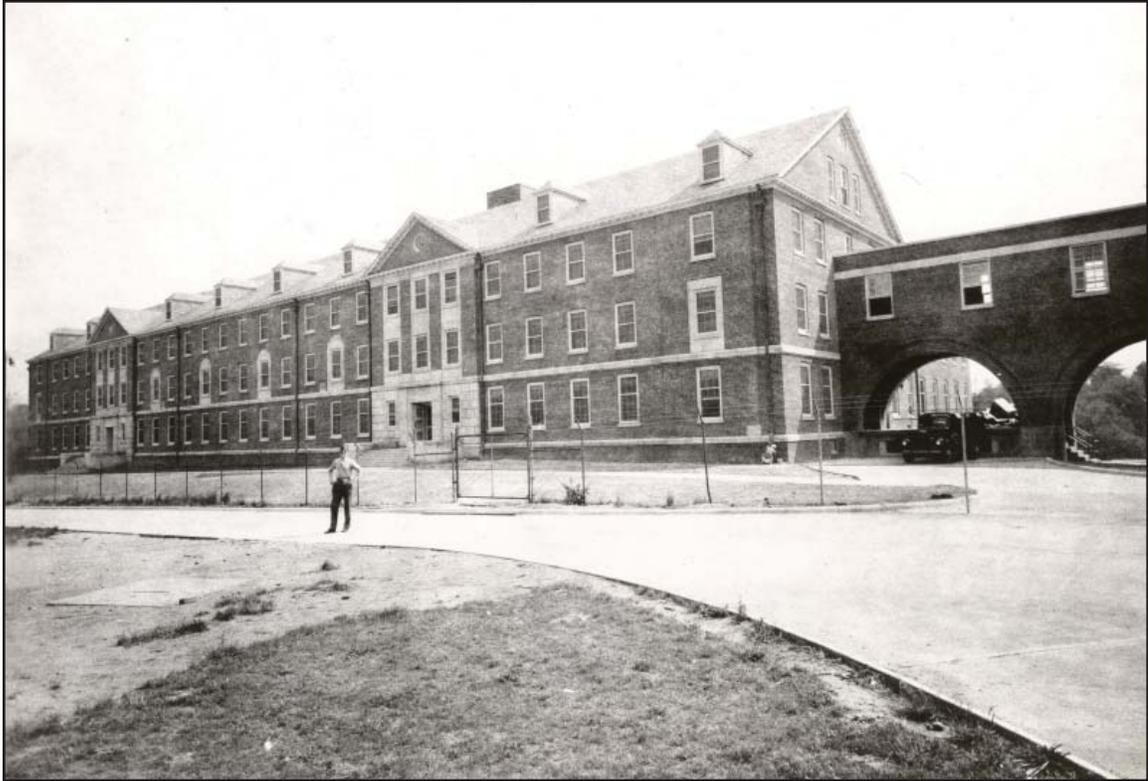
**Figure 4-37.** Building 19 ca. 1946. *Source: Nebraska Avenue Complex Public Works Archives.*

After the war ended, construction continued at the NAC to accommodate the increase in personnel brought on by the relocation of the Registered Publications System to the NAC. **Building 19** was constructed for this purpose in 1946 and provided additional office space (Figures 4-37 and 4-38). It was designed in the Georgian Revival style to match Building 18. In the same year, a two-story **arched passageway** was constructed to connect Buildings 18 and 19. The arches are well-proportioned and dramatic but today only frame views of service yards and parking lots.

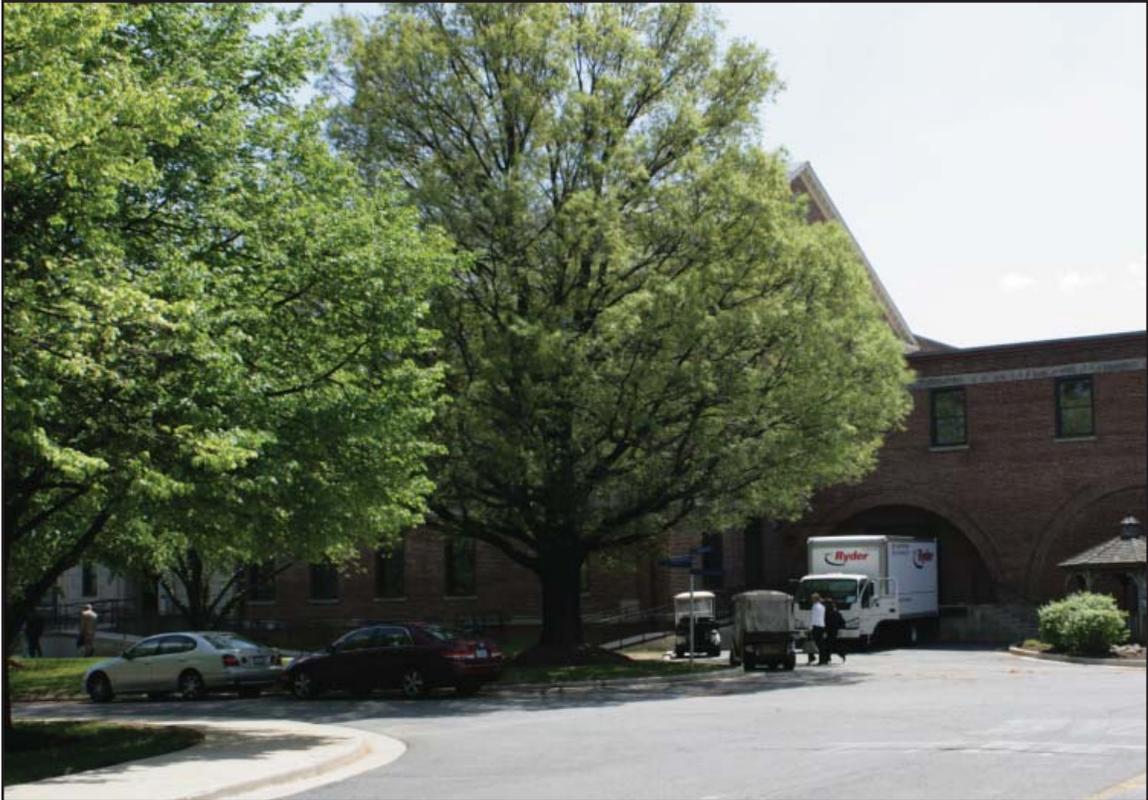
**Figure 4-38.** Building 19 ca. 2010. *Source: JMA 2010.*

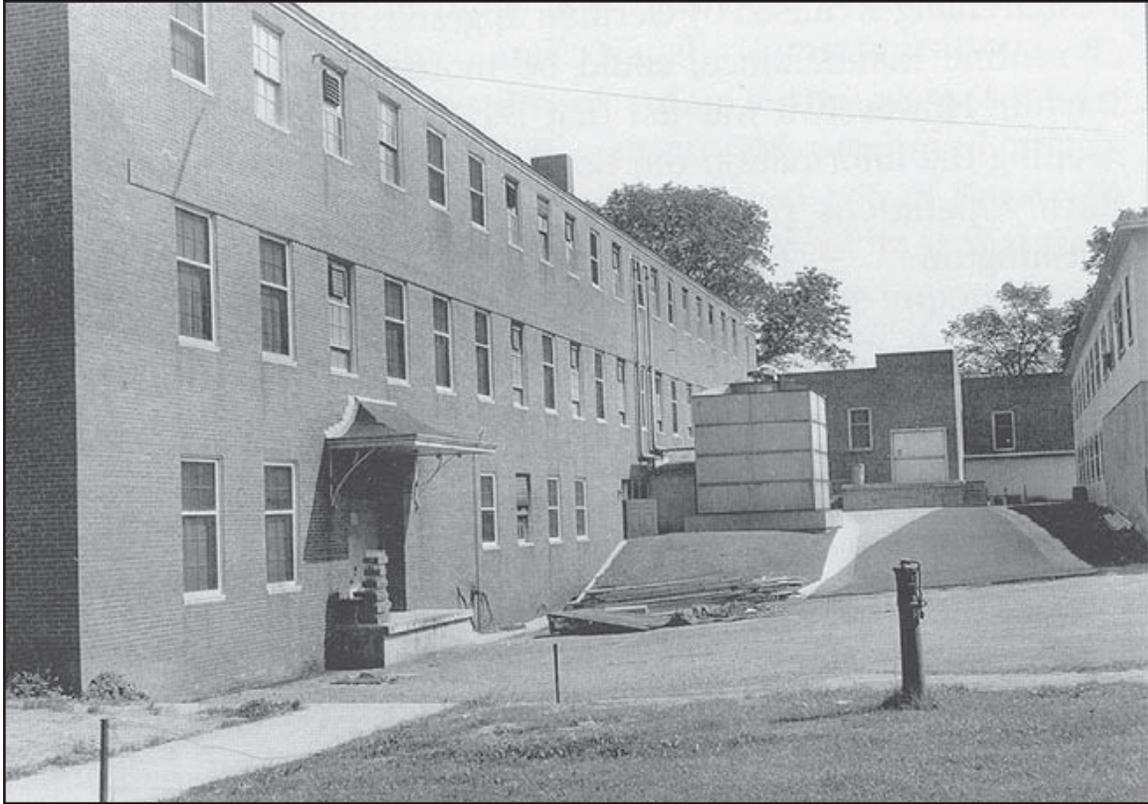
**Figure 4-39.** Space between Buildings 4 and 20. *Source: Nebraska Avenue Complex Public Works Archives.*

Off of Mount Vernon Drive extend other internal drives developed prior to 1946, including **Enigma Way**, which passes through the arches between Buildings 18 and 19 and **Intelligence Way**, which extends to the northeast behind Building 3 and terminates in a **service court** between Buildings 4 and 20. The space of the service court is extant and the few changes that have been made include the size and configuration of utilities and the installation of ramps (Figures 4-39 through 4-42).

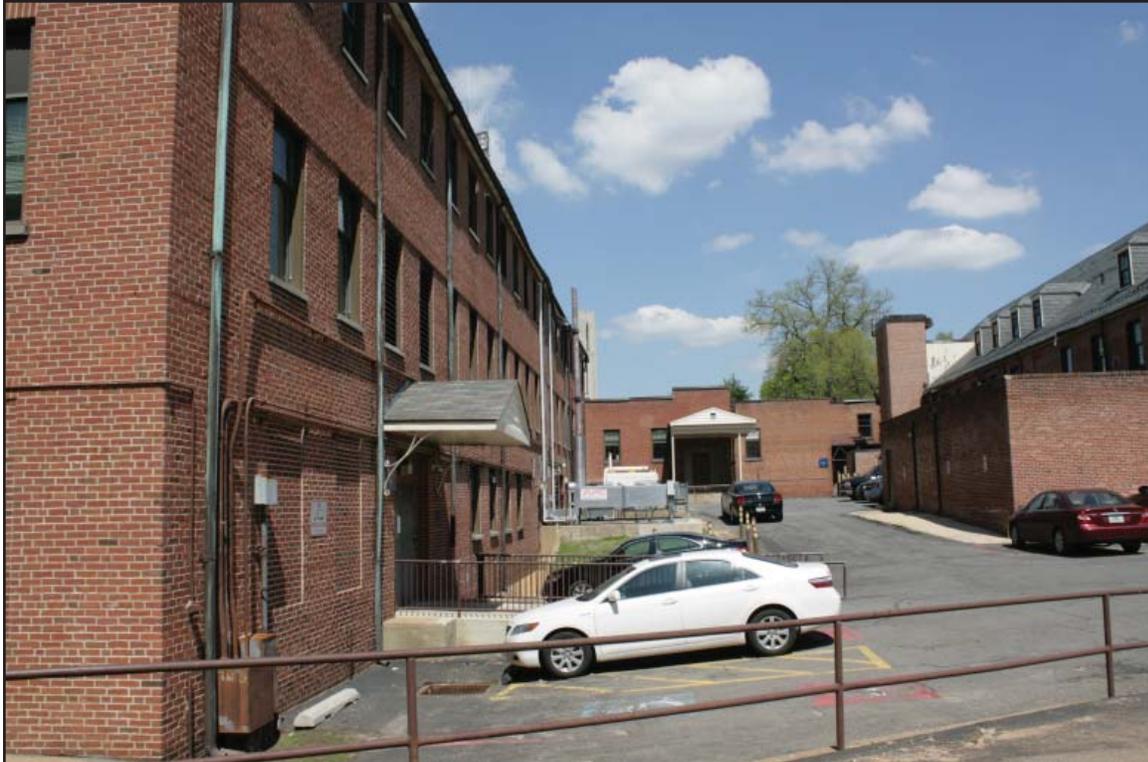
**Figure 4-40.** Space between Buildings 4 and 20 ca. 2010. *Source: JMA 2010.*

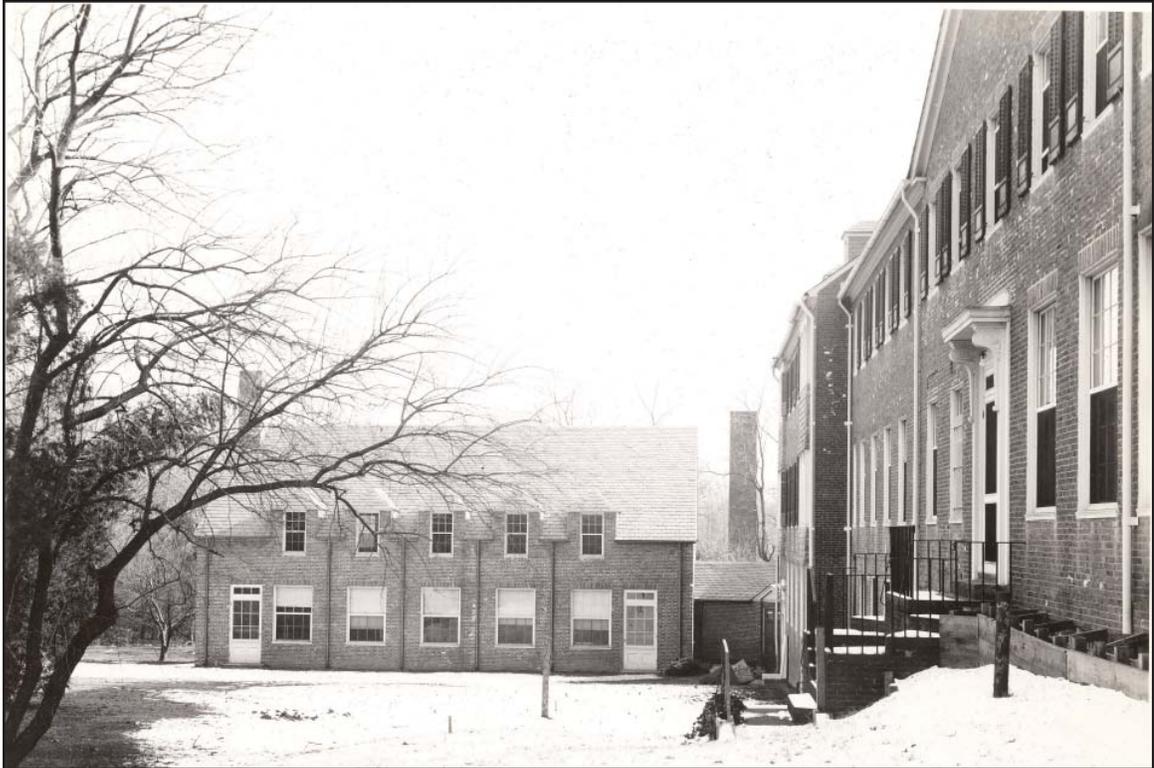
Figure 4-41. View of Building 2 ca. 1942. Source: Nebraska Avenue Complex Public Works Archives.

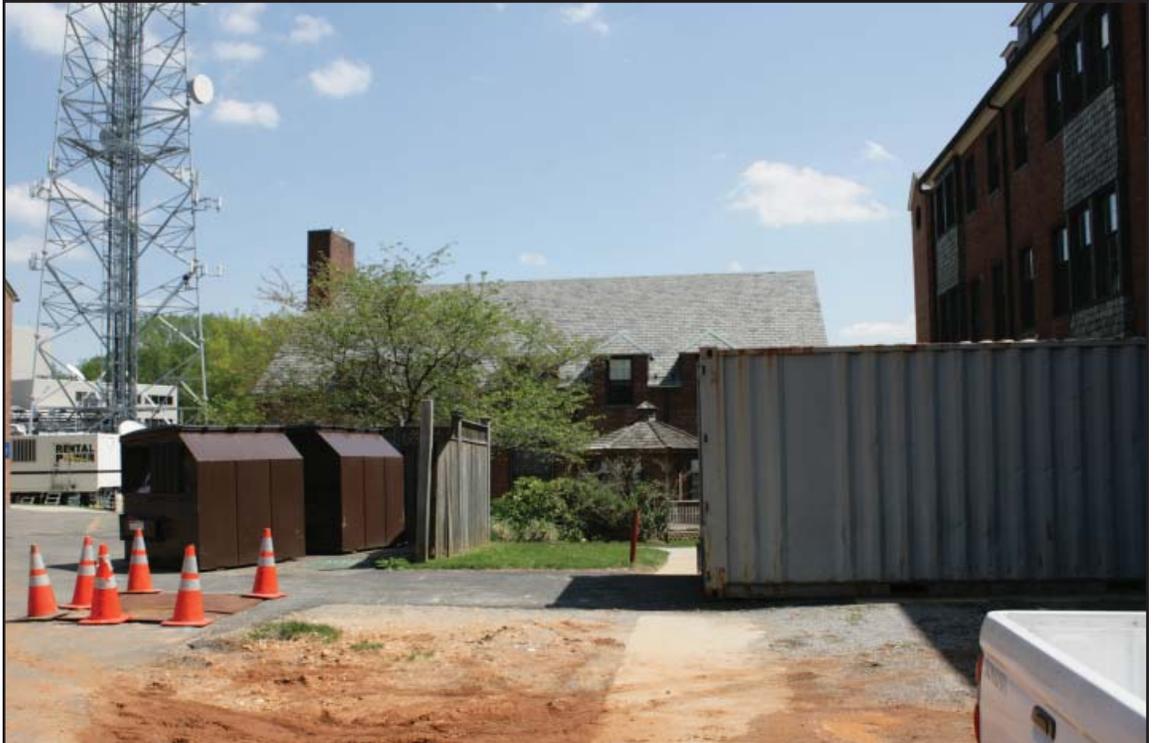
Figure 4-42. View of Building 2 ca. 2010. Source: JMA 2010.

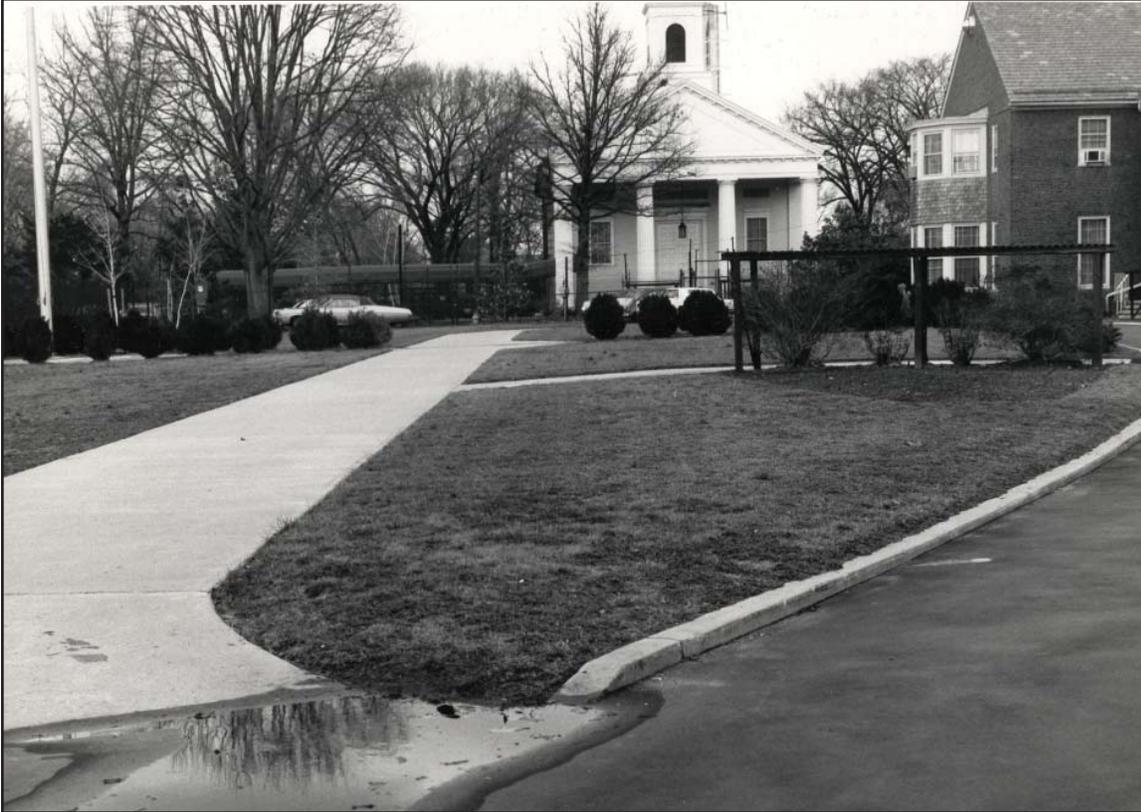
**Figure 4-43.** The Chapel and sidewalk in the 1960s. *Source: Nebraska Avenue Complex Public Works Archives.*

The western end of the Mount Vernon Seminary service drive was removed to accommodate the new entrance court and Building 17, but a remnant remains in the form of two diagonally-oriented parking spaces in adjacent to Building 7. Its eastern reach was retained and is extant today in its original alignment with the exception of its central island at the **circular turnaround**, which was eventually paved over. In addition to vehicular circulation, pedestrian circulation was provided throughout the site via **concrete sidewalks** along Mount Vernon Drive. Similar walkways led to various building access points. Of particular note is the concrete sidewalk installed through the center of the demilune lawn at Building 1 (Figures 4-43 and 4-44). Historic photographs indicate that this may have been installed prior to 1945.

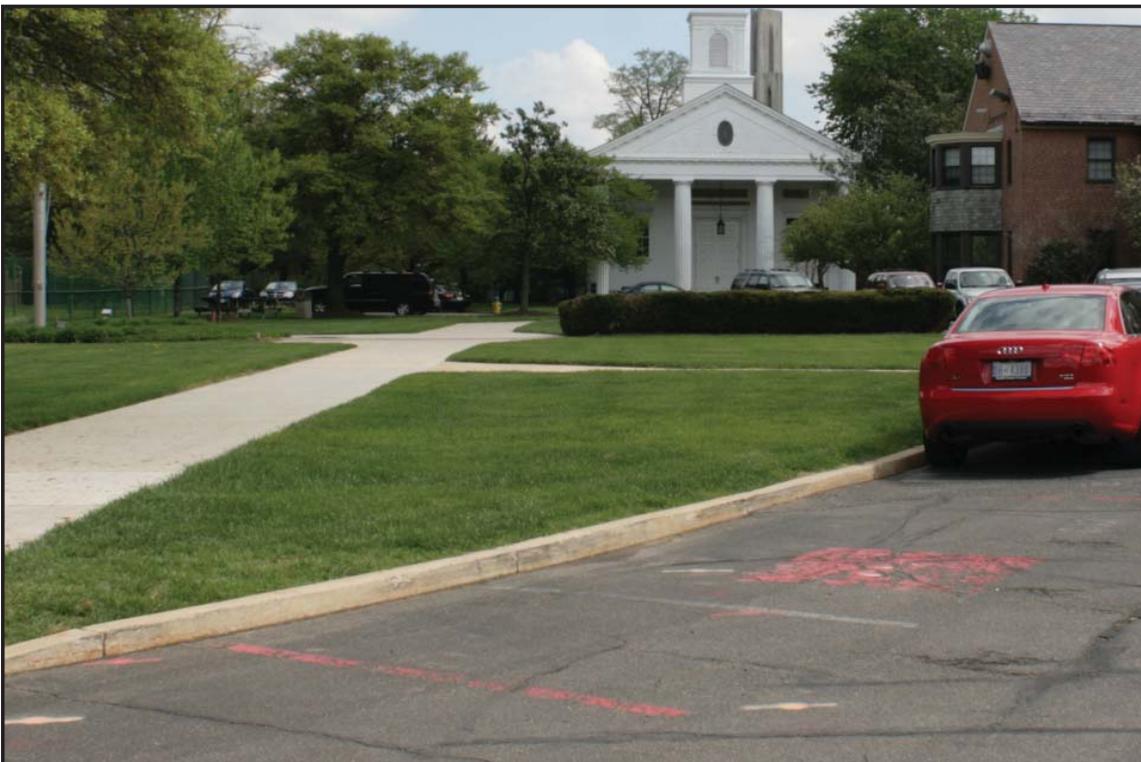
**Figure 4-44.** The Chapel and sidewalk. *Source: JMA 2010.*

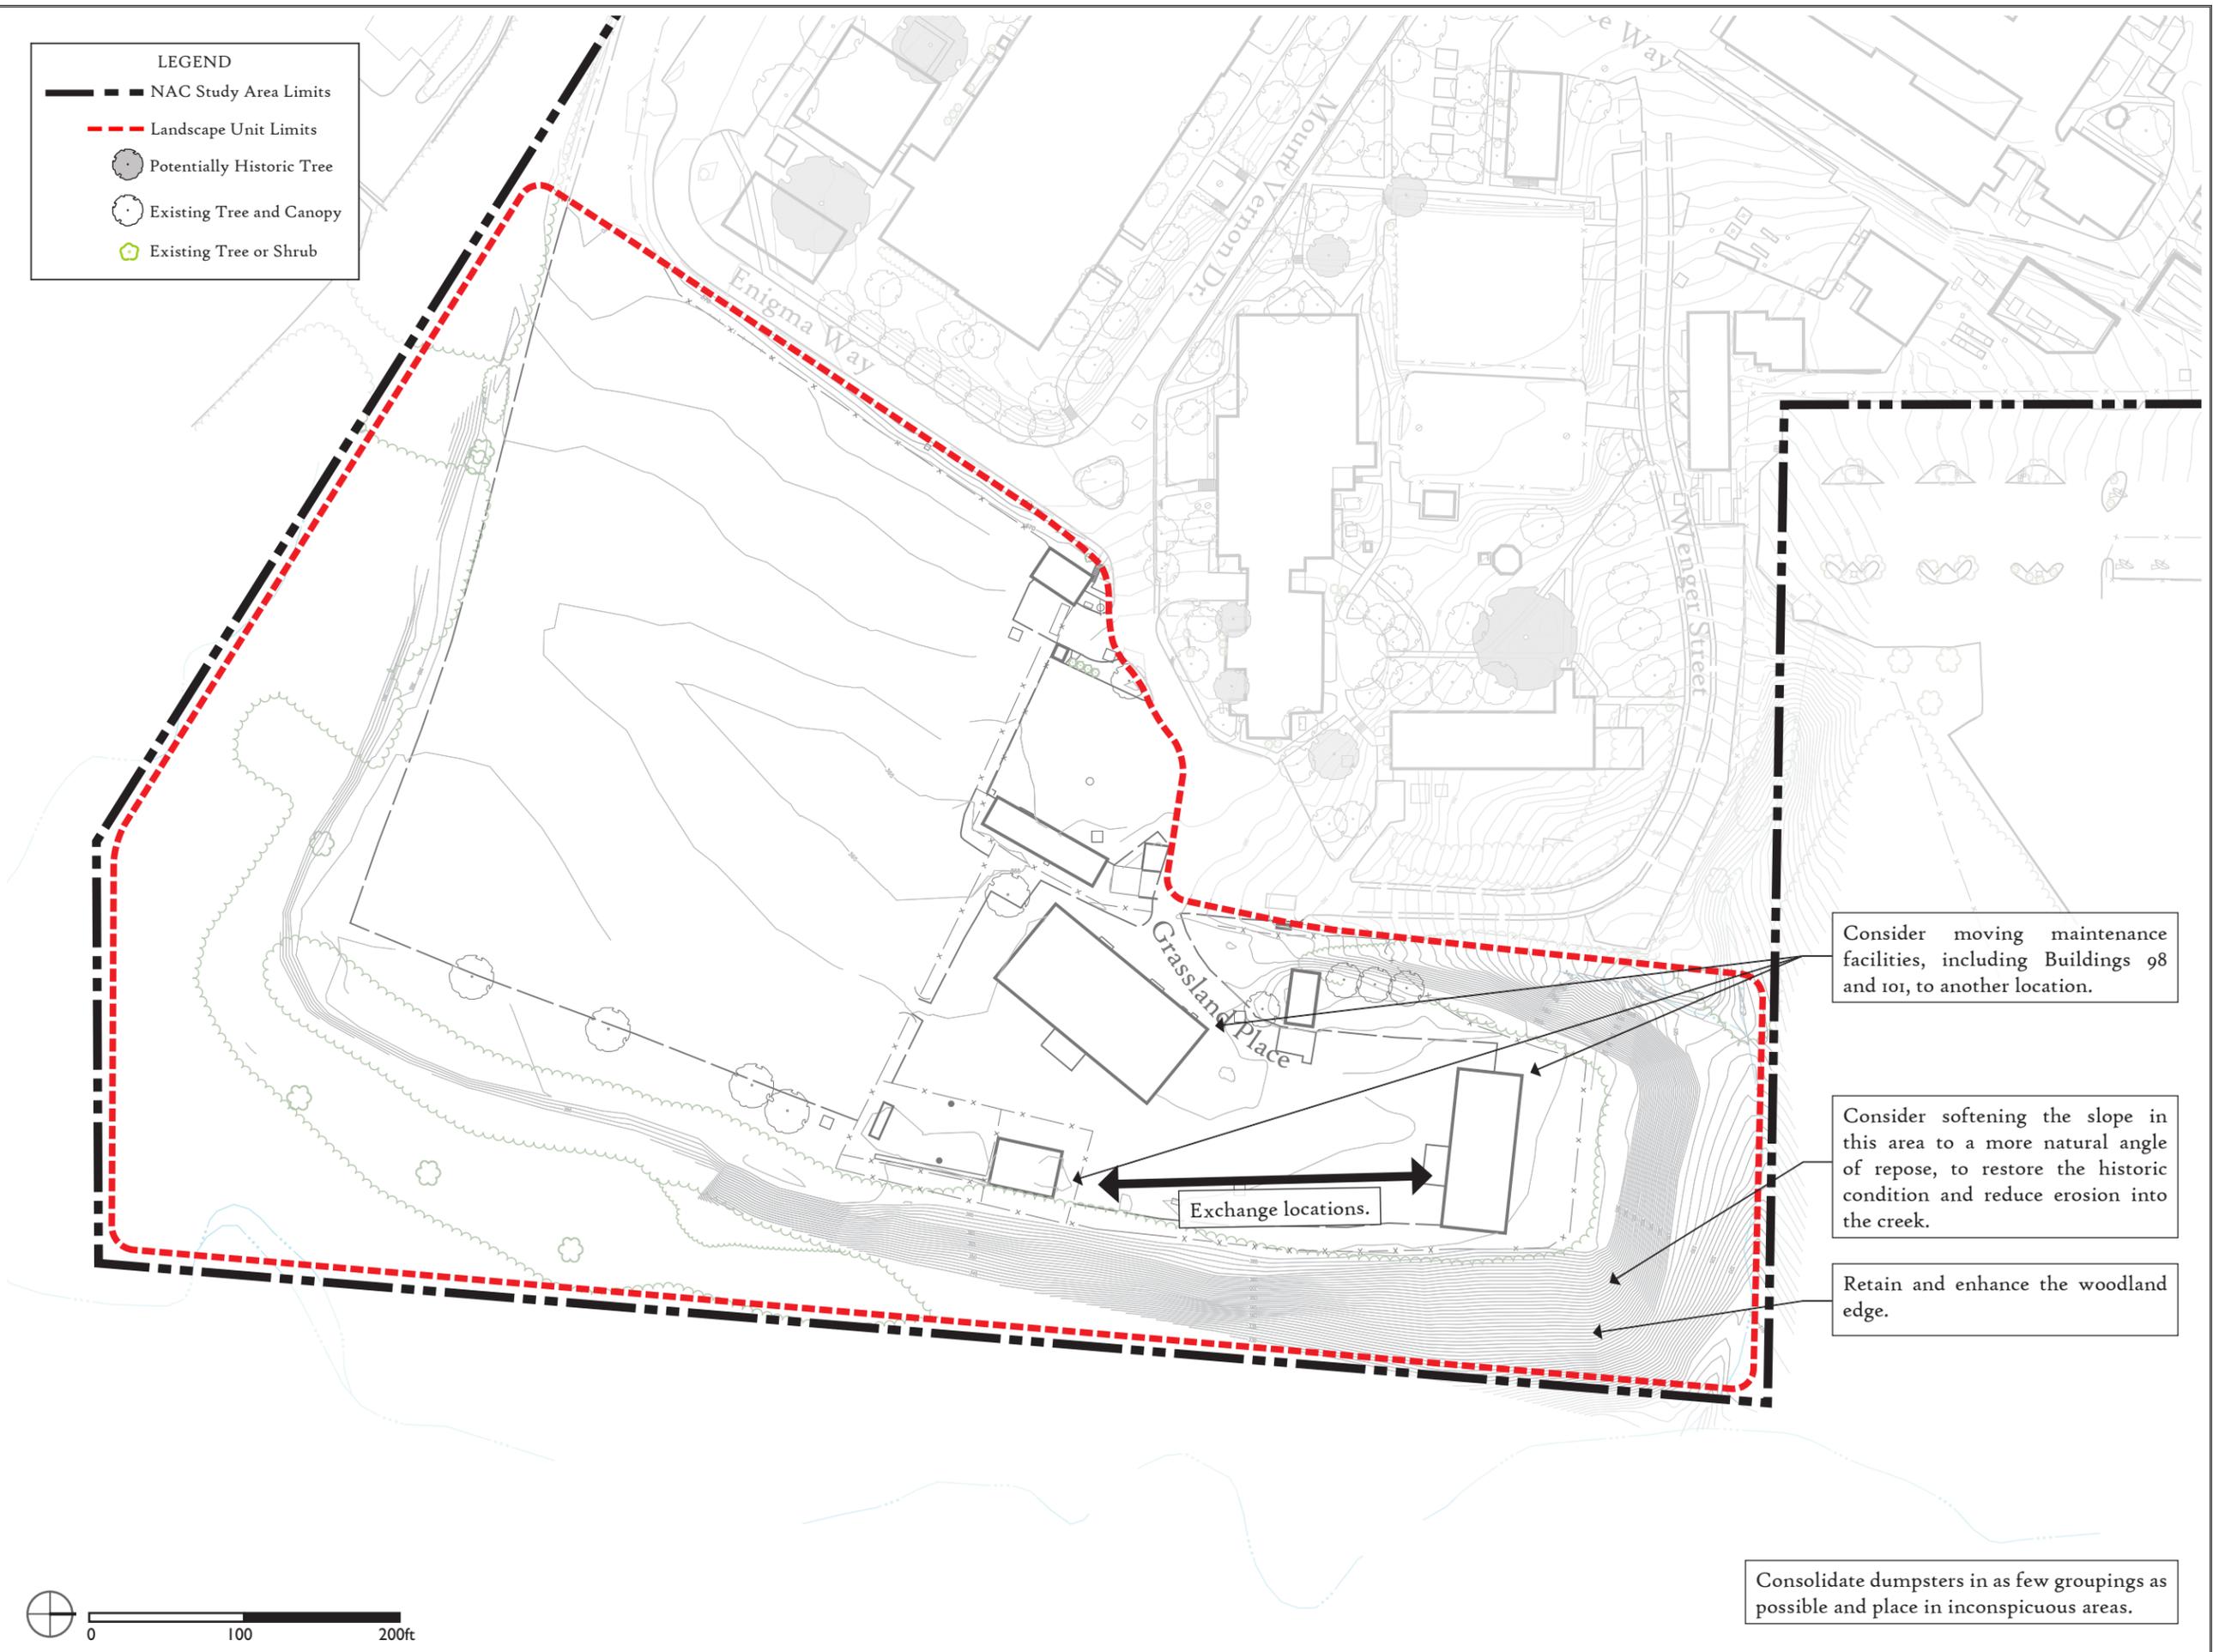
Consider moving maintenance facilities, including Buildings 98 and 101, to another location.

Consider softening the slope in this area to a more natural angle of repose, to restore the historic condition and reduce erosion into the creek.
